DOVER HIGH SCHOOL AND CAREER TECHNICAL CENTER Site & Building Assessment Report

Dover, New Hampshire

August 2015

Volume 2 of 3

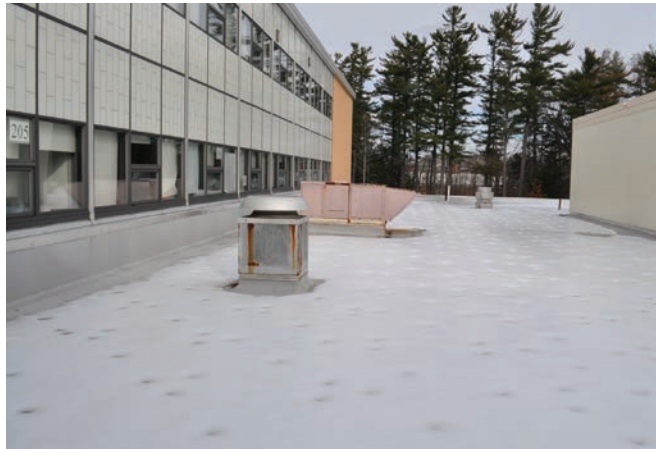
View of Roof with snow cover

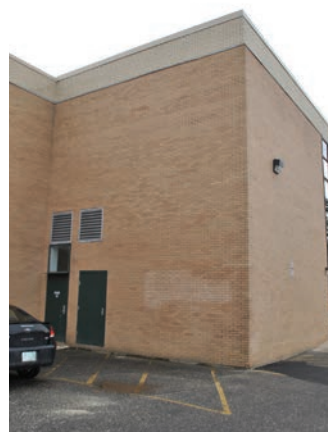
Visible Efflorescence

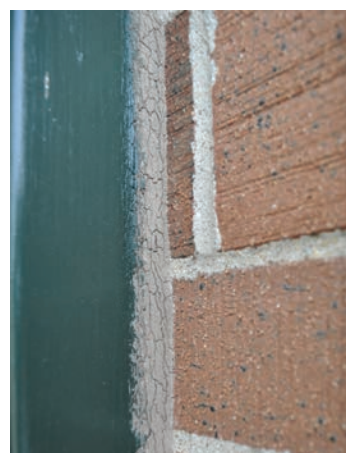
Cracked Sealant

The sealant around windows, doors, and control joints is showing signs of cracking, and some of the visible loose lintels are rusting with decay. There are various corners around the building where brick has been damaged and requires replacement. Although the masonry wall system does not meet today's code, the overall condition appears to be good, and with minimal work, new sealant, selective repointing, selective brick replacement, and a thorough cleaning, further investigation to its reuse should the building be renovated is recommended.

Brick Veener – Exterior wall not compliant with IECC, seek alternate compliance methods or upgrade wall to be compliant. Recommend recaulking at all control joints, doors, windows and inside masonry corners, selective repointing and replacement brick

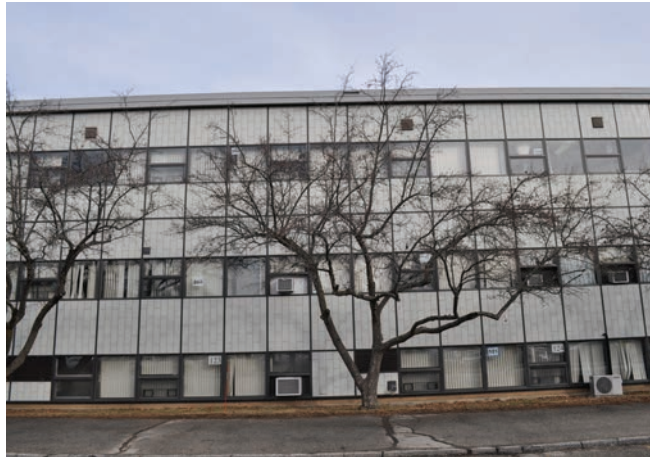
Exterior Wall System 2 - Curtain Wall with Kalwall Infill

Aluminum Curtain Wall System – Full replacement of Exterior Kalwall Insulated Panel system and windows. See structural report for required structural upgrades with any replacement

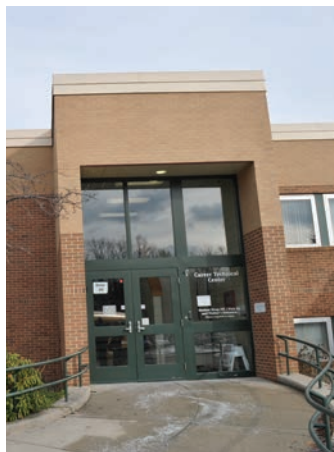
CTC Entrance & Brick in Disrepair

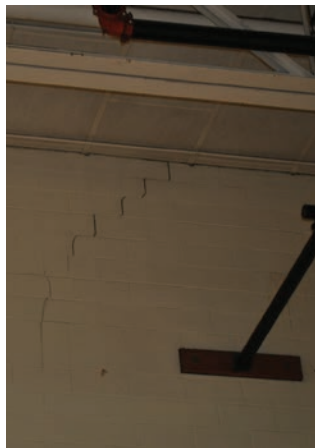
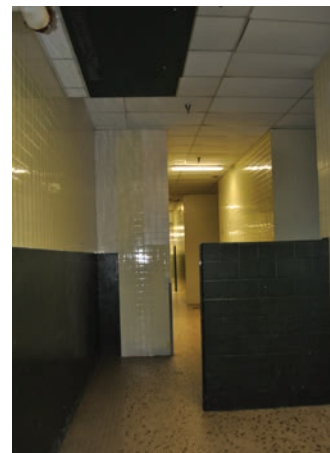
Boy's Locker Rooms

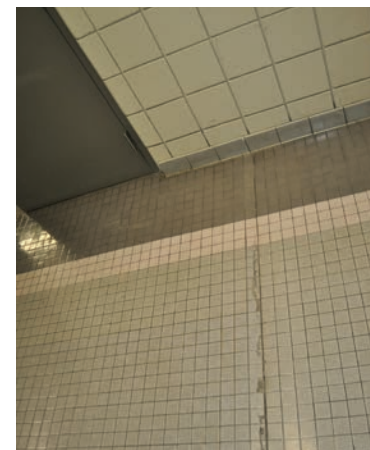
Cracked Tile Floor

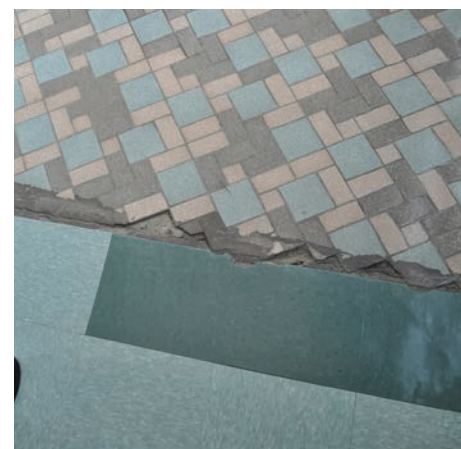
Missing Expansion Joint at 2002 Addition

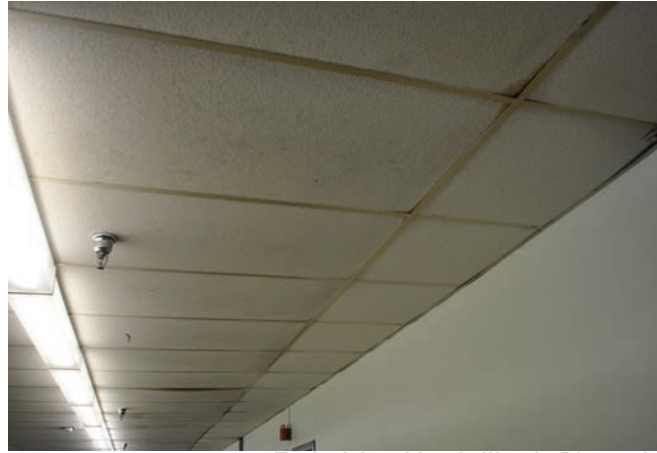
Typical Corridor Ceiling in Disrepair

Acoustic Ceiling Tile (ACT) is installed throughout the school, and is in complete disrepair. Much of the ceiling tile and grid is warped, stained, or painted. None of the existing ceiling tile and grid is salvageable and will require full replacement with any renovation.

- a. Replace all ceiling tile and grid

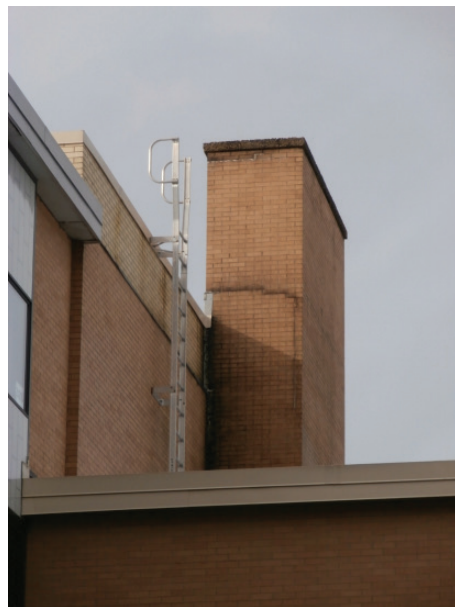
6. Masonry chimney – note step crack near upper roof line.

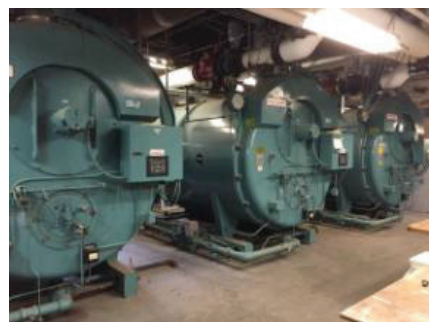
The building is primarily heated by gas fired hot water boiler plant. There are three (3) gas-fired hot water boilers located in the lower level boiler room. The boilers were manufactured by Cleaver Brooks (Model CBLE-700 240 125, Serial Nos. 0L102065, 0L102066, 0L102067) with 9,900 MBH gas input. The boilers are equipped with CB Hawk boiler controls. The boilers were installed circa 2002 and are approximately 12 years old. The boilers appear to be in good physical condition.

Existing Boilers

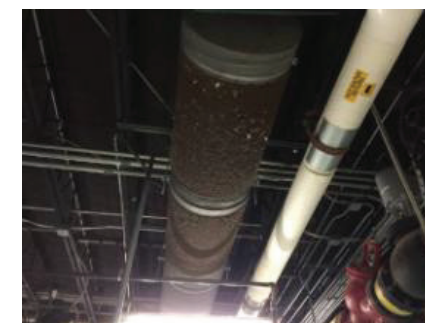
Combustion Air Perforated Supply Diffuser

Combustion air for the boilers is provided by two (2) inline combustion air fan systems. Combustion air is distributed to the boilers via galvanized sheetmetal ductwork and perforated supply diffusers that are located between the boilers. The perforated supply diffusers were observed to be dirty and clogged.

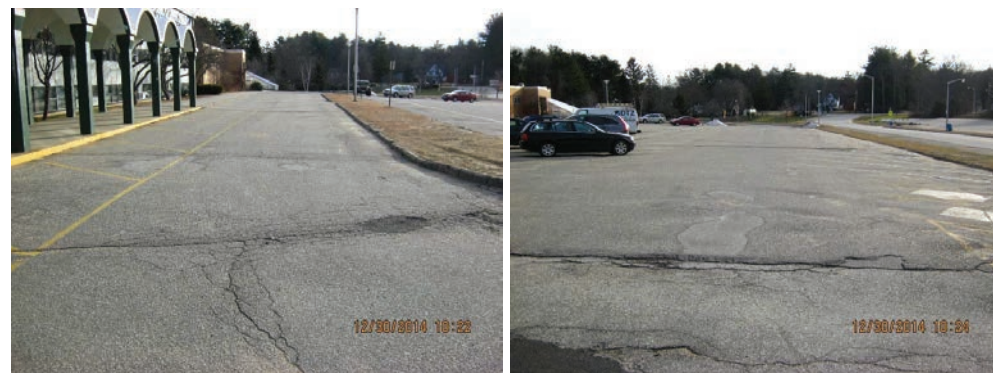
- Upon visual inspection the condition of the existing pavement is generally less than satisfactory. Numerous cracks (longitudinal, traverse, alligator) were observed in both the bus-drop off loop and the A Lot. Few of the cracks observed in the pavement have been sealed using asphalt crack sealant while the majority of the cracks have been left untreated.
- Some patch work and pavement overlays have been done over the years presumably to address the worst sections of pavement.
- Some raveling and aging (pavement surface deterioration/loss of aggregate) of the pavement is evident throughout but is the worst in the visitor parking spaces.
- The pavement overlays at the entrance and exit from Alumni Drive are in good condition.

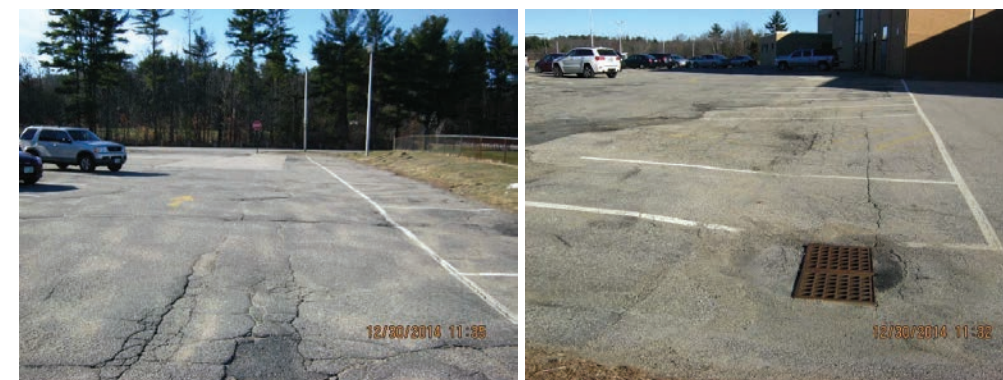
B Lot

- Upon visual inspection the condition of the existing pavement is generally poor. Numerous cracks (longitudinal, traverse, alligator) were observed in both the B lot and the portion of the lot associated with the 2002 addition. Few of the cracks observed in the pavement have been sealed using asphalt crack sealant while the majority of the cracks have been left untreated.
- Some patch work and pavement overlays have been done over the years presumably to address the worst sections of pavement.
- Some raveling and aging (pavement surface deterioration/loss of aggregate) of the pavement is evident throughout.
- The pavement overlay at the entrance and exit from Alumni Drive is in good condition.
- The entrance and exit from Alumni Drive is in less than satisfactory condition.

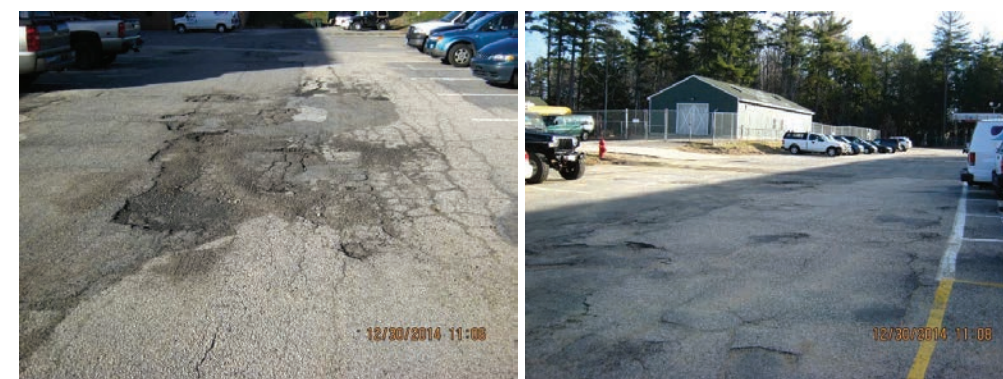
C Lot

- Upon visual inspection the condition of the existing pavement is generally very poor. Numerous cracks (longitudinal, traverse, alligator) were observed in the C lot. A few of the cracks observed in the pavement have been sealed using asphalt crack sealant while the majority of the cracks have been left untreated.
- Some patch work and pavement overlays have been done over the years presumably to address the worst sections of pavement.
- Serious raveling and aging (pavement surface deterioration/loss of aggregate) of the pavement is evident throughout sections of the C lot. This likely results in surface ponding during/following rain events.
- The entrance and exit road from Alumni Drive is in less than satisfactory condition.
