# Technical Memorandum

January 7, 2015

Tolend Road Peer Review  
Dover, New Hampshire  
UE Job #1876

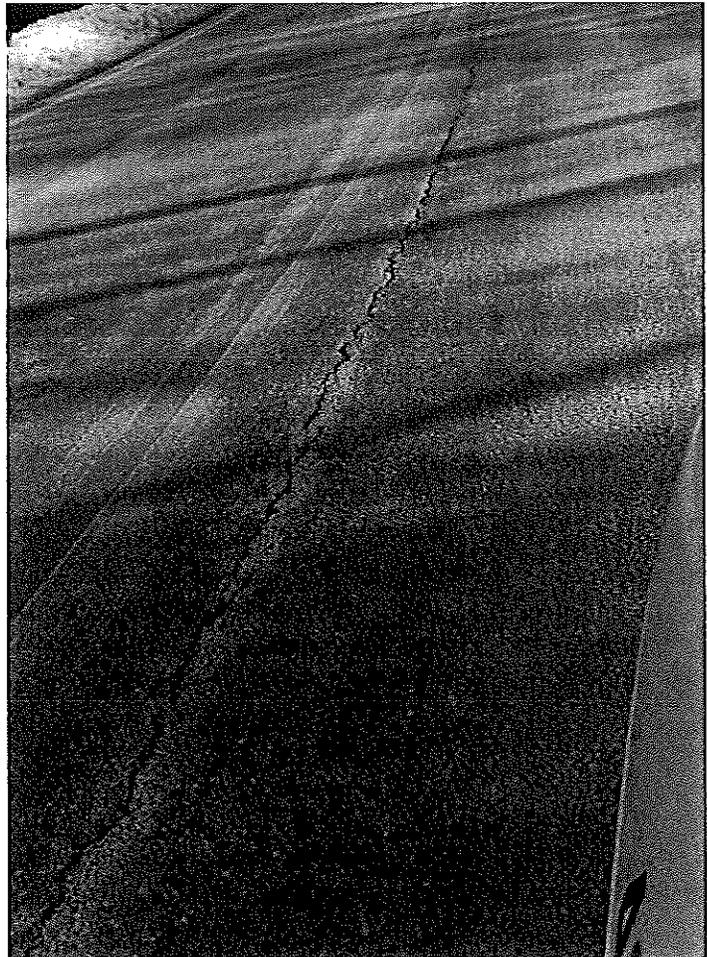
In January 2014, pavement cracking was observed. In July 2014, CMA completed an inventory of the cracking. A draft Change Order was prepared to mitigate the cracking prior to placement of the wearing course.

Photo 1. Cracking observed in January 2014

- If not done so already put the Contractor on notice that the pavement is considered defective in accordance with the appropriate section of the contract documents.
- Provide temporary mitigation of cracking by completing crack sealing prior to winter. This will reduce water migration.
- Make efforts to reduce truck traffic on Tolend Road until the mitigation efforts are complete and final structural pavement overlays are installed.

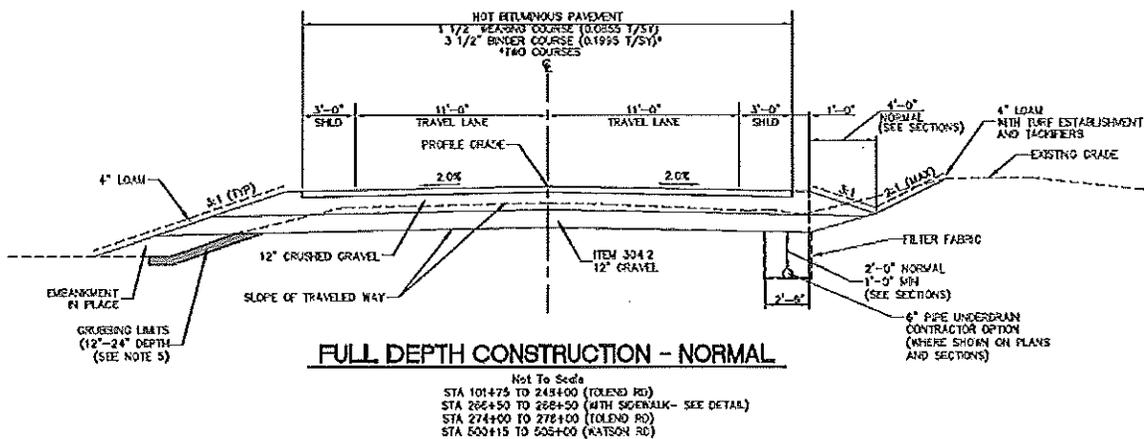
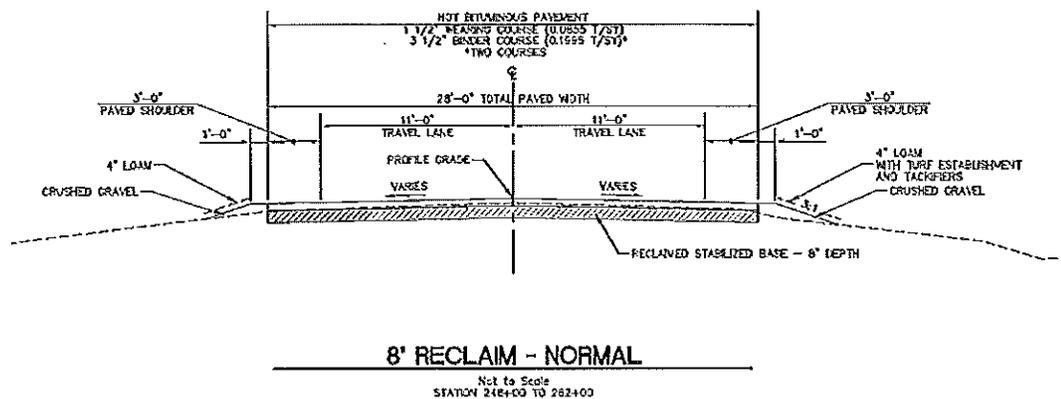
The Contract Documents called for a 'boxed out' reconstructed road section from Barrington to STA 248+00 (14,675 feet) and reclaim beyond STA 248+00 (1,750 feet). The standard details from the construction drawings are shown below:

The cross-sections identified a standard 2% crown, except where transitions occurred or where superelevation was designed into the roadway. The longitudinal slope (road
