CITY OF DOVER FACILITIES, GROUNDS & CEMETERIES MASTER PLAN

CITY OF DOVER, NEW HAMPSHIRE

FEBRUARY 2018

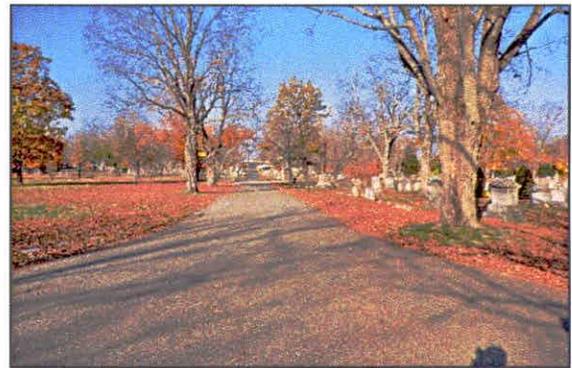
In addition, the narrow entrance drive width and road steepness make both visibility and vehicle access difficult. Main Avenue in the location of the Chapel is in poor condition with cracking pavement and areas of failure. Pedestrians can access the cemetery via a sidewalk from Central Avenue that extends up to the Chapel. The sidewalks in this location are in extreme disrepair.

- Road sections where failure of pavement (heaving and settlement) occur, milling of pavement and repaving is recommended. Where there is excessive heaving or settlement, a full depth reconstruction should be completed.
- Decrease the amount of vehicular access points into cemetery from East Watson Street and Court Street.

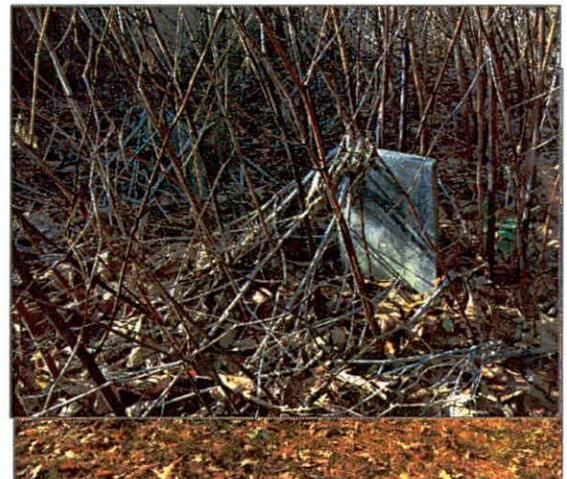
- **Invasive Plant Material.** It is recommended that the Japanese knotweed along the southerly border be addressed as the aggressive root system will continue to overtake the cemetery. Currently, numerous headstones are buried within the knotweed.

Eradication of Japanese knotweed requires a thorough process and dedication to its removal. The below table outlines two treatment schedules that vary in length of time to reach results.

Knotweed can also be eradicated by deep excavation of the root system and removal of contaminated soils. This method is highly intrusive and can be costly. It is recommended for isolated pockets of knotweed. Removed soils must be disposed of properly to prevent spread.

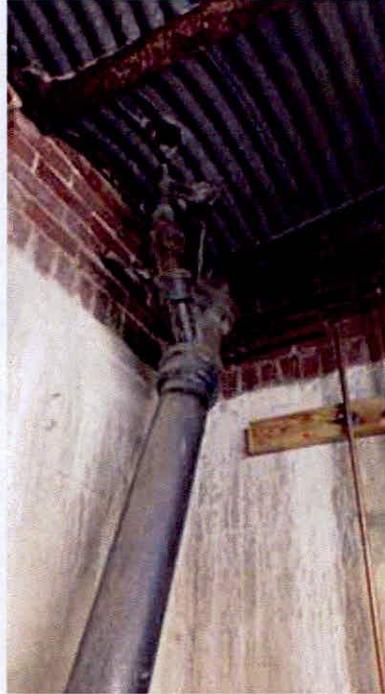
Chapel drainage piping.
