City of Dover

New Hampshire

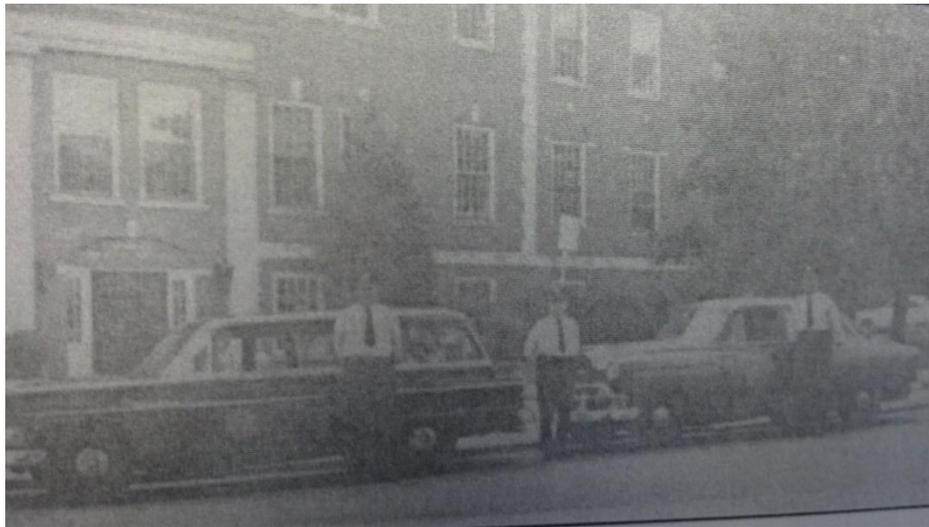
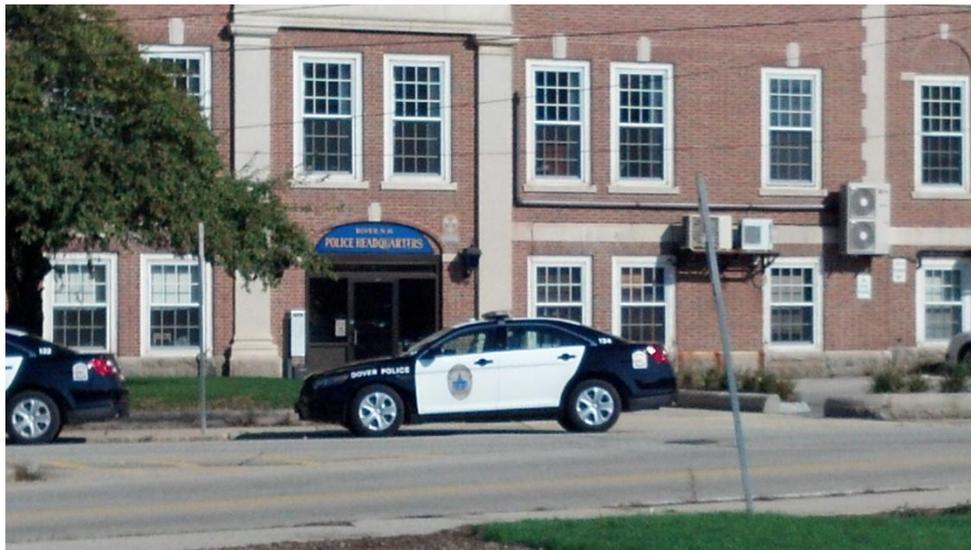
The need for a new police facility has been repeatedly stressed through professional studies; most recently the City of Dover Master Plan and Space Needs study by AG Architects of 2007, as well as the Planning Department/Lassel Architects Space Study of 2001 and the City of Dover Cost Containment study by Bennett Associates of 1993. Additionally the Police Department Strategic Planning Committees of 2012, 2006, and 1997, comprised of citizens, has determined that the need for a new police facility is of the highest priority.

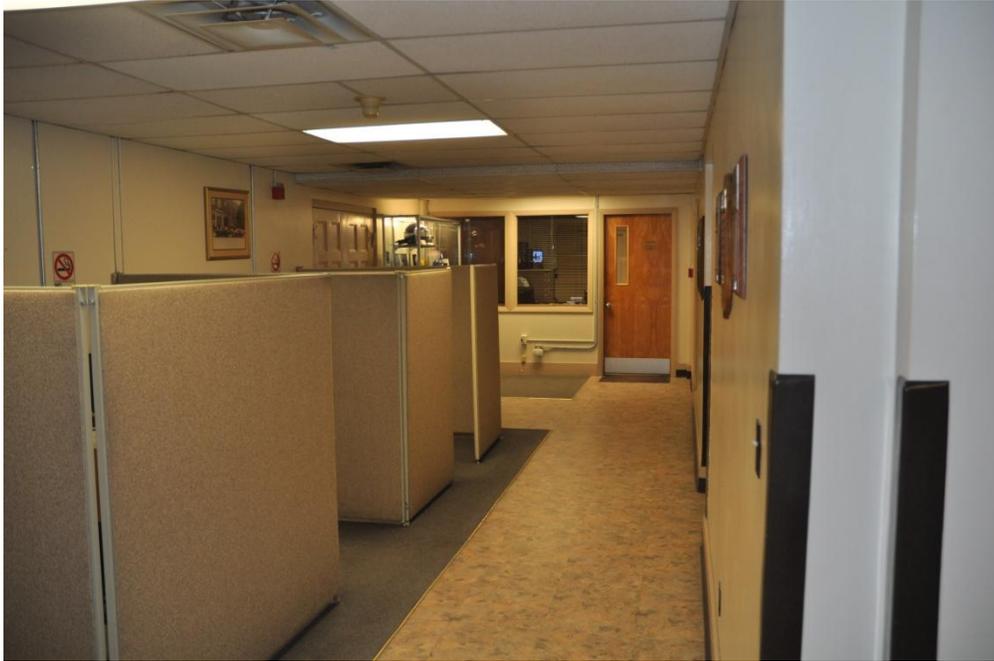
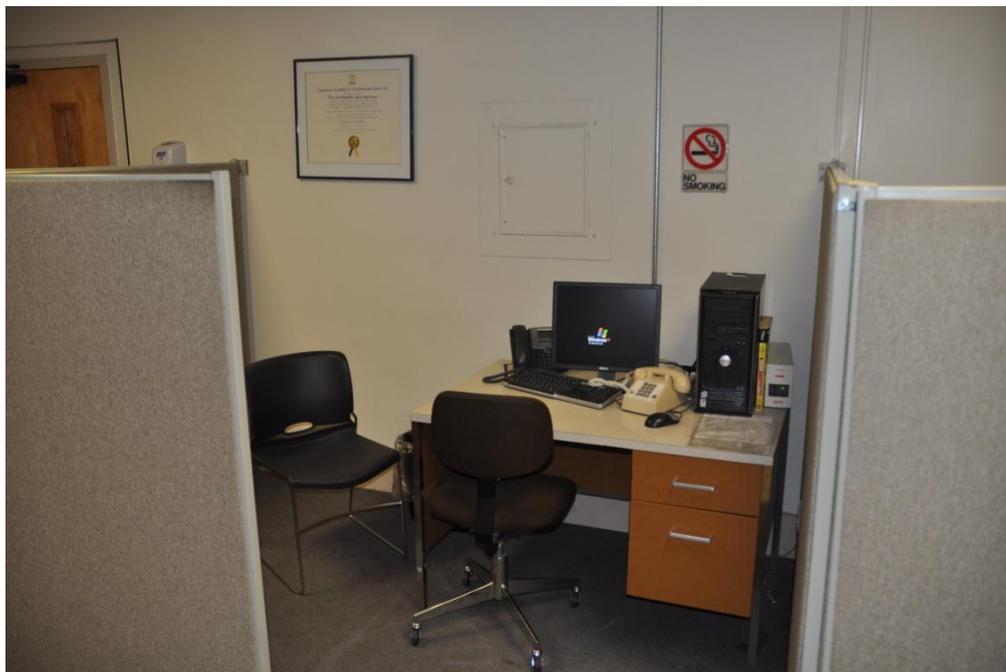
Records Bureau Office

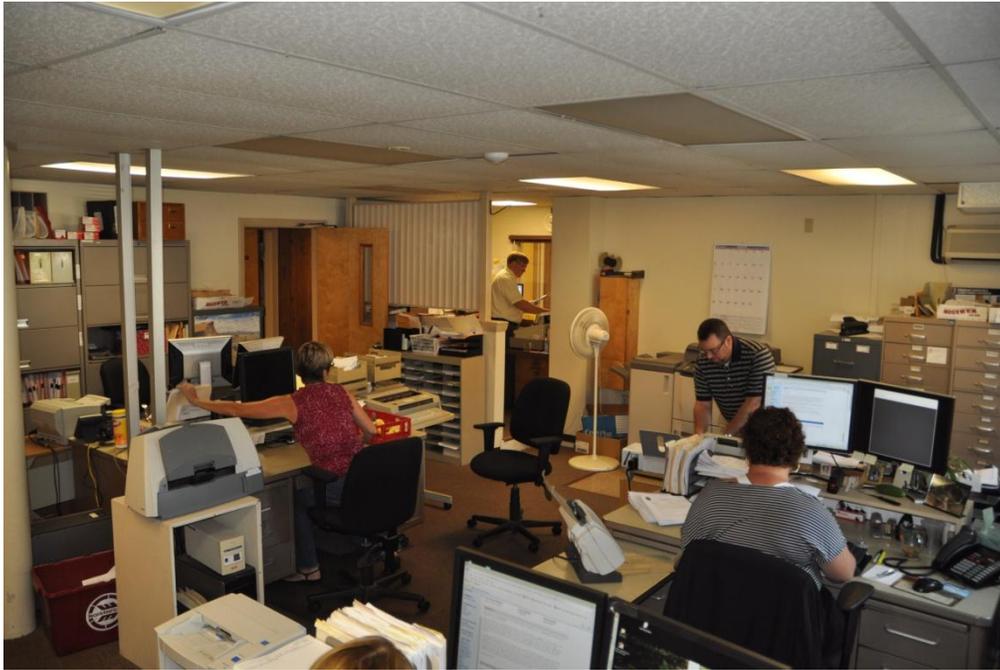
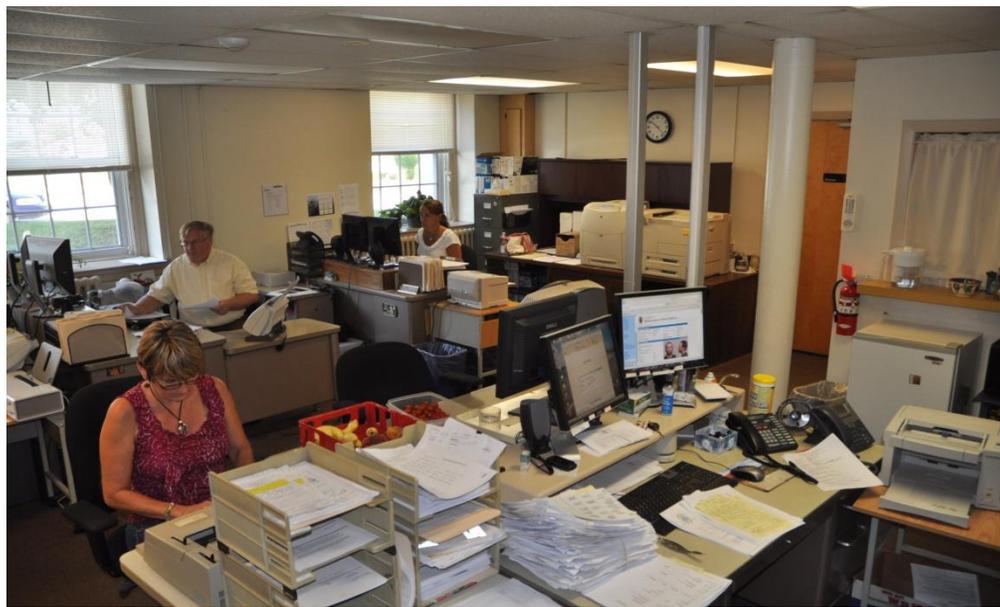
Interior view of unfortified window in Records Bureau office

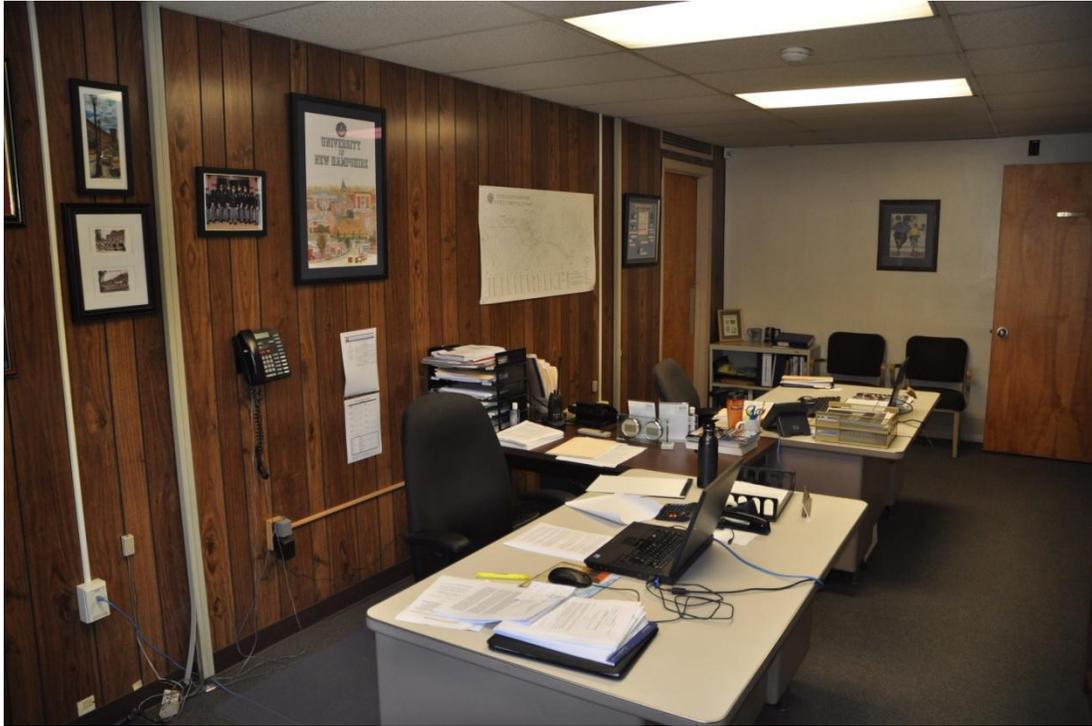
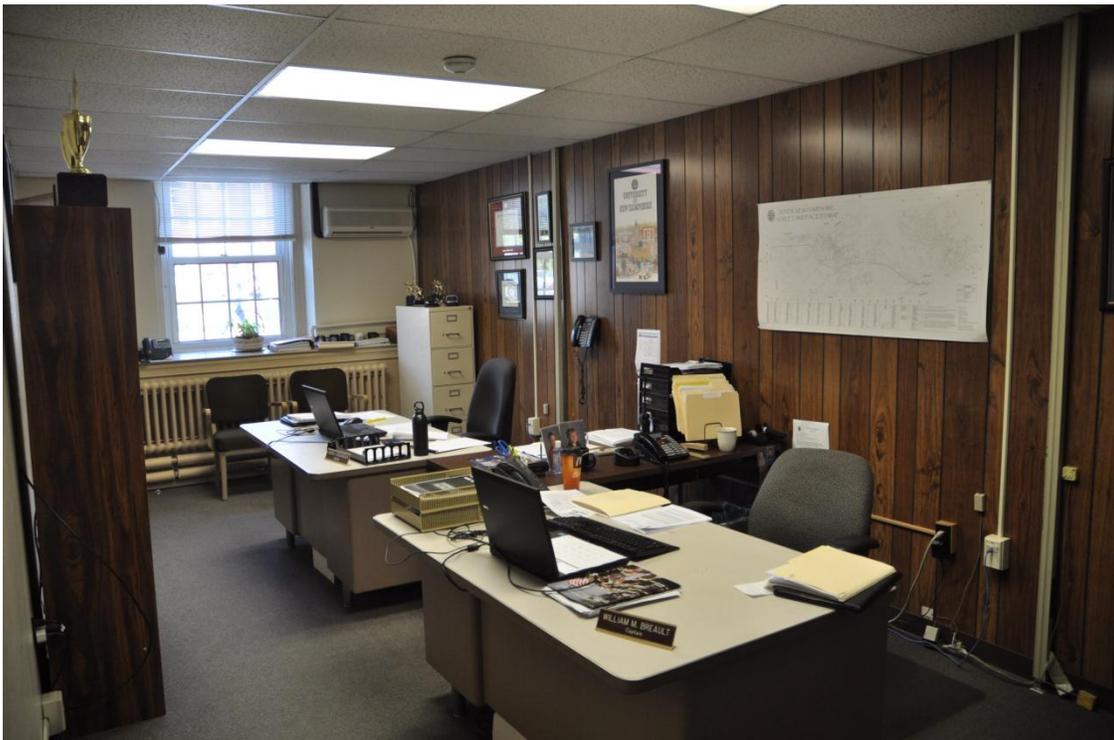
Parking Bureau Office

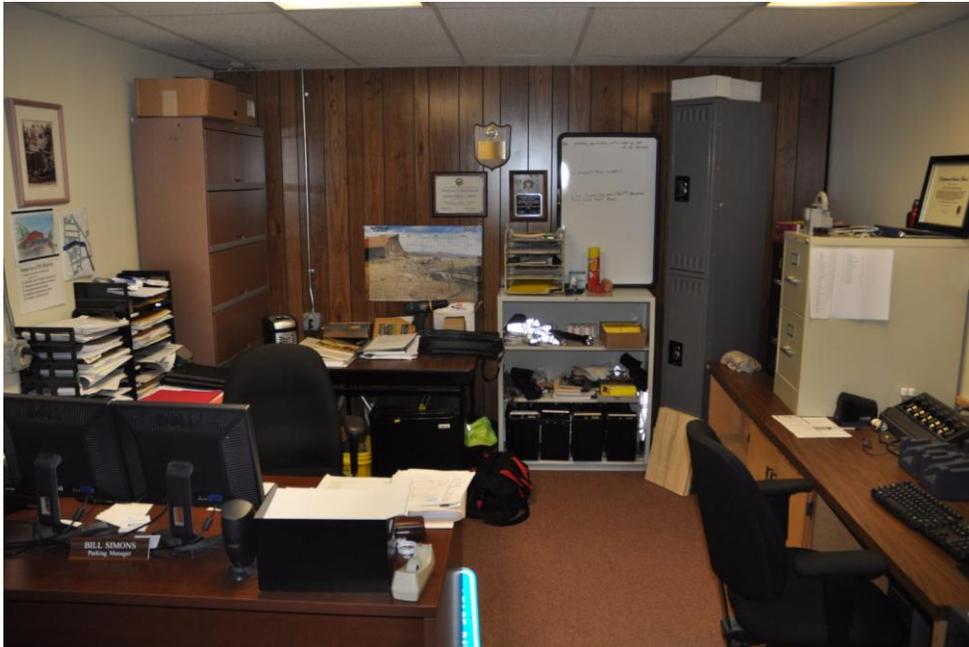
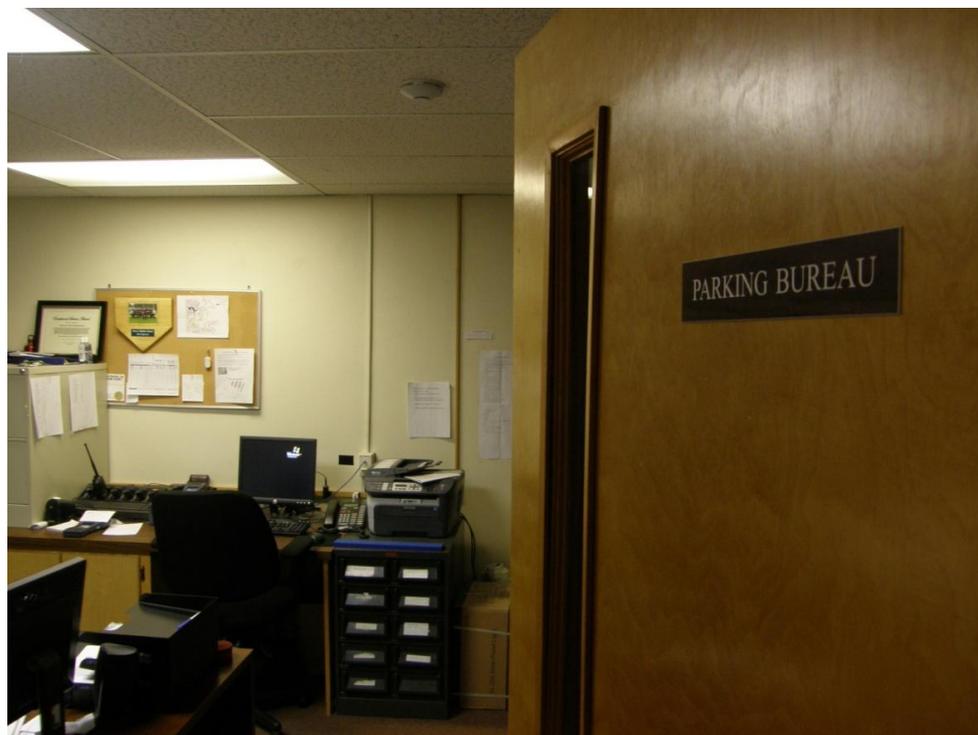
Special Investigations Bureau Office

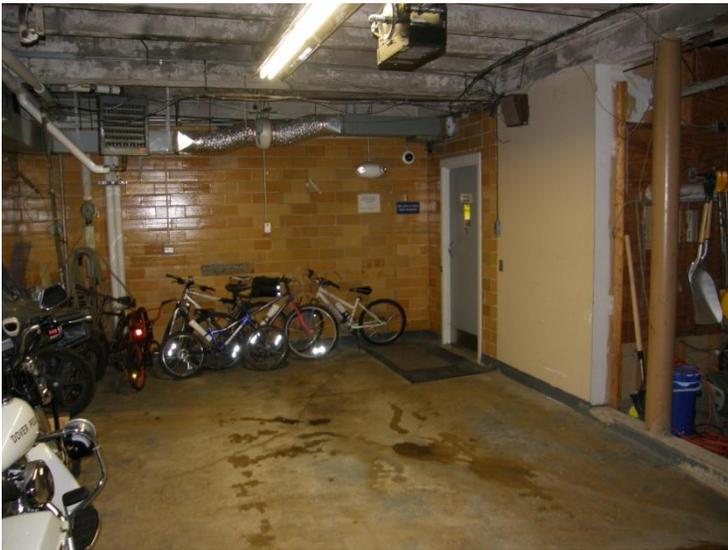
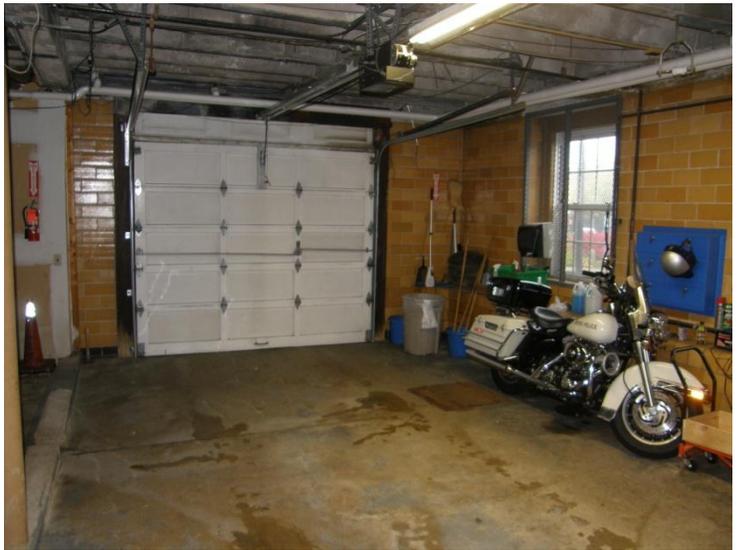
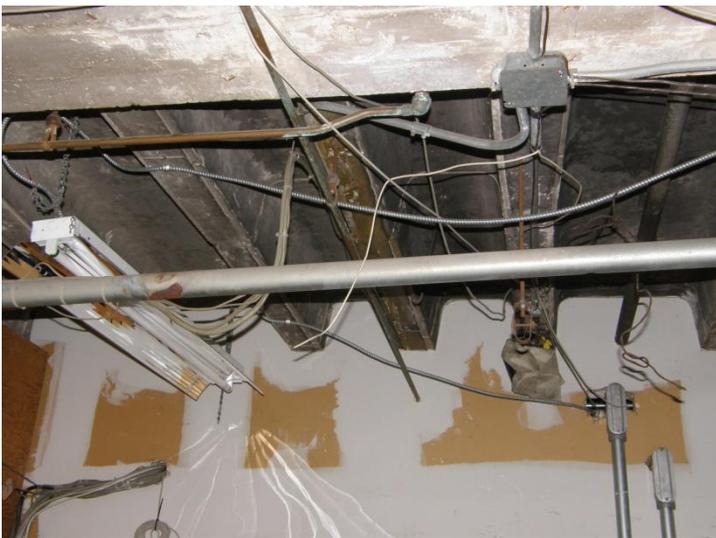
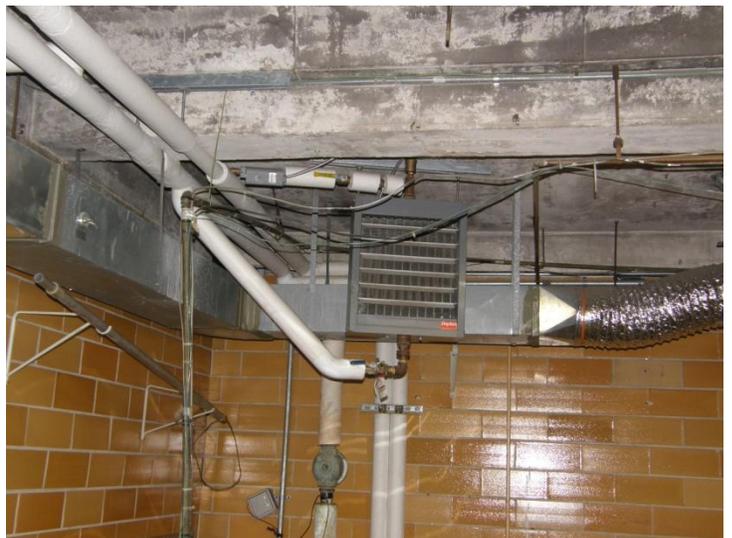
The sally port or garage bay located on the north side of the Locust Street façade is used for the temporary parking of police vehicles that are transporting arrestees. Due to a lack of space within the facility, the area is used as overflow, and short term storage. The area, through which officers are required to walk prisoners, has exposed wiring and plumbing.

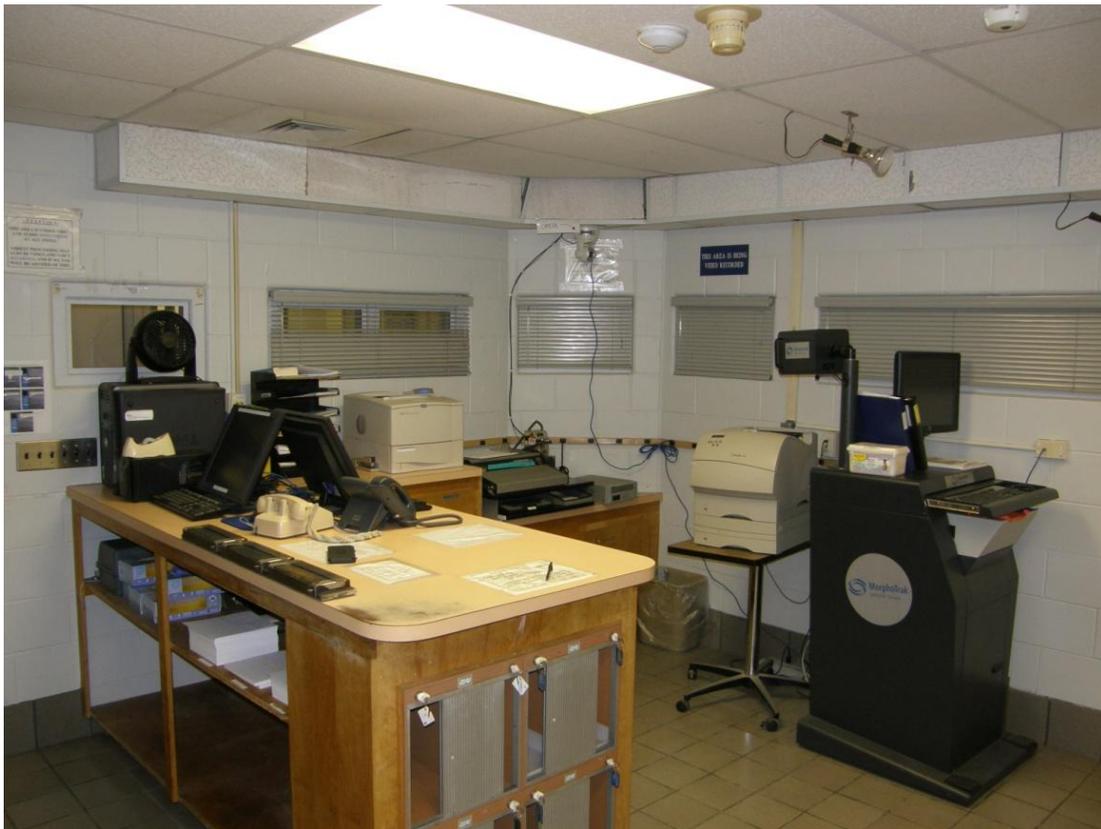
Prosecution / Animal Control

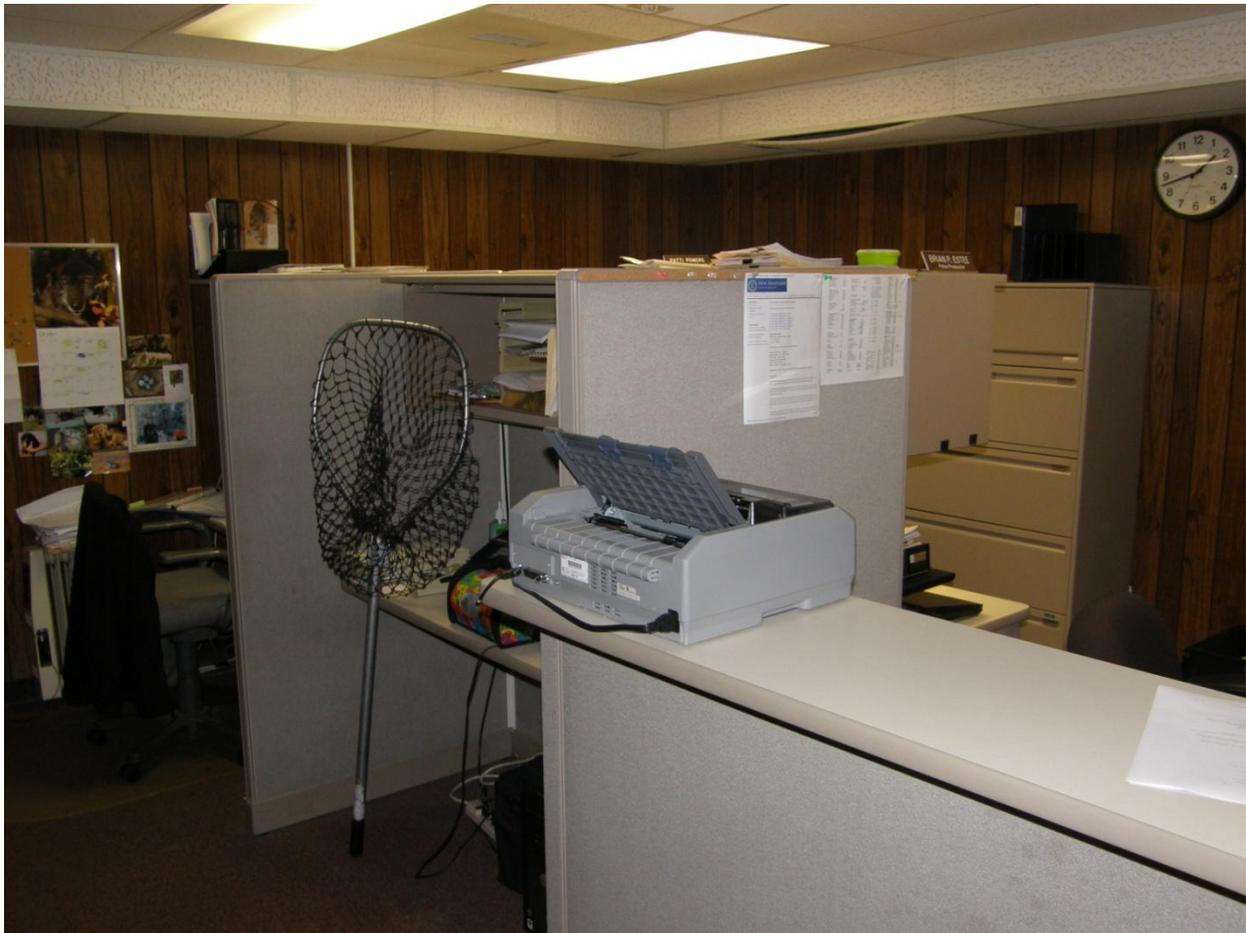
The room currently used to house the police prosecutor, victim witness advocate and prosecution secretary had been the roll call room until 2000. Due to a lack of space elsewhere in the facility, the animal control officer is housed in the same room. In order to perform her duties, the animal control officer has several nets, traps and cages that are stored in the same room. Additionally, the room has no heat and the proximity to an exterior door forces the use multiple space heaters during winter months.

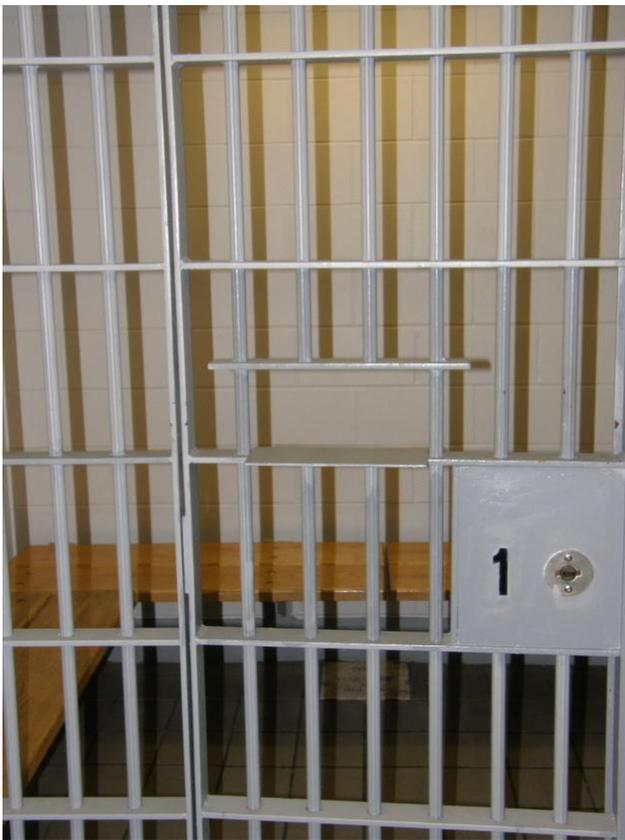
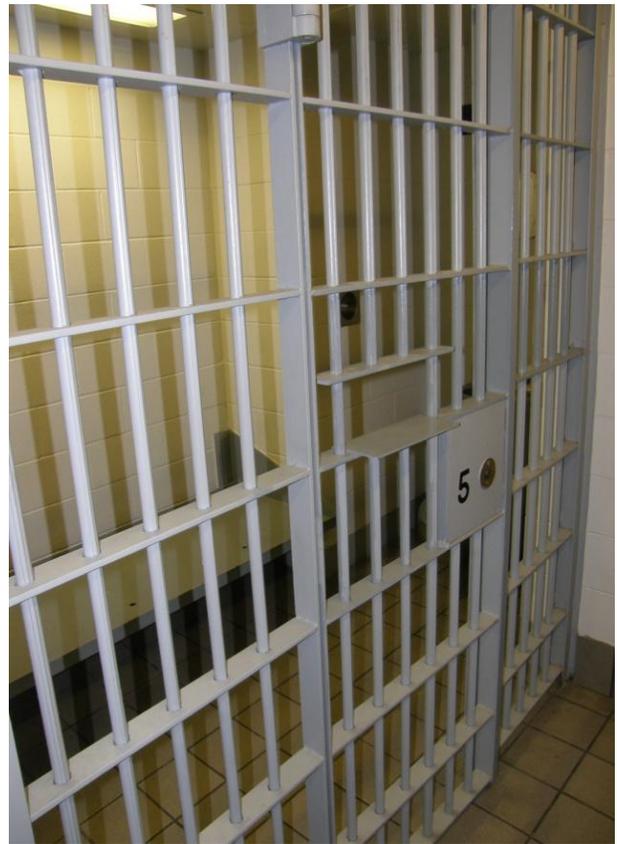
Indoor vehicle storage

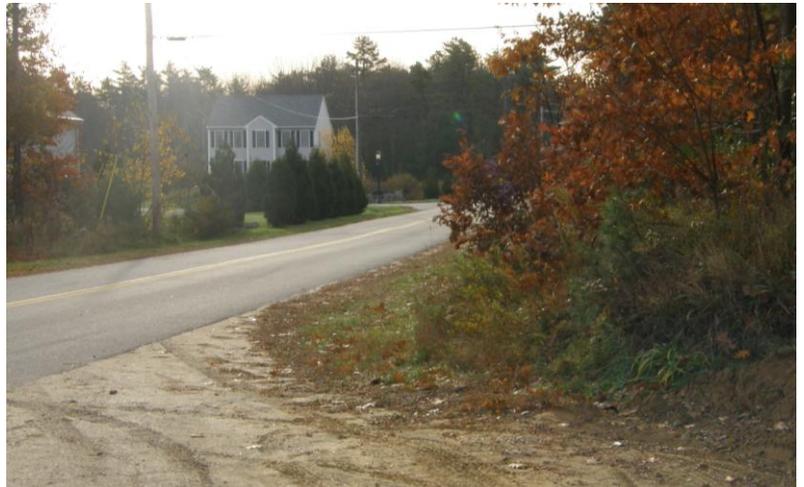
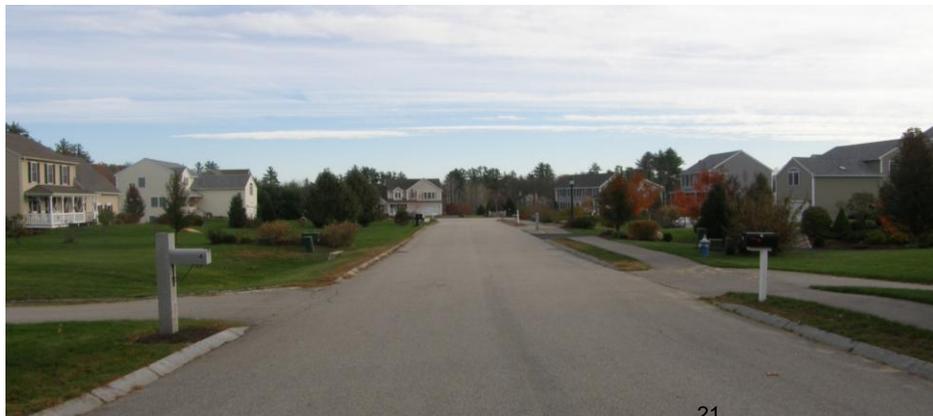
View of neighborhood approximately 100 yards from firing range

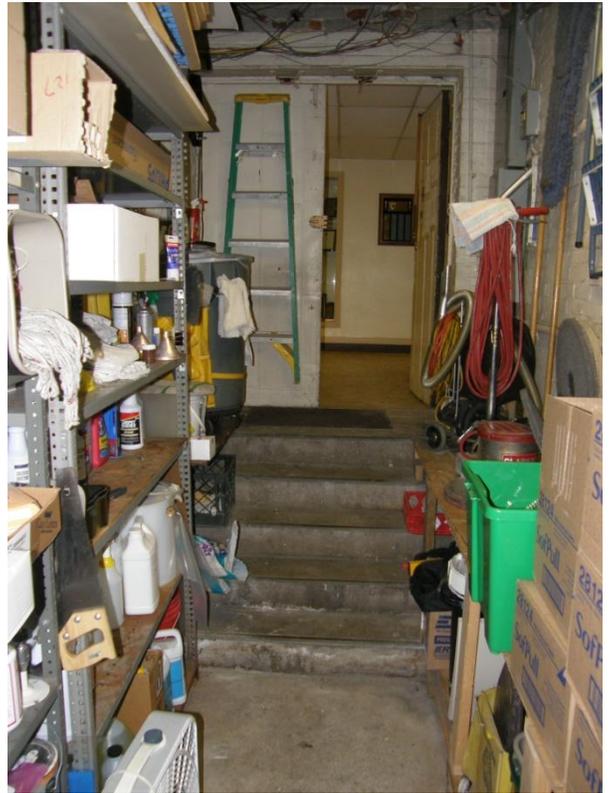
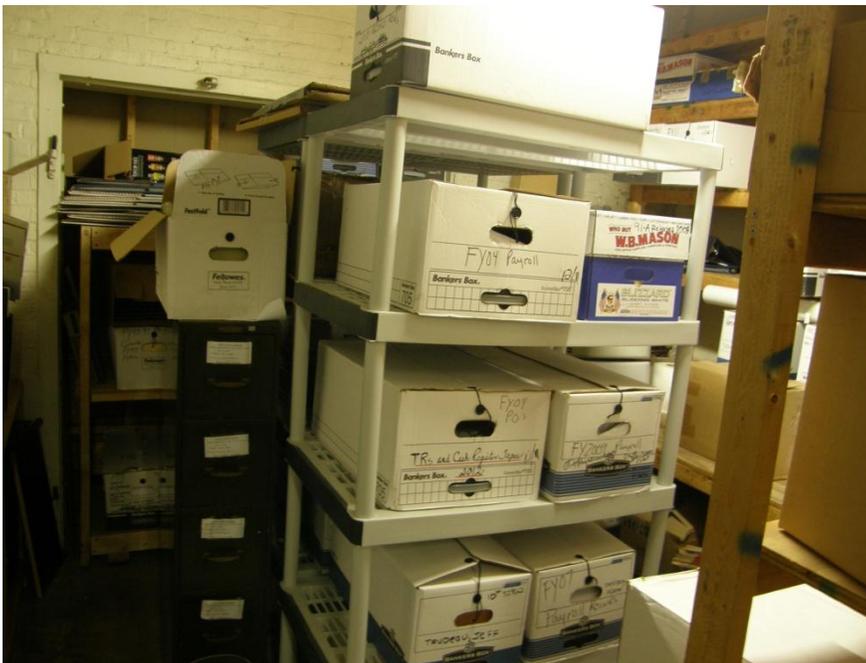
Records storage area that is damp and periodically has standing gray water. At one time the room was used to store evidence but deemed unacceptable due to the potential damage to evidence.

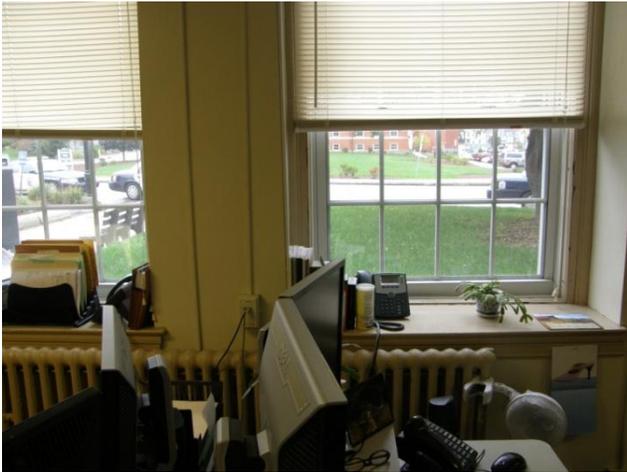
Ground floor windows in the Records Bureau that are not fortified.

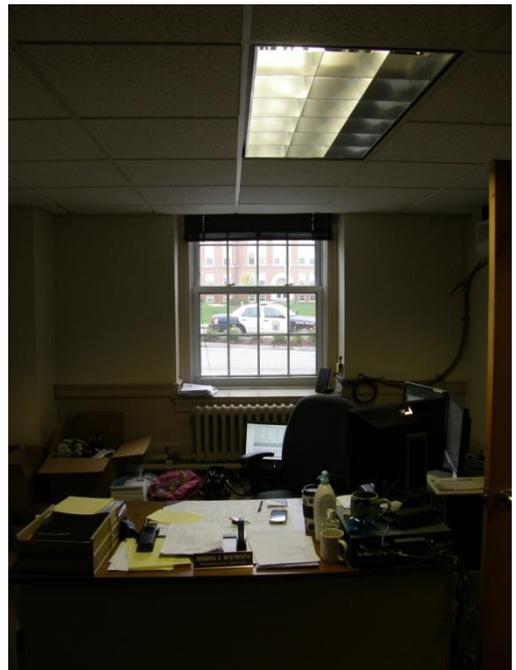
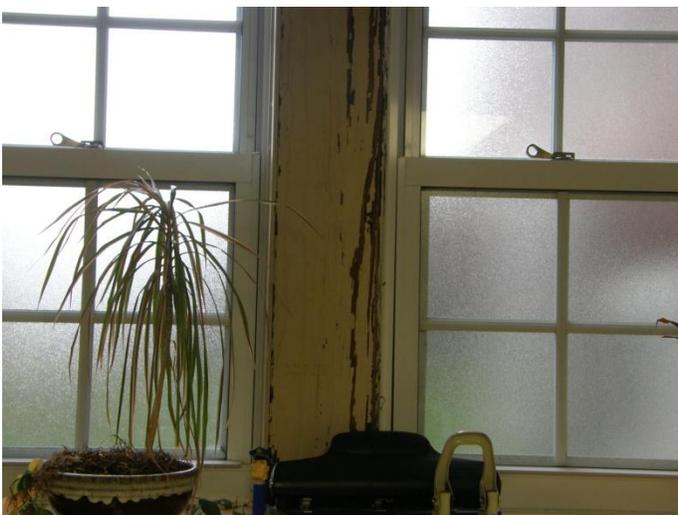
Ground floor windows in the Special Investigations Bureau office that leak and are located above detectives' desks.

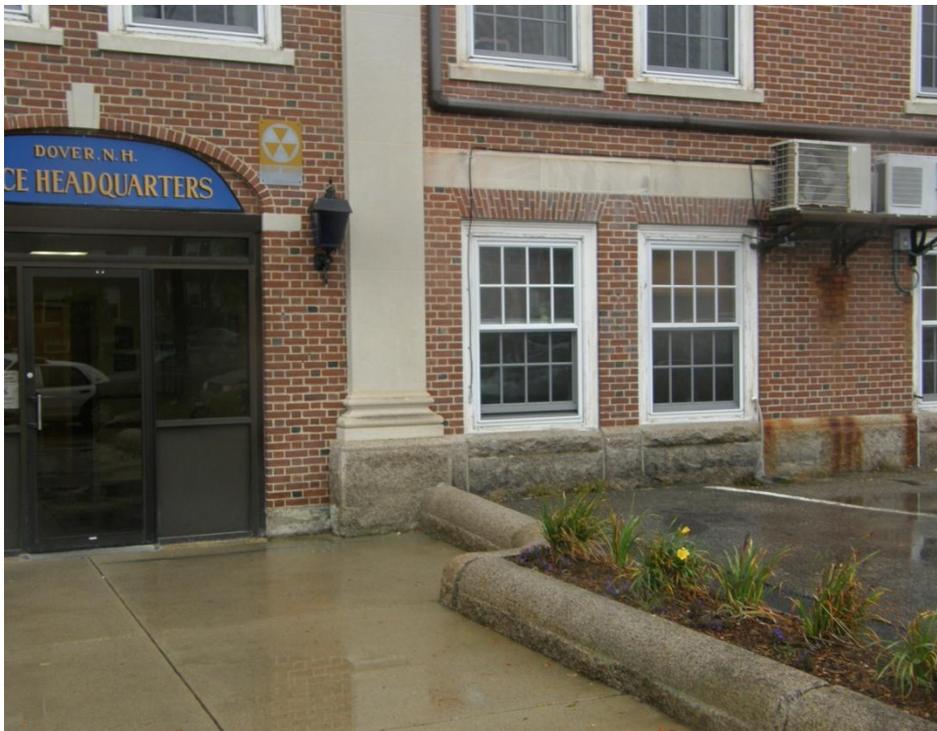
Unfortified
ground level
windows to the
Communications
Bureau.

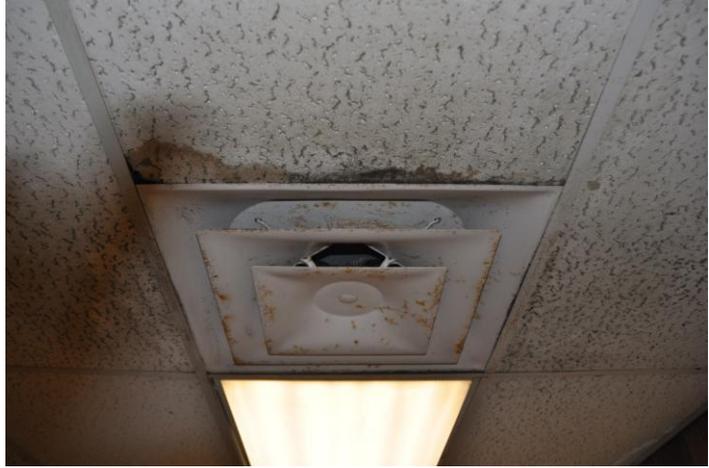
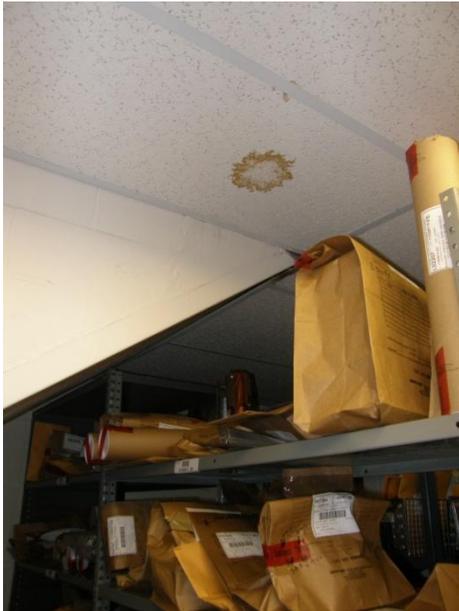
Water leak in evidence storage area
"B Room".

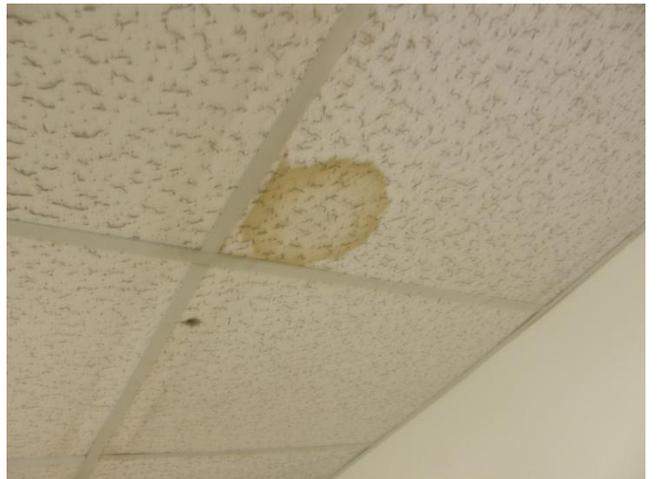
Water leak in men's locker room.

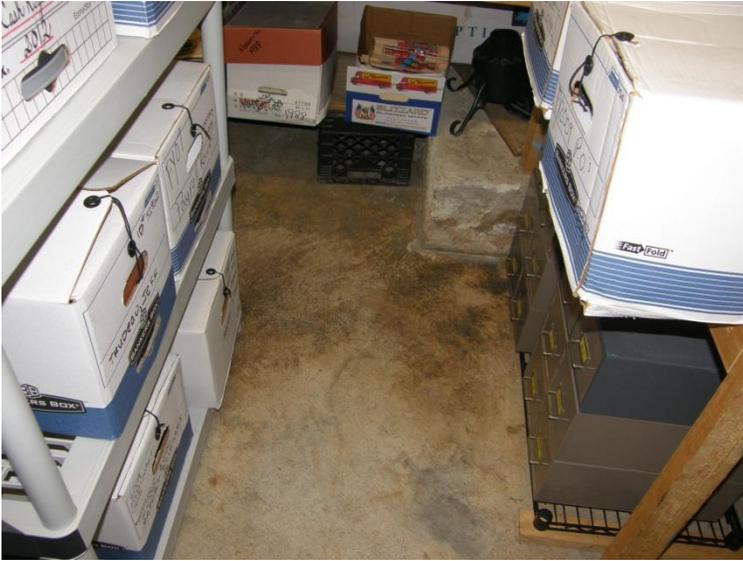
Remnants of gray water flooding in records storage area.

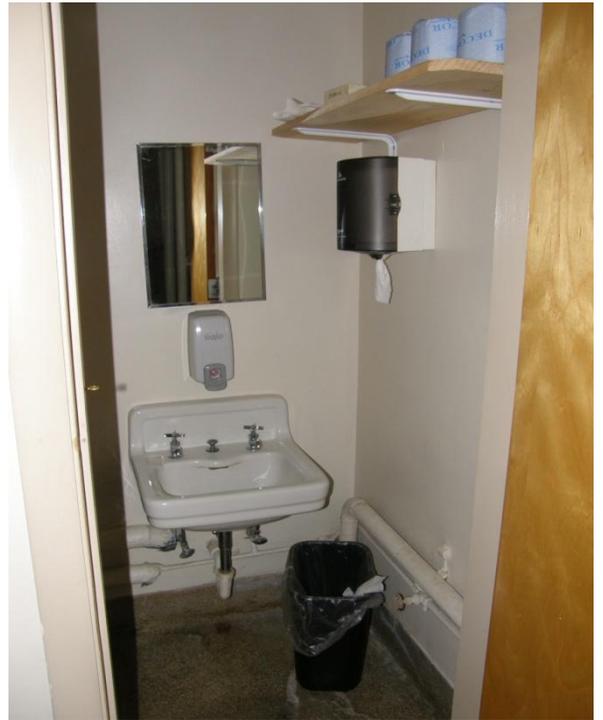
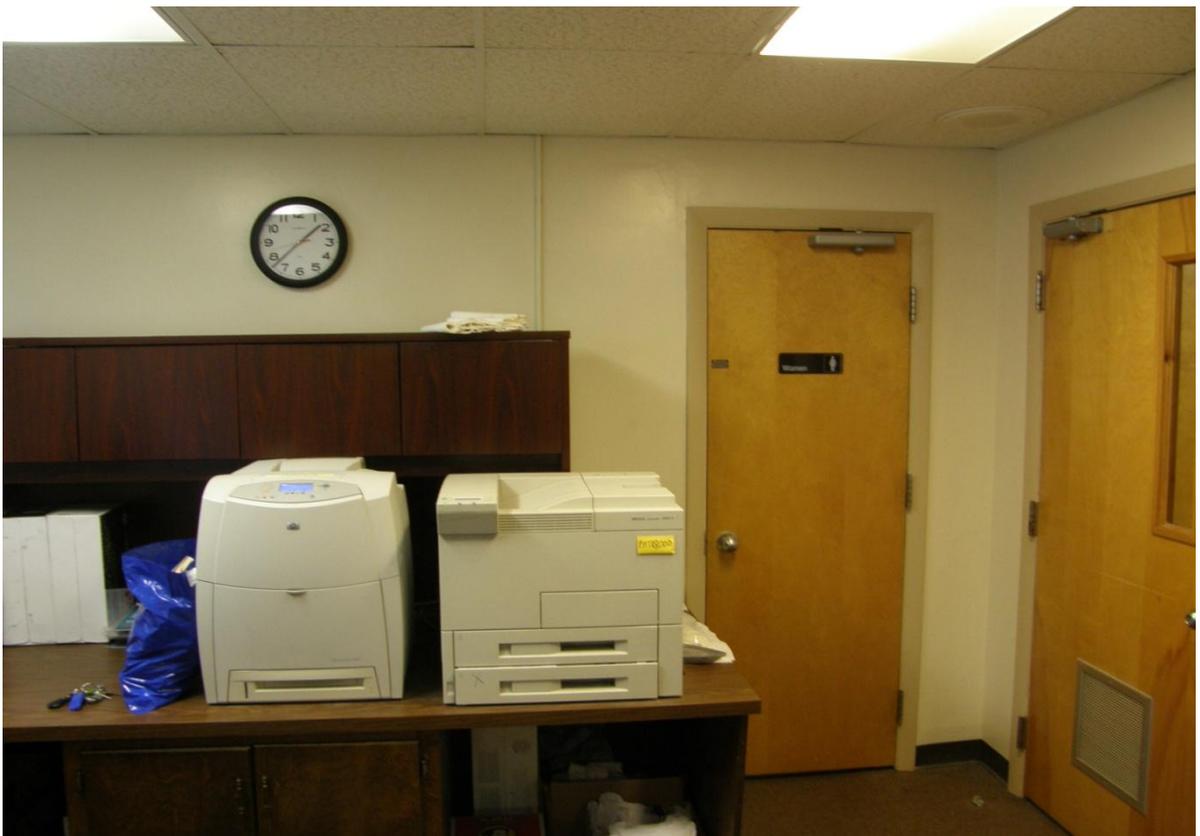
Restrooms are not handicap accessible and have no ventilation, and most are immediately adjacent to work spaces.

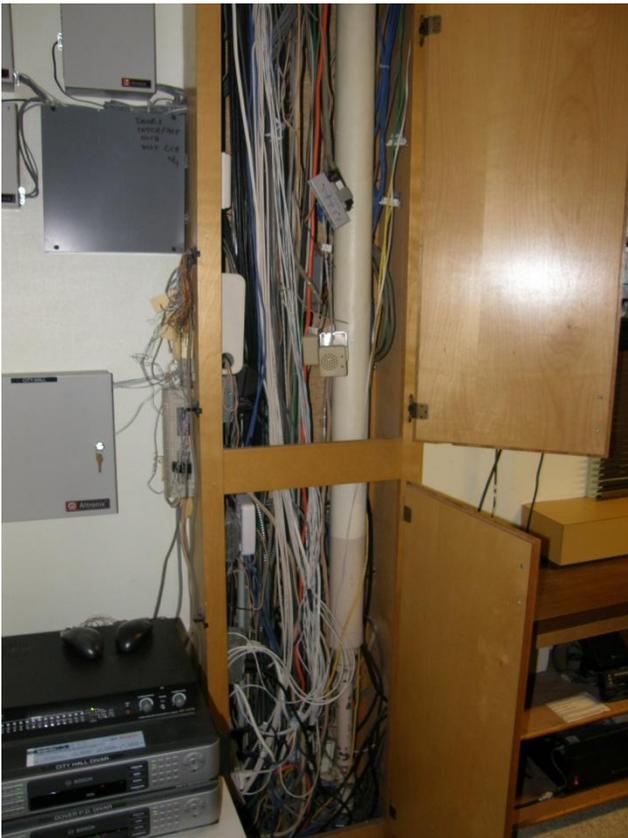
An electrical chase in the Communications Bureau that contains hundreds of wires.

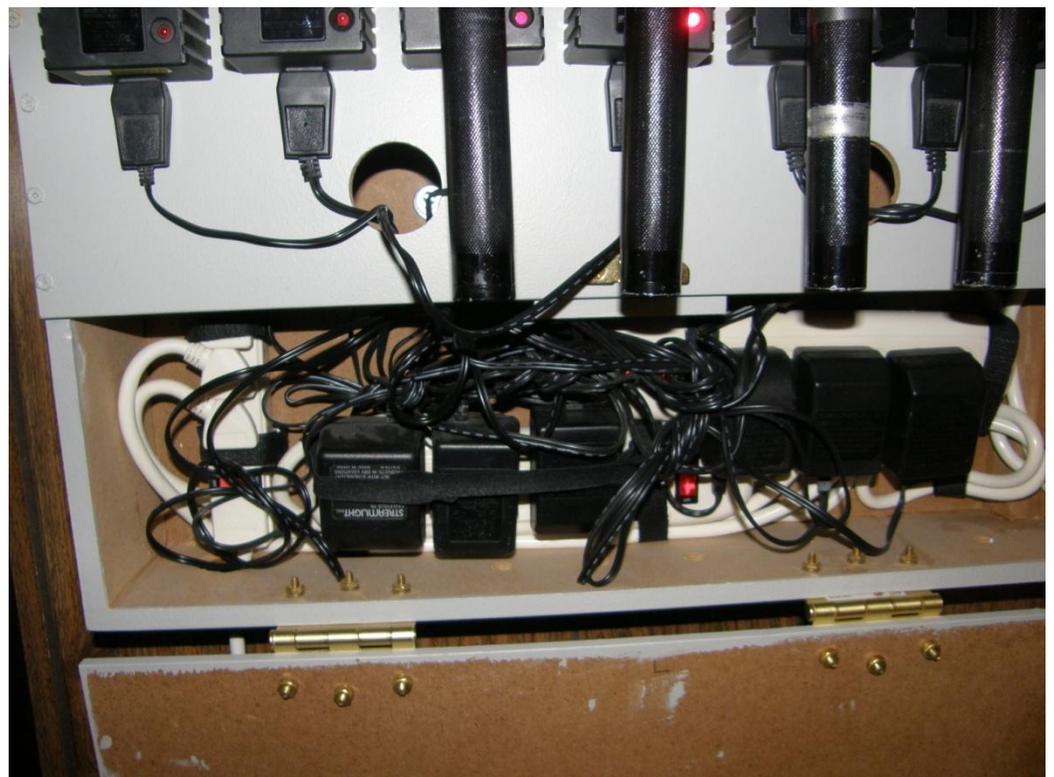
Multiple power strips used to charge flashlights

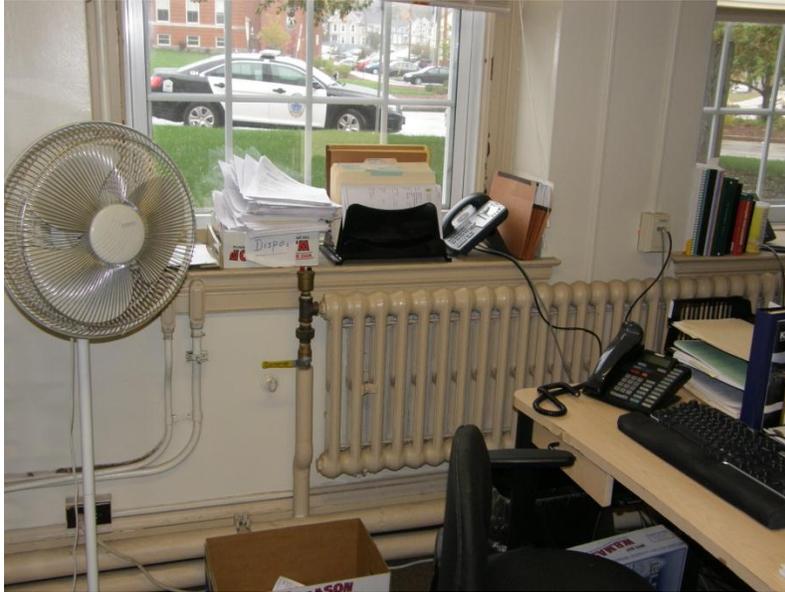
Wall mounted radiator in the Records Bureau office. The location of the radiators keeps desks from being against certain walls.

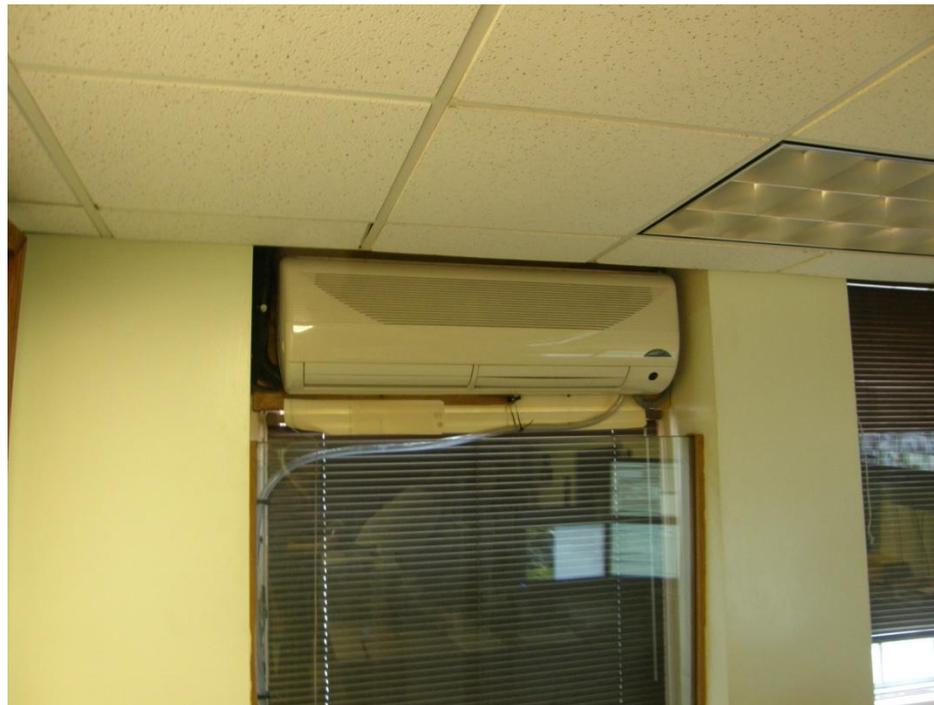
Wall mounted AC unit in Communications Bureau

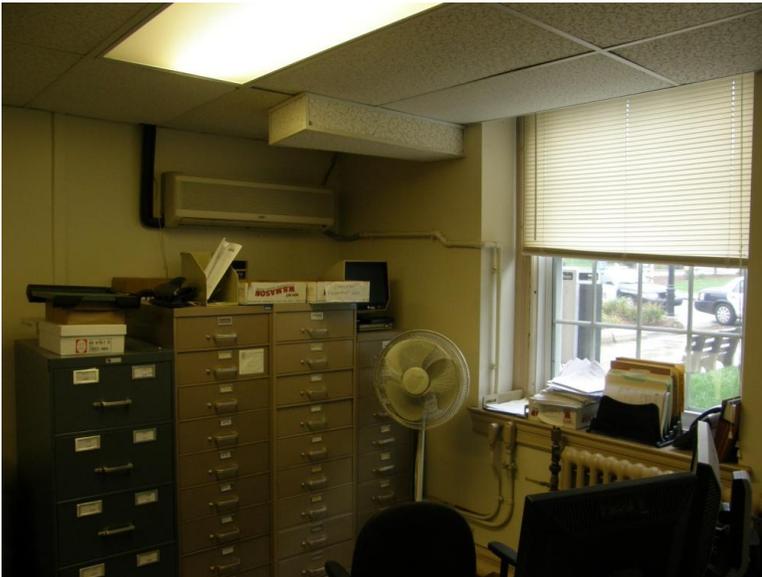
Wall mounted AC unit in Records Bureau office. The AC unit is above records storage that is at risk should the unit leak.

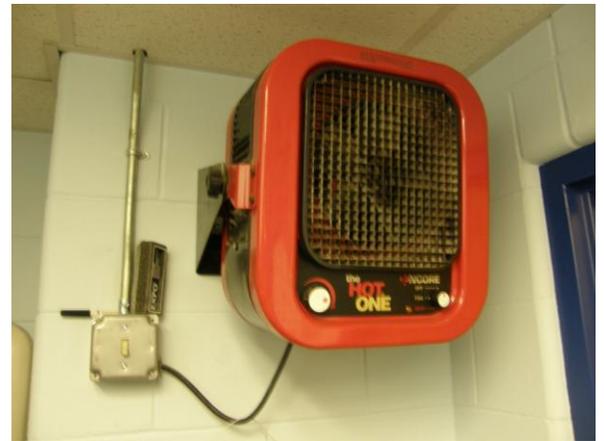
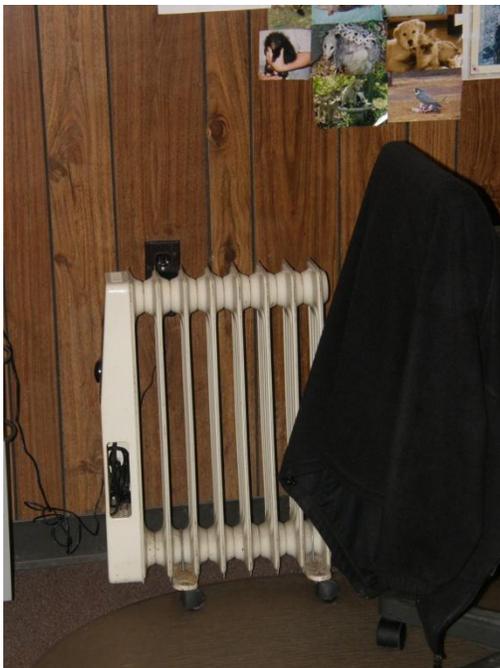
Space heater in prosecution office.
