## MEMORANDUM

**TO:** Dean Peschel  
**FROM:** John Hall, Bill Hall, Ben Kirby  
**DATE:** October 26, 2016  
**RE:** Annual Variation in Eelgrass Cover by Region in Great Bay

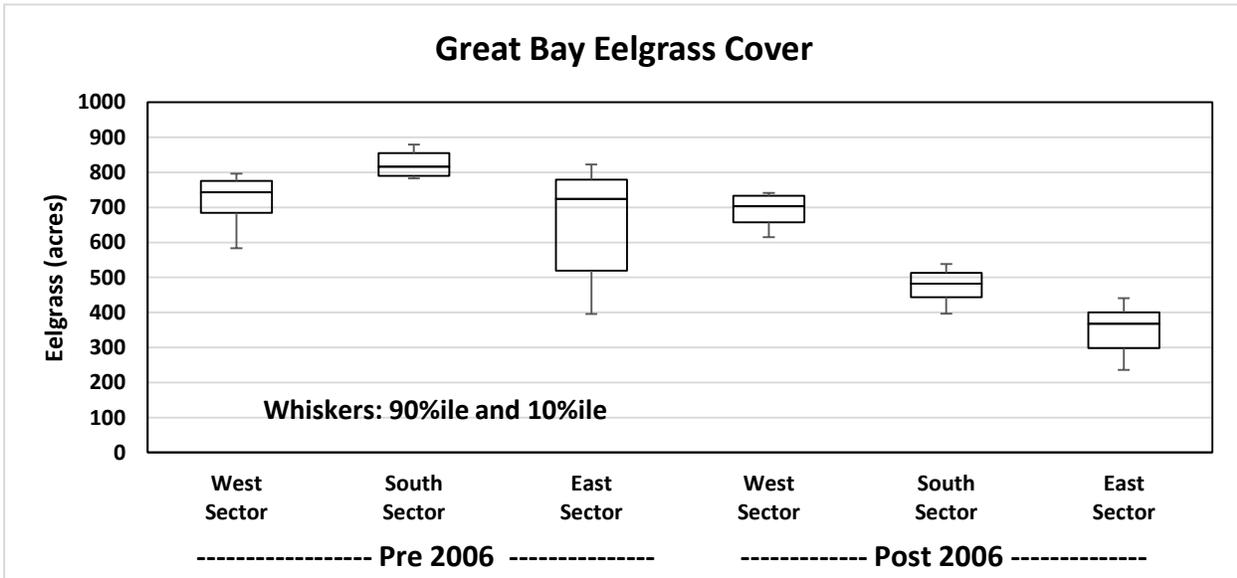
**Figure 6: Sector Eelgrass Cover Before (1986, 1990-2005) and After (2007 – 2013) 2006**

As discussed above, there has been significant variability in the eelgrass cover for the three sectors. Figure 6 illustrates this variability for the period prior to 2006 and the period following 2006.

A statistical evaluation of the sector performance prior to and after 2006 shows that the West Sector had not changed significantly over the two period, while the South Sector and the East Sector experienced significant declines in eelgrass cover (Table 1).

Sector	Average Eelgrass Cover (acres)		ANOVA Probability
	1986; 1990 – 2005	2007 – 2013	
West Sector	716.7	689.8	0.46
South Sector	824.4	467.5	< 0.0001
East Sector	642.9	350.2	0.0005

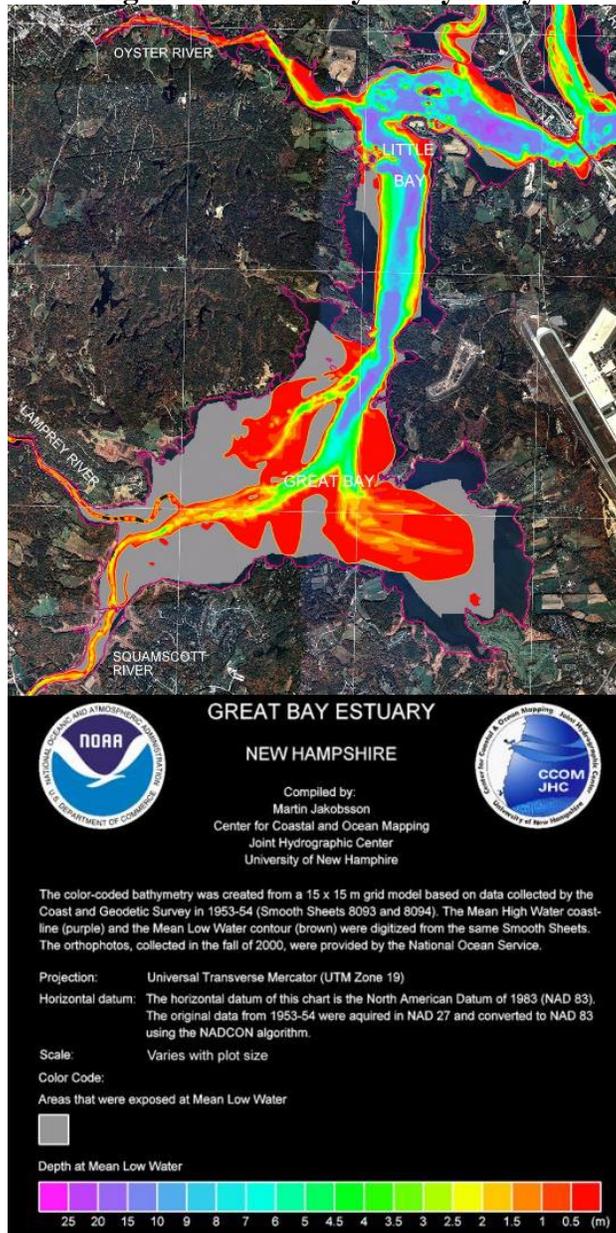
Figure 1: Great Bay Bathymetry

The bathymetry of Great Bay reveals the estuary's drowned ancient river beds (see Figs. 1, 2). Typical patterns of eelgrass cover are separated by these deep channels, where eelgrass cannot grow. As such, these channels made convenient boundaries to analyze eelgrass cover variability in distinct geographic regions of Great Bay. These regions, of approximately equal area, were designated East, South, and West sectors (see Fig. 3). Individual ArcGIS polygons were categorized by geographical sector to evaluate annual change in eelgrass cover for each of the sectors. The total eelgrass area for each sector was summed and plotted by year to visualize localized variations in eelgrass coverage (see Fig. 4).

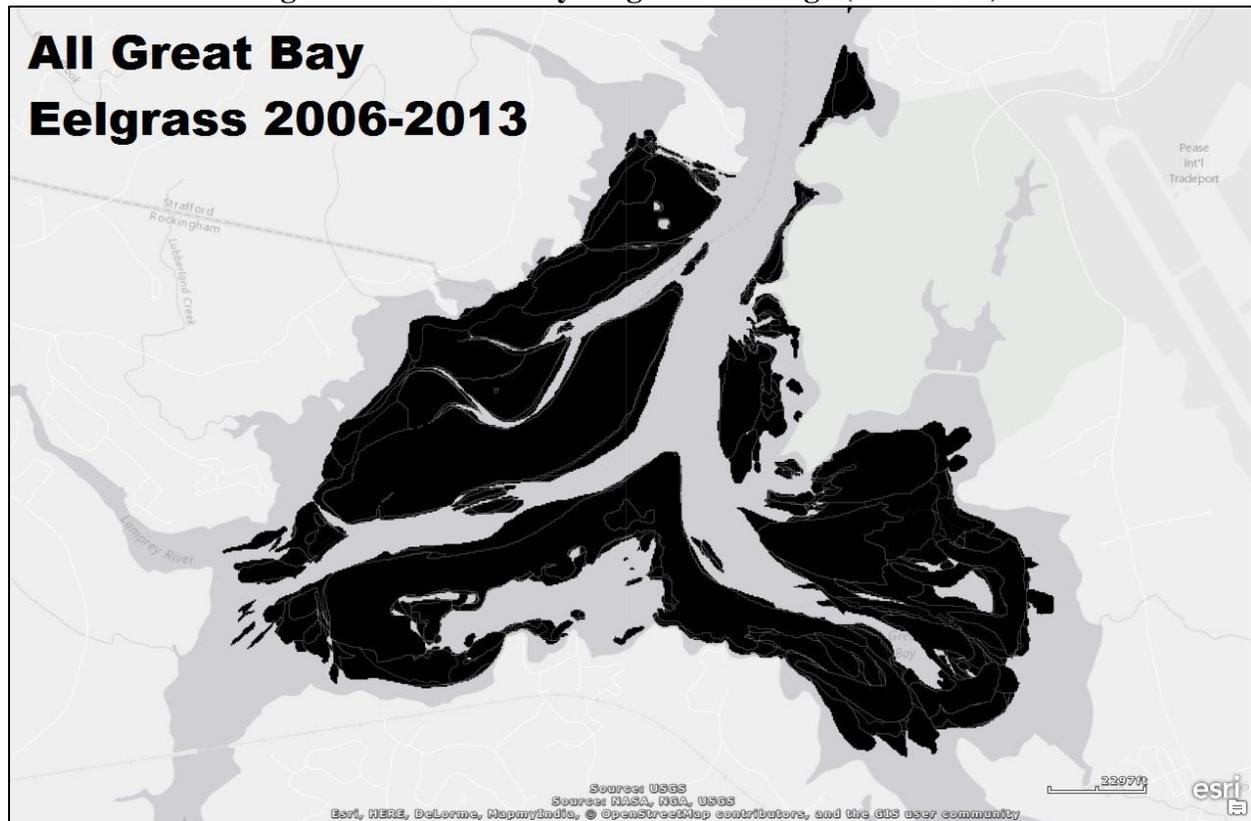
Figure 5: All Great Bay Eelgrass Coverage (2006-2013)

with a period of high rainfall and regional flooding. Over the next three years, eelgrass cover increased to 560 acres. Since 2009, eelgrass cover has declined to 500 acres or less. An inspection of the annual eelgrass maps shows that an area along the coast which previously supported eelgrass has remained barren since 2006 (see Figs. 5, 6). The area of this hole was estimated in ArcGIS to be 150 acres. Eelgrass maps from 1996 and 1998-2005 indicate that this area was previously covered by eelgrass (see Figs. 3, 7). The prolonged period of no eelgrass cover since 2006 suggests that the area may no longer be suitable as eelgrass habitat.

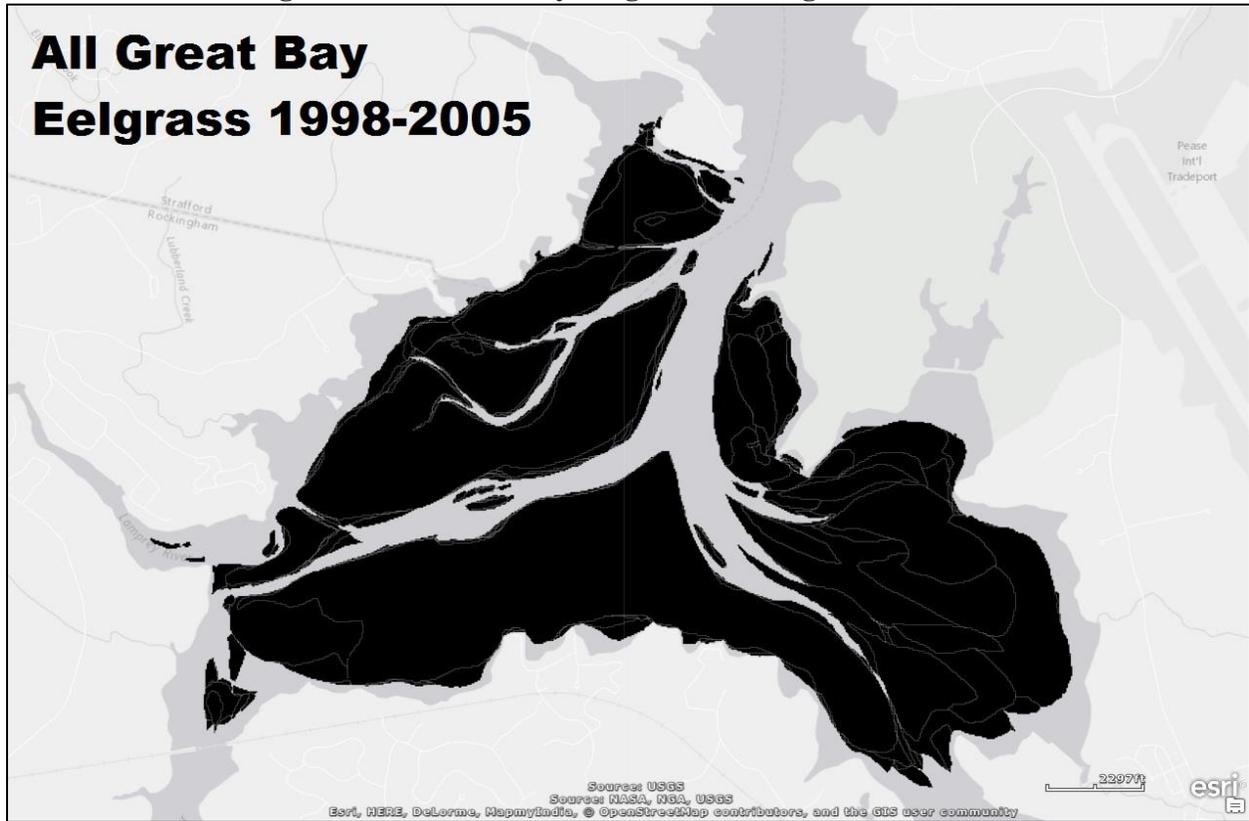
Figure 7: All Great Bay Eelgrass Coverage (1998-2005)

The East sector has fluctuated widely throughout the period of record, ranging from 850-205 acres. Eelgrass cover in this sector was relatively stable in the early 1990s, when eelgrass cover averaged about 800 acres. This period of stability has been followed by rapid change beginning in 1999 with eelgrass cover experiencing steep declines or rapid recovery during subsequent years. The periods of decline have been most severe in this sector, with eelgrass losses exceeding 40% in 2000, 2003 and 2007. As with the South sector, this sector experienced a sharp decline in 2006. An area devoid of measurable eelgrass appeared in 2006 (see Fig. 5). This hole covers approximately 15 acres and may represent an area no longer suitable as eelgrass habitat.
