Berry Brook Watershed Management Plan –Implementation Projects Phase III

**Final Report to
The New Hampshire Department of Environmental Services
Submitted by**

**The City of Dover and the UNH Stormwater Center
December, 2017**

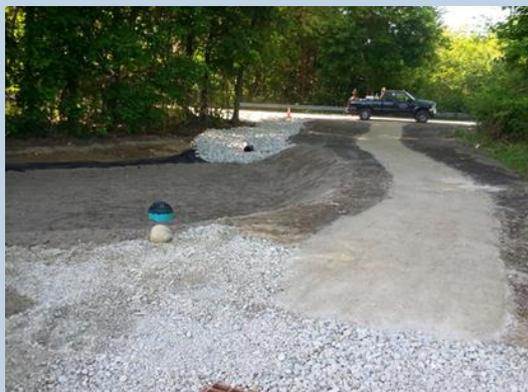
Photograph 1: Bioretention system at Roosevelt Avenue

Deliverable 1: Roosevelt Avenue Bioretention. A series of catch basins and treatment systems were installed off of Roosevelt Avenue to treat a drainage area of 1.9 acres with 0.92 acres of previously untreated DCIA associated with suburban residential development. Runoff from existing roadway was collected by a series of two deep sump catch basins (CB #3 and #4) and

directed to a stone infiltration basin off the north side of Roosevelt Avenue. The infiltration basin was designed to remove coarse sediments and debris while also reducing the velocity of the runoff before discharging to a deep sump catch basin (CB #2). Discharge from CB #2 was directed to a bioretention system designed to treat a water quality volume of 0.15 inches. The bioretention system discharges to an additional deep sump catch basin (CB #1) before discharging to Berry Brook. In addition a stone infiltration trench was installed to manage and treat sheet flow across an un-stabilized area between the old waterworks building and Berry Brook. The infiltration trench also serves as part of a pedestrian path leading through the upper Berry Brook restoration area. The Roosevelt installation was constructed in May through June of 2014. Details of the installation are provided in the photo documentation and design drawing in Appendix A.

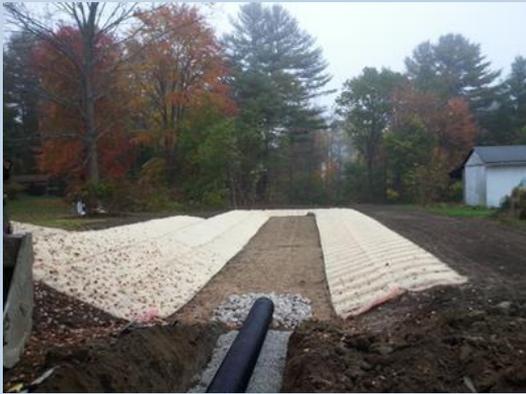
Photograph 2: Bioretention system at lower Horne Street

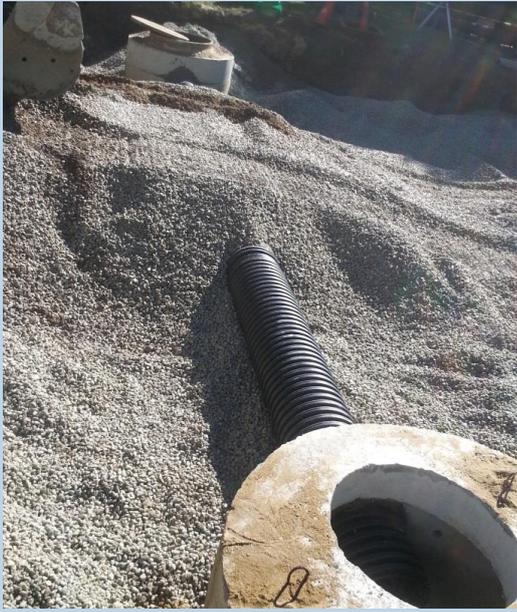
Photograph 4: Grove Street subsurface gravel filter.

Deliverable 4: Grove Street Subsurface Gravel Filter

Another innovation pioneered in this project was the development of a subsurface gravel filter. Lacking equipment to maintain the recommended porous asphalt system, they developed the “Boulanginator,” a system that mimics the features of a porous asphalt system through a subsurface storage and filtration component connected to easily maintainable catch basins. This system looks like a typical cross-section of a porous pavement but is paved with normal dense mix asphalt. The hydraulic inlet and outlet are instead controlled through perforated inlets and underdrains. The system was designed and installed

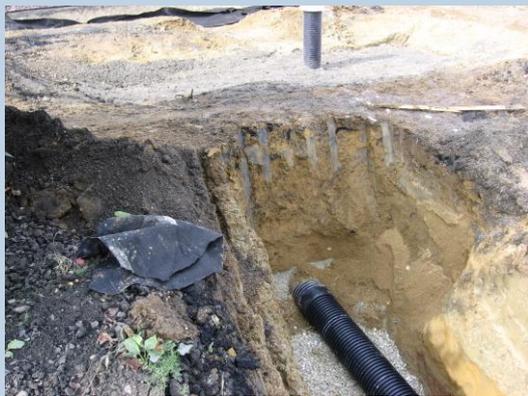
Photograph 5: Hillcrest Avenue infiltration trench.

Deliverable 5: Hillcrest Avenue Infiltration Trench

Taking advantage of highly permeable soils (HSG A) City staff installed additional drainage structures and instead of connecting them with solid pipe, connected them with perforated pipe bedded in two feet of crushed stone. A simple but effective adaptation, this approach can be replicated in other suitable areas throughout the city. The system was designed and installed to treat runoff from 3.36 acres of drainage area and 1.04 acres of previously

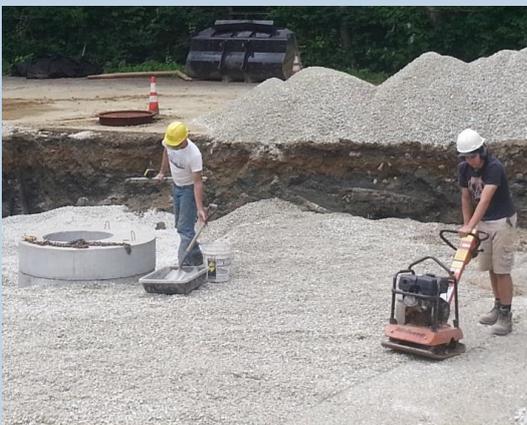
Photograph 7: Kettlebell Subsurface Gravel Filter

Deliverable 7: Kettlebell Subsurface Gravel Filter

The first of the subsurface gravel filter systems installed is located in the parking lot of Seacoast Kettlebell, a fitness center located off of Horne Street. The primary treatment mechanism of this control is filtration; however, the design may also reduce runoff volumes through infiltration. Due to the extremely low hydraulic conductivity of the native soils at this site, volume reduction through infiltration is most likely negligible. The system was

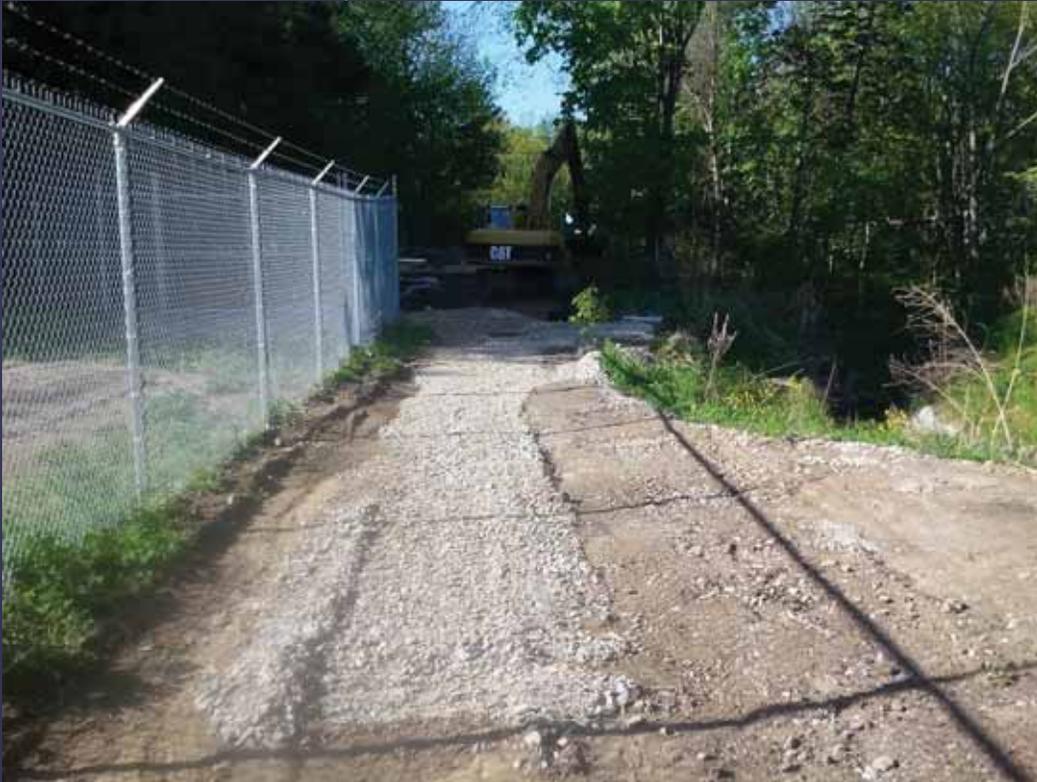
{ Infiltration Trench
Installed

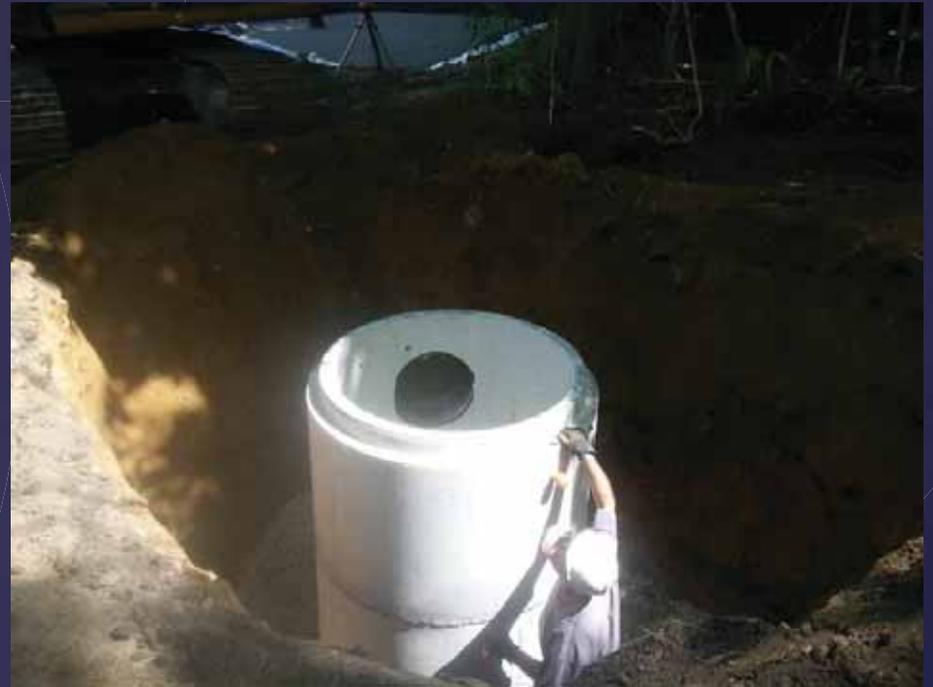
{ Excavation of Rock
Infiltration Basin

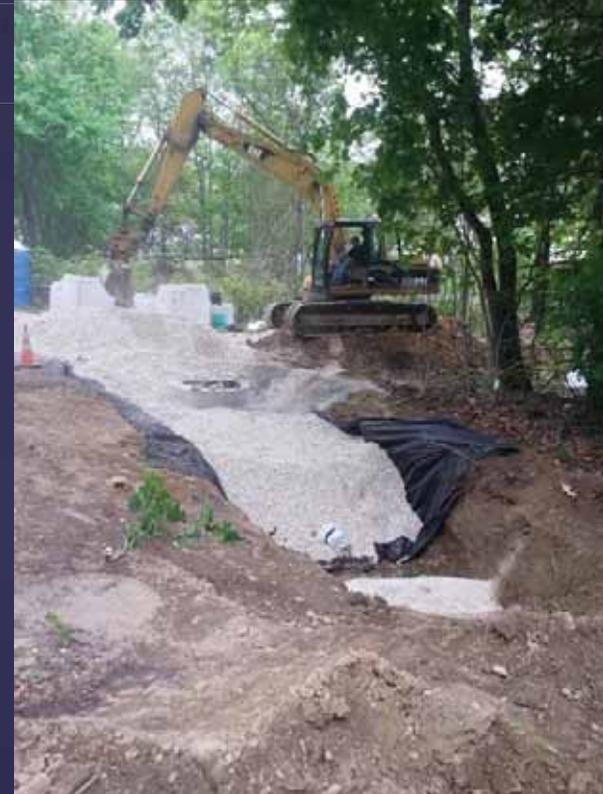
{ Placement of $\frac{3}{4}$ " Stone
Layer in Infiltration Basin

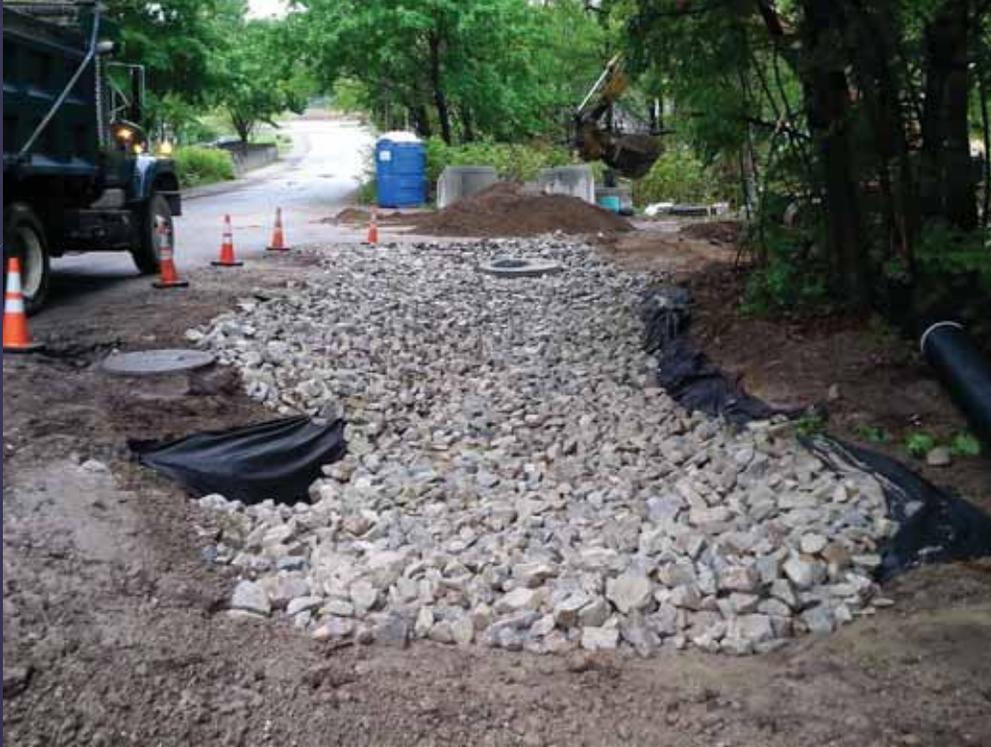
{ Rock Infiltration
Basin with Layer of
Rip Rap Installed

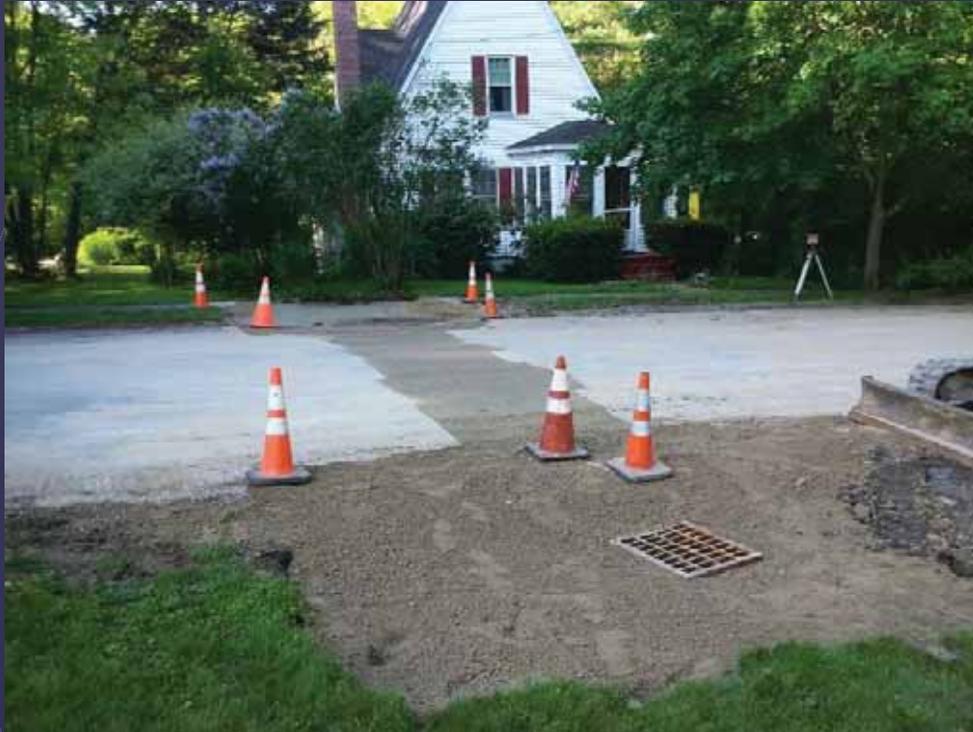
{ Rock Infiltration Basin
Filled to Grade

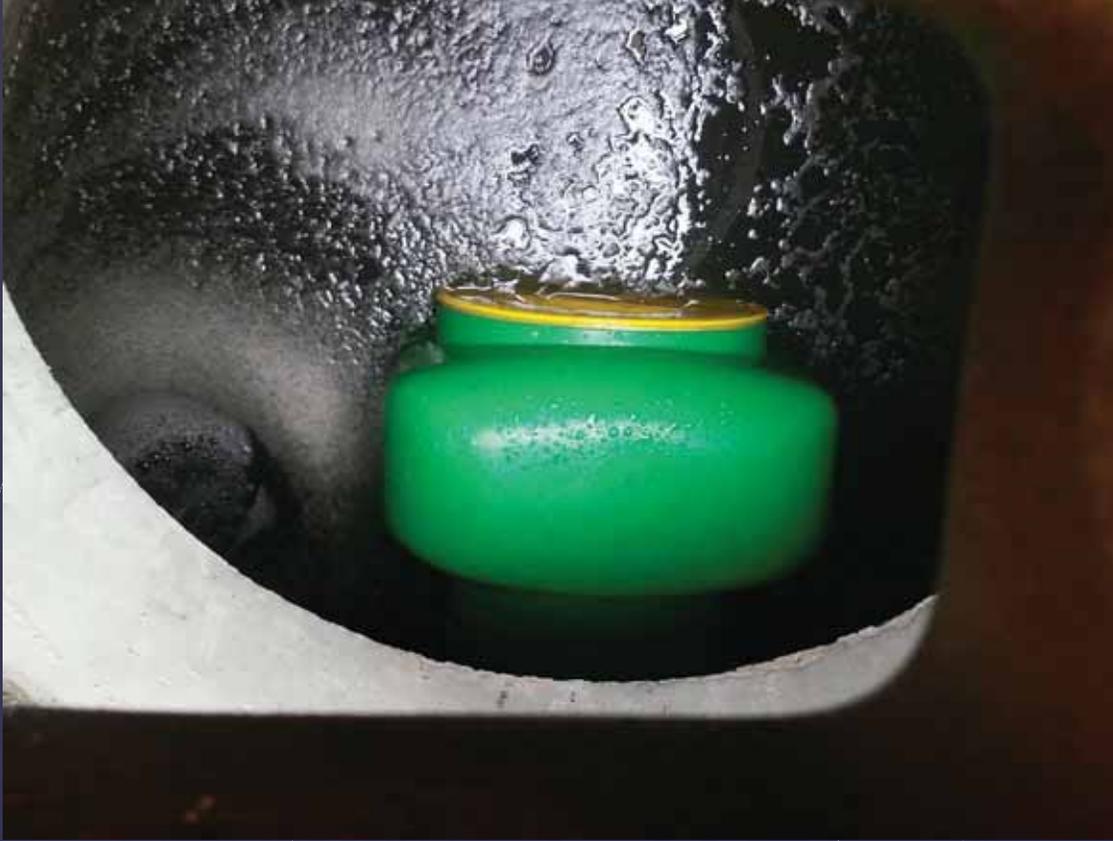
{ Installation of catch basin oil and debris trap (The Eliminator™)

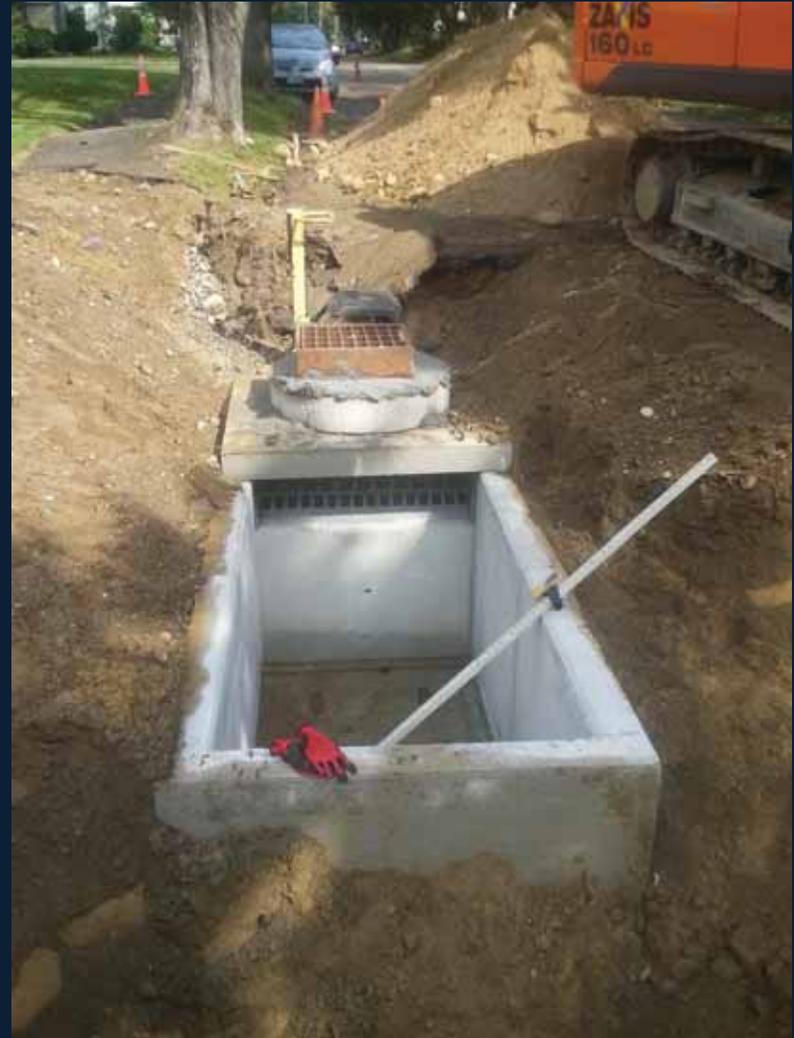
Placement of gravel bed and the sump section of the Media Box Filter

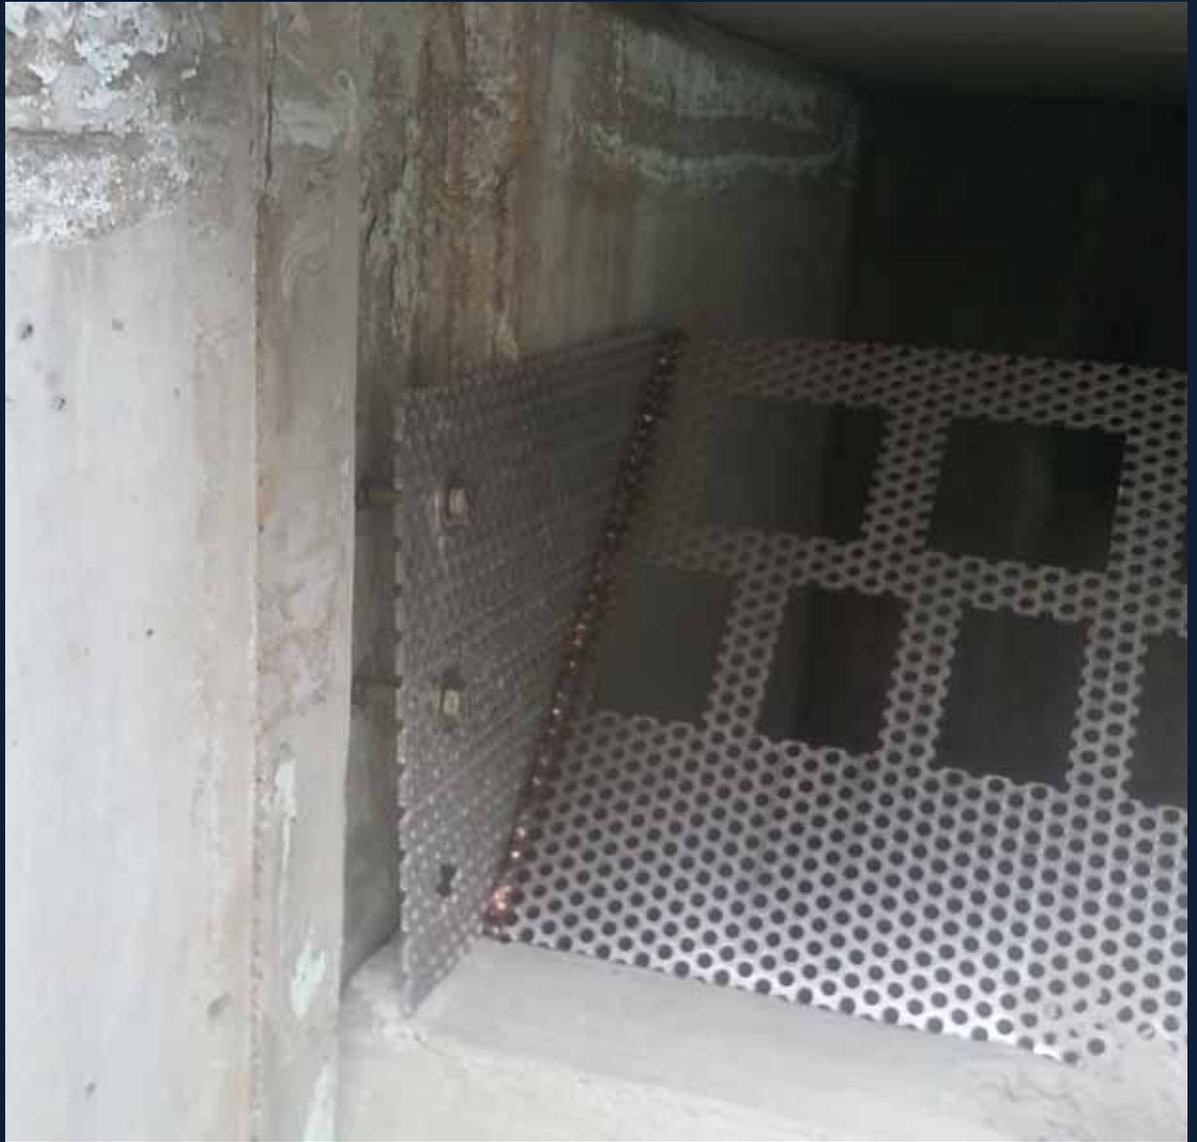
August 2017
Innovative Leaf/Debris Weir
