DOVER HIGH SCHOOL AND CAREER TECHNICAL CENTER Site & Building Assessment Report

Dover, New Hampshire

August 2015

Volume 2 of 3

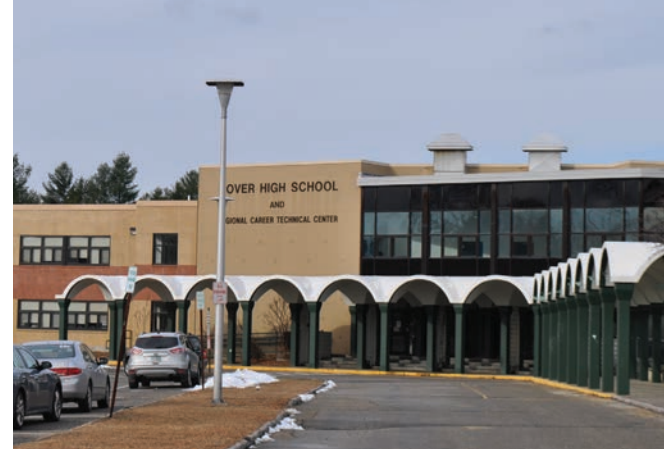
View of Entrance Canopy

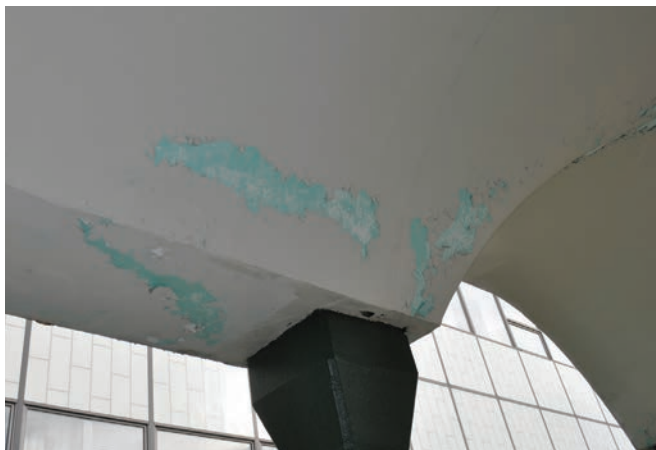
Flaking Plaster at Entrance Canopy

At the main entrance a large double barrel vaulted canopy covers the walkway approach to the school. The canopy is held up by painted concrete columns, and the roof structure is concrete with painted plaster. The structure itself is sound, however the plaster is continuously flaking, requiring yearly maintenance repairs. (See Structural Report for further information)

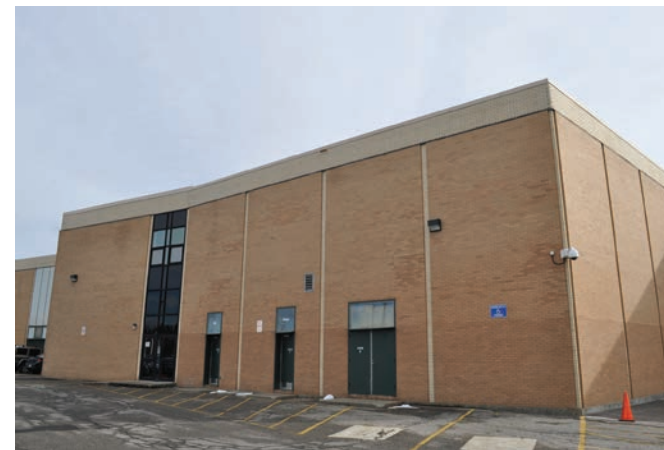
Exterior Wall System 1 - Brick Veneer

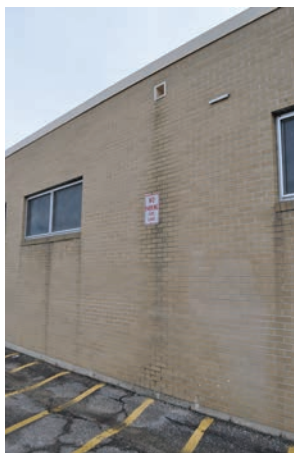
Stained Brick

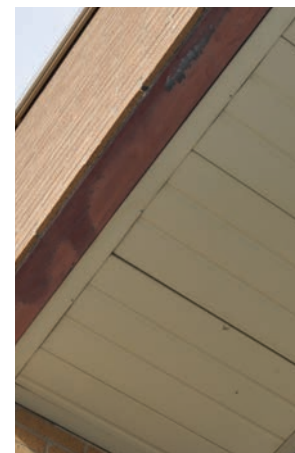
Rusted Lintels

The sealant around windows, doors, and control joints is showing signs of cracking, and some of the visible loose lintels are rusting with decay. There are various corners around the building where brick has been damaged and requires replacement. Although the masonry wall system does not meet today's code, the overall condition appears to be good, and with minimal work, new sealant, selective repointing, selective brick replacement, and a thorough cleaning, further investigation to its reuse should the building be renovated is recommended.

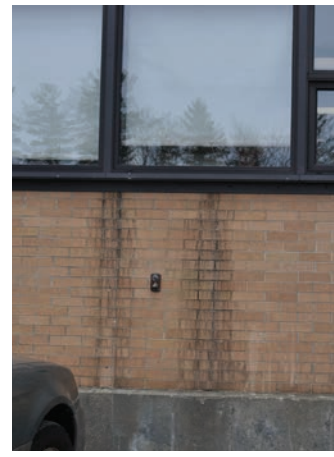
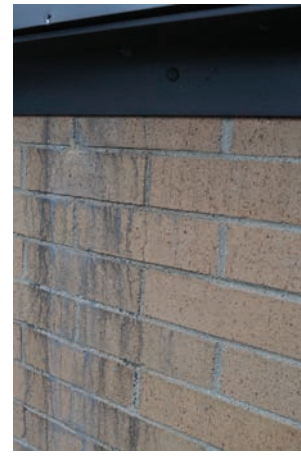
Stained Brick Under Curtain Wall System

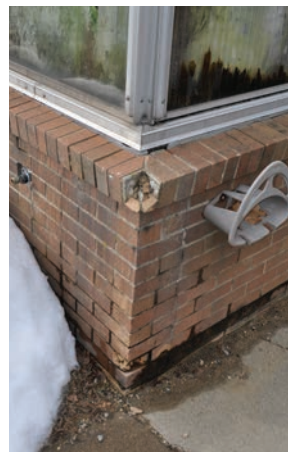
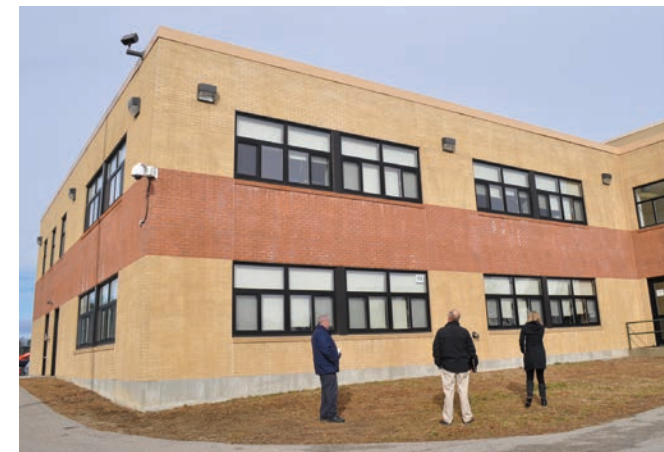
2002 Addition with Visible Efflorescence

Both the addition added in 1989 & 2002 utilize a similar brick veneer wall system with a CMU back up wall and 2" of rigid poly-urethane insulation. This wall construction would meet today's IECC 2009, using an alternate compliance method. Over all the brick veneer is in good shape, with small areas of visible staining at window sills, and the 2002 addition has visible efflorescence stains. Further investigation regarding the efflorescent stains is recommended, to ensure there is not a larger problem with the drainage cavity and weeps of the wall system, that can lead to larger failures of the wall system over time.

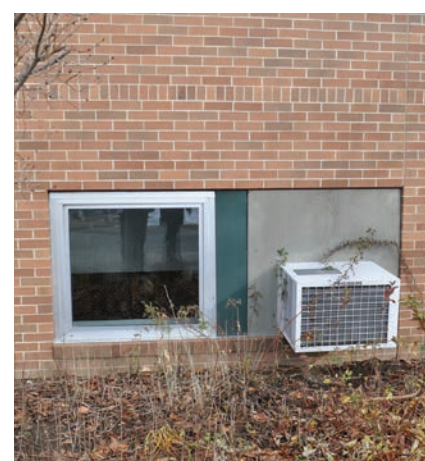
Windows Located at Grade, same window after snow storm

The windows at the 1967 building are original to the building. They are aluminum with a single pane 1/4" tempered glass. There are a variety of fixed and operating windows. The windows are still functioning, but have exceeded their useful life and complete replacement is recommended if a renovation option is selected. As noted in the summary, many of the interior spaces do not have any windows; in fact 21 out of 52 classrooms are interior with no views to the exterior. The current configurations of windows would not qualify for the prerequisite access to views or the day lighting credits for LEED, which is one rating system for high performance buildings. The 2002 addition have aluminum frame windows with double glazing. These windows are approaching their half life, and have been reported to have significant drafts. Overall the window construction is in good condition. The exterior doors are constructed of aluminum with aluminum frames and have 1/4" tempered glass similar to the windows. There are 9 roll up garage doors, 7 of which are used for CTC, and two at the loading docks. The roll up doors are functioning and in fair condition, replacement is recommended. The windows on the lower level of the north side are located almost at grade, and have to be shoveled out when it snows, creating a maintenance nightmare, and increase risk for leaking.

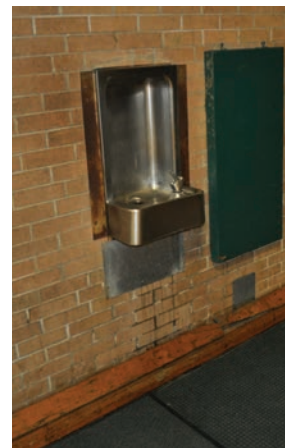
Drinking Fountain, Aged Base Board & Cracking CMU

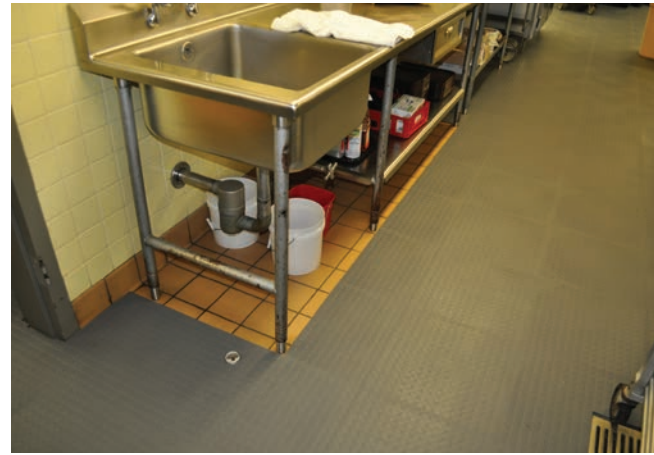
Kitchen Rubber Floor

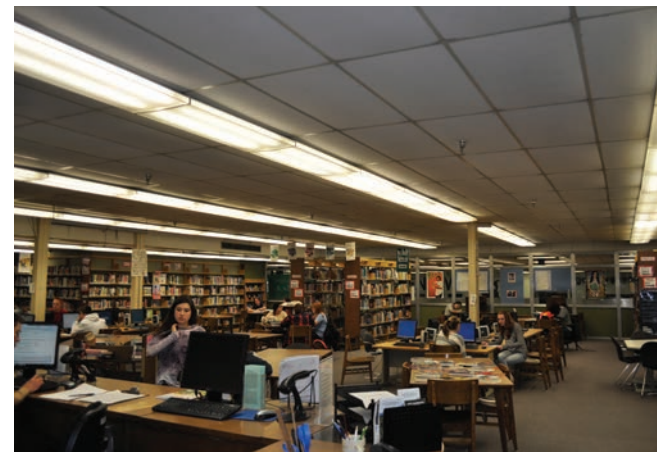
Library, No Natural Daylight

The Library is located central to the school on the main level. There are no exterior windows or natural light, and the interior lighting is poor. This interior space is furnished with aged tables, chairs and book shelves. The wall paper is original to the school, and shows visible tears and repairs with duct tape. The space requires a complete renovation, and all finishes should be replaced. This space would benefit greatly from natural light.

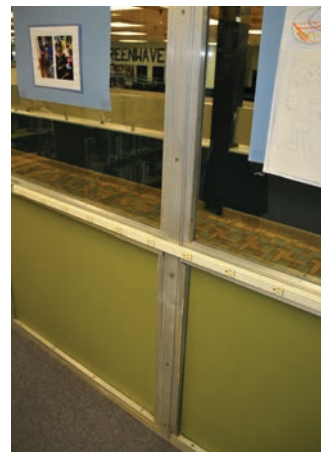
Interior Aluminum Wall System & Aged Bookshelves

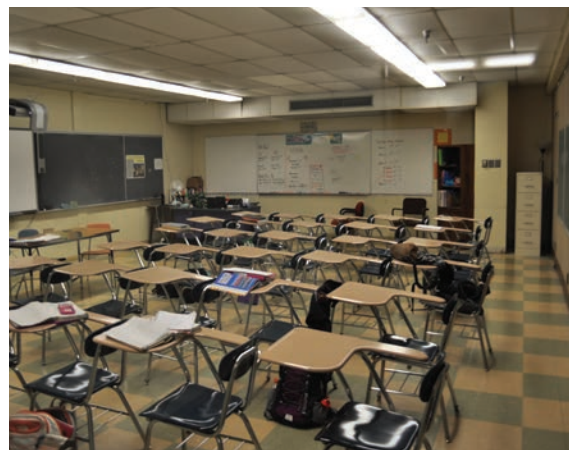
Typical Classroom - Asbestos Tile Floor

The 1966 portion of DHS has a variety of floor types throughout the school. The corridors, kitchen, bathrooms, and lockers rooms are ceramic tile, the classrooms and cafeteria are Vinyl Coated Tile (VCT), the auditorium, library, computer room, administration areas and select other spaces have carpet, the gymnasium is athletic wood flooring. All of the flooring in the 1966 portion of the school is beyond its useful life and would require full replacement. The 2012 AHERA report as attached in the appendix, indicates that all of the flooring listed above with the exception of the gym floor is assumed to have asbestos containing material, and would need full remediation prior with any renovation, demolition or addition.

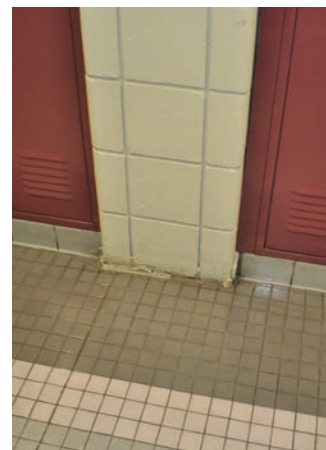
Base in Disrepair

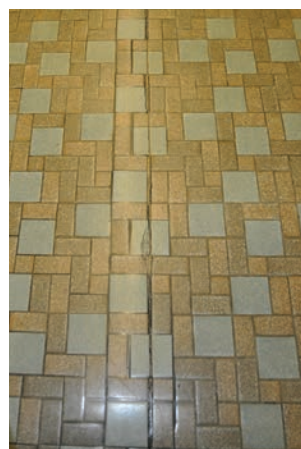
Cracked Tile Floor

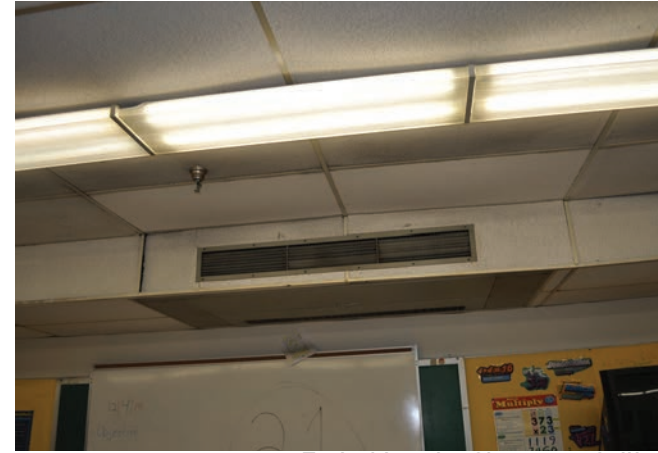
Typical Interior Classroom Ceiling

Acoustic Ceiling Tile (ACT) is installed throughout the school, and is in complete disrepair. Much of the ceiling tile and grid is warped, stained, or painted. None of the existing ceiling tile and grid is salvageable and will require full replacement with any renovation.

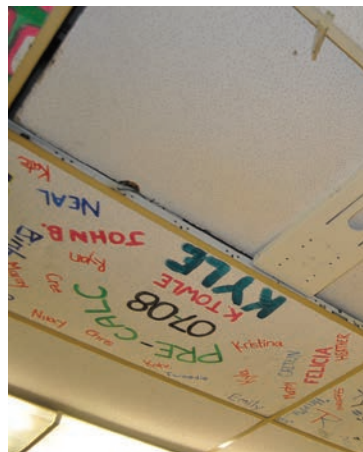
Typical, Painted Ceiling Tiles

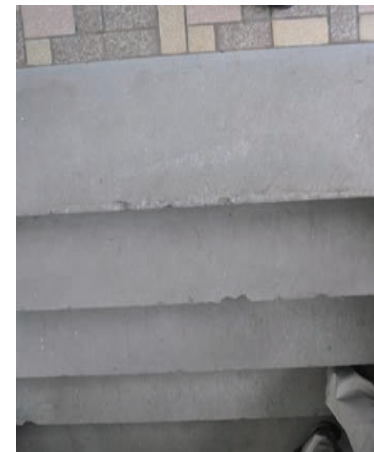
Chipped Blue Stone Treads

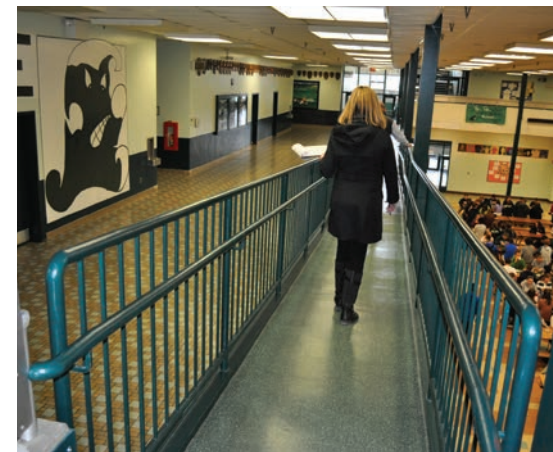
Ramp Near Main Entry

There is one permanent ramp in the school located approximately 140 feet from the main entrance. The ramp is approximately 60 feet long and connects the main entry level to the first floor. The ramp is constructed of painted steel stringers, guardrails and handrails. In the 1967 building there are 4 main stairs that connect all three levels. The stairs are constructed of painted steel stringers and risers, with slate treads, and stainless steel hand rails. The handrails are 36" high and require a guardrail up to 42" high to be compliant with Current code. The vertical supports are spaced approximately every 3 ft, and do not have any infill pickets. The maximum opening between pickets to meet current code is 4". Any renovation would require full replacement of the handrail and guardrails (see full code analysis in Appendix). The treads are made of blue Stone and chipping throughout. The 1989 CTC addition added one stair and a new entrance to the CTC building. The entrance is equipped with a vertical platform lift for accessibility. The 2002 World Language Addition also added a stair, which is equipped with a stair lift for accessibility, however a stair lift is not recognized by ADA or IBC to be included as part of an accessible route. There is one elevator located in the Northeast corner of the 1967 building, and was constructed with the original school. Replacement of the elevator is recommended with any new renovation, and would be required to be brought up to current elevator and ADA codes. See Section 4.3 for a full code analysis of the existing building.

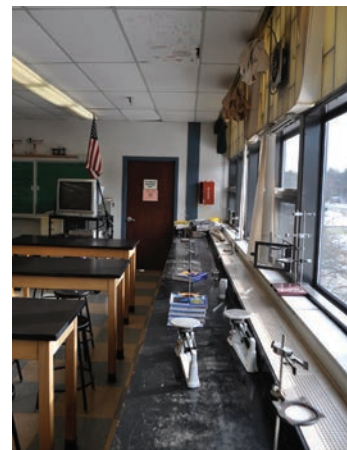
Counter Tops in Disrepair

All of the interior built in furnishing are original to the school, and in poor condition. The majority of built in casework is located in the science classrooms and labs. Full replacement is recommended with any renovation.

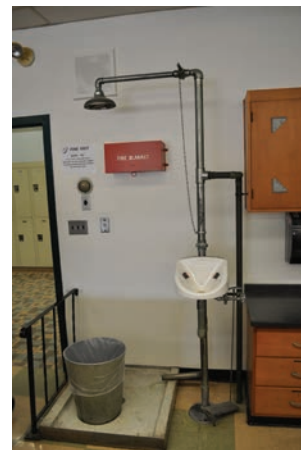
Original Chemical Shower

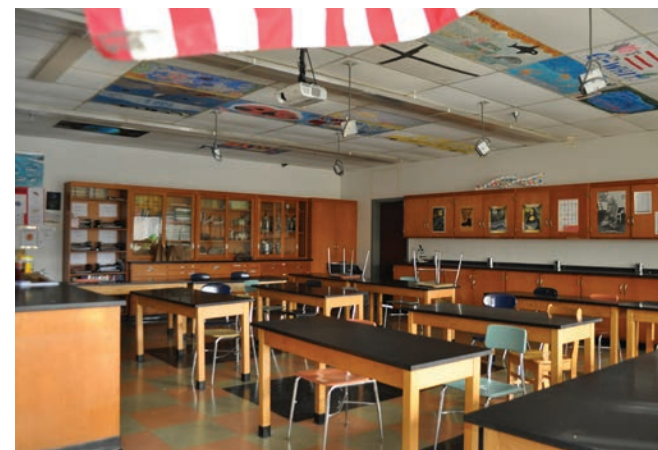
Typical Science Classroom Casework

- a. Replace all base and upper cabinets
- b. Replace all library shelving , tables and chairs
- c. Provide accessible tables in science classrooms

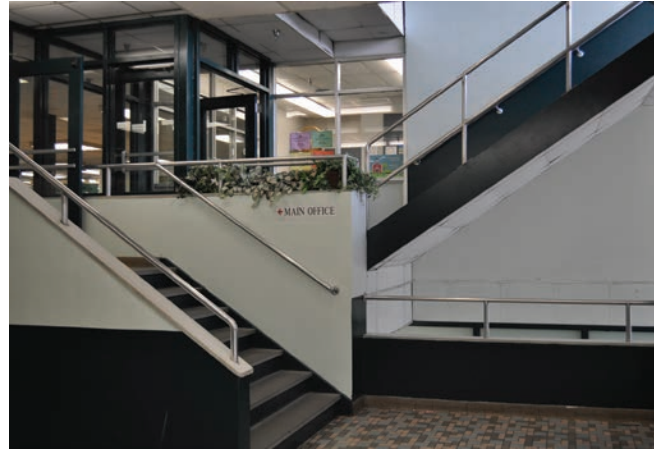
Multiple Levels

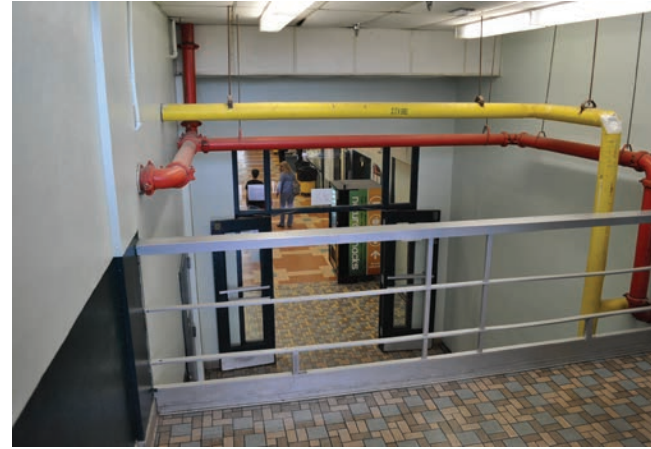
Rails and Guards

- a. Replace existing 3 stop Elevator
- b. Add addition new elevator 3 stop
- c. Replace all hand rails and pickets to meet code
- d. Replace all stair treads

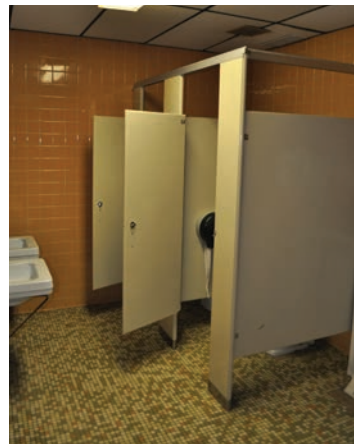
Inaccessible Toilet Stalls

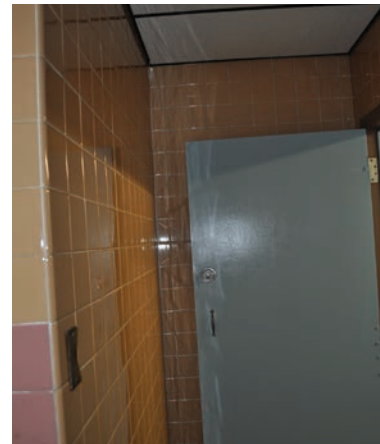
Hardware Issues

- Door hardware must be upgraded or replaced to meet ADA regulations including, but not limited to, door handles, closers and panic devices, as previously noted

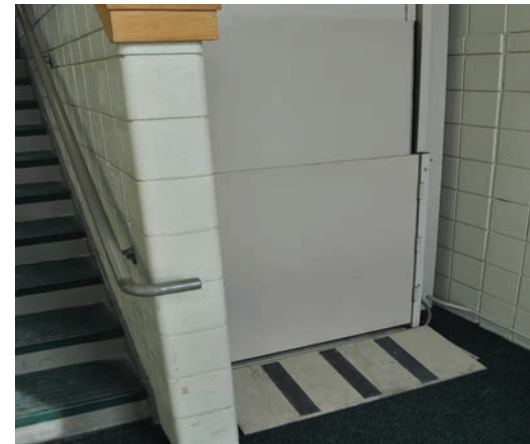
Lift at CTC Entrance

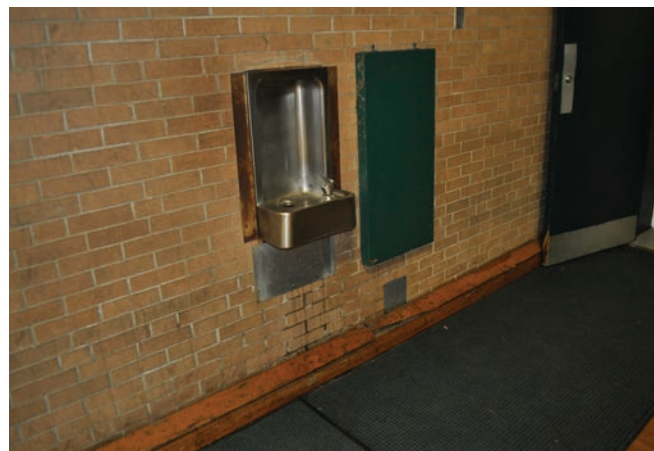
Inaccessible Water Fountain

- Currently the drinking fountains lack appropriate clear floor space and height requirements ADA.
- Many of the doors do not provide the required push/ pull clearances and must be replaced or relocated to meet the ADA requirements. This condition occurs throughout the building including several of the classroom entrances, and secondary egress doors.

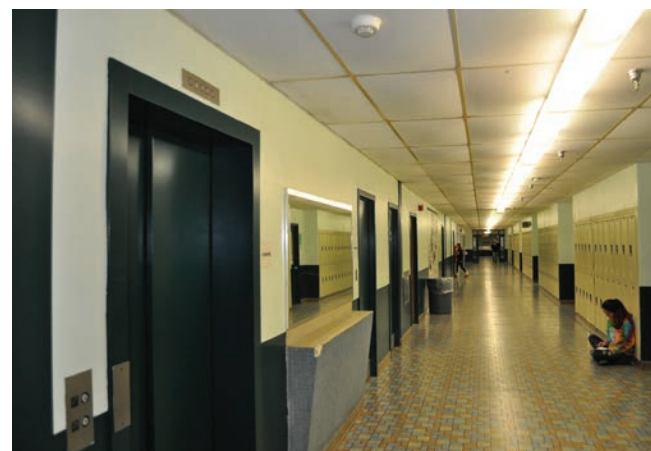
Remotely Located Elevator

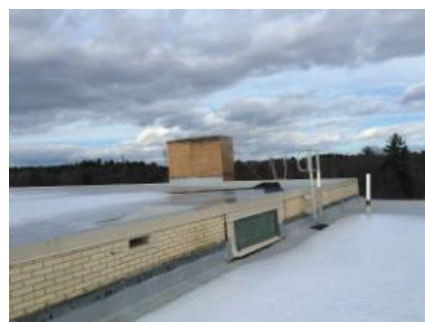
The boilers are vented by a common manifold double wall steel breeching system that terminates through a masonry chimney to the outdoors. There are some visible cracks at the top of the chimney. The condition of the interior liner was not inspected during the site visit.

Boiler Chimney

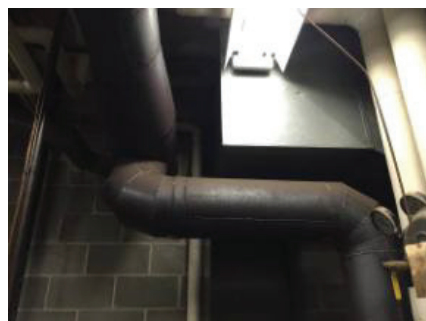
The boilers are vented by a common steel breeching system that terminates through the roof to the outdoors. The steel breeching is uninsulated, and the exterior breeching shows visible signs of rust and corrosion.

Interior Boiler Breeching

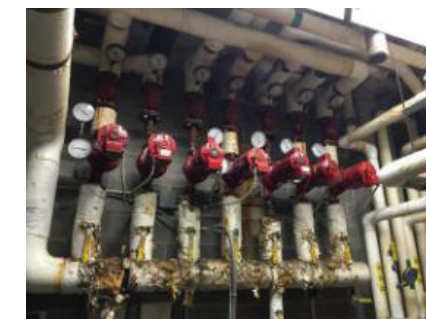
Hot water is distributed from the Boilers to terminal heating equipment located throughout the building by six (6) inline zone circulator pumps. The pumps appear to have been installed in 1989. In general, the pumps appear to range from fair to poor physical condition. Much of the adjacent piping insulation is damaged. There is a hot water expansion tank which appears to be in good condition.

Existing Hot Water Pumps

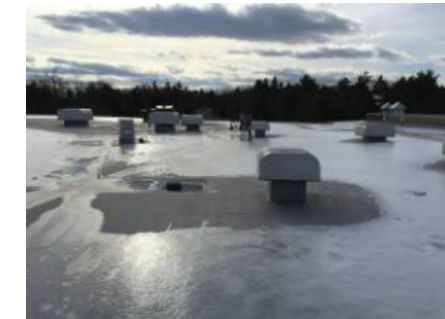
Ventilation air is exhausted from the majority of areas of the building by a combination of inline, propeller and roof mounted exhaust air fans. The majority of exhaust fans appear to be originally installed equipment, however some exhaust fans have been replaced within recent years.

Roof Intake and Exhaust Air Hoods and Fans

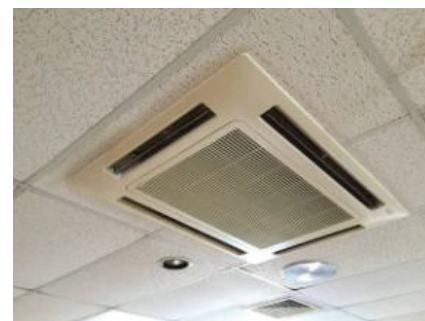
1989 Addition Dining Room Ceiling Ductless AC Unit (typical of 2)

The 1989 Addition Dining room is heated and air conditioned by a ductless AC split system heat pump system. There is also perimeter hot water fin tube radiation heating. It has been reported that the heat pump AC system and hot water fin tube radiation heating operate simultaneously at certain times of the year, resulting in both excess energy usage and temperature control complaints. The ductless cassette type AC heat pump system has its own stand-alone thermostat controls which are not fully integrated into the building control system.

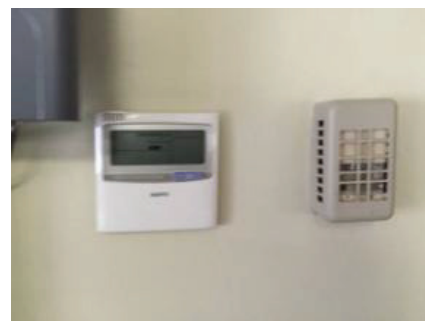
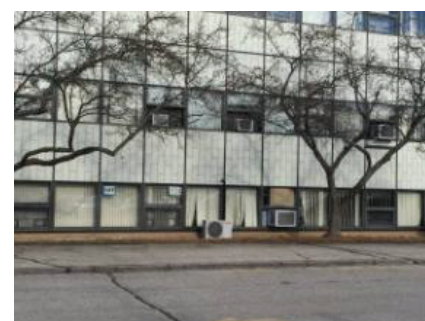
The majority of the building is not air conditioned. Some areas of the building are air conditioned by window AC units, split-system and ductless cooling type air conditioning systems. There are several roof mounted and grade mounted air-cooled condensing (ACC) units that are connected to ductless split system AC units located throughout the building. The Administration area, Copy room, Computer Classroom and Main Server room are air conditioned by split system AC units. The teacher Dining Room, Custodian's office and various Classrooms are air conditioned by Window AC units. In general the majority of these units appear to have been installed within the past 5-10 years and in fair to good physical condition. There was one older condensing unit observed that appeared to be of an older vintage and in need of replacement.

Window AC Units

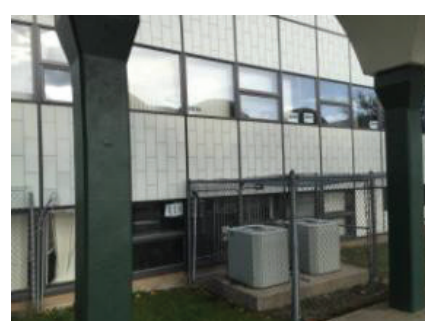
Grade Mounted Air Cooled Condensing Units

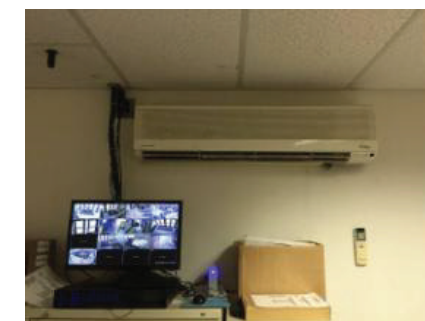
Ductless Cooling Unit – Operations Office

The Operations office is air conditioned by a ductless AC unit.

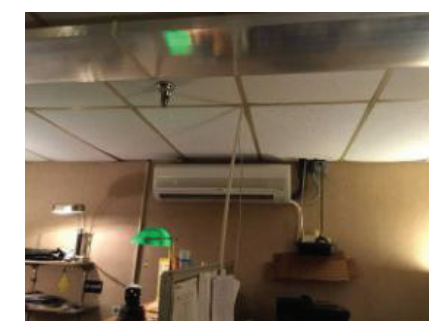
Ductless Cooling Unit – IT Server and Office

The IT Server and Office room is air conditioned by a ductless AC unit. It was reported that the room is consistently warm and experiences inadequate airflow and temperature control.

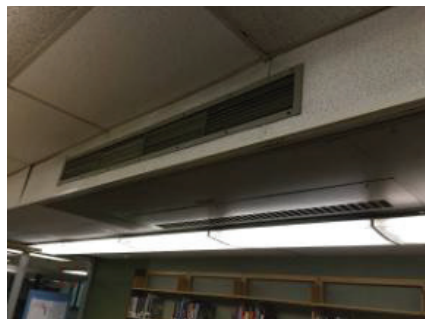
The Library/Media Center is heated and ventilated by indoor ceiling suspended heating and ventilation unit ventilators. The units were installed circa 1967, and are approximately 48 years old and past their expected service life. The Library/Media Center is also heated by supplemental fin tube radiation that is located along the perimeter exterior walls.

Library Heating & Ventilation Unit

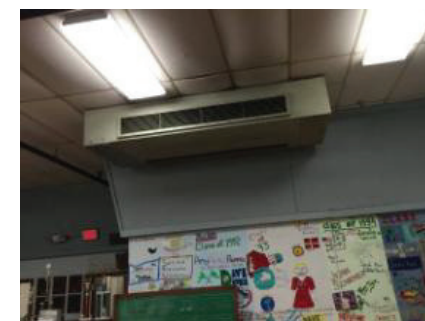
The Music classrooms are heated and ventilated by horizontal type classroom unit ventilators, and are exhausted by exhaust air fan systems. The unit ventilators and ductwork distribution systems appear to be originally installed equipment, installed circa 1967, and past their expected service life. Some Music classrooms also have supplemental hot water fin tube radiation installed; the fin tube radiation also appear to be originally installed equipment.

Music Classroom – Unit Ventilator

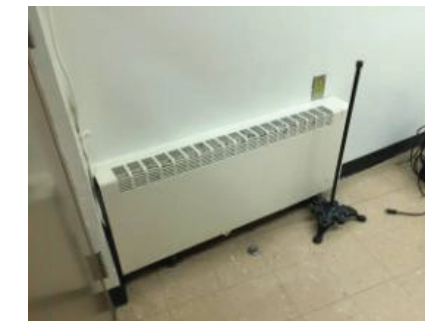
Music Classroom – Fin tube Radiation

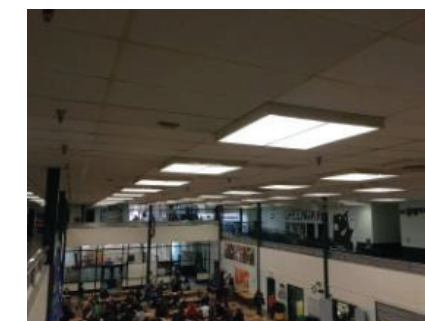
The Cafeteria is heated and ventilated by an indoor hot water air-handling unit (AHU-6) that delivers supply air to the space via a galvanized sheetmetal distribution system and ceiling mounted diffusers. Return air is primarily removed from the space by low wall return registers. The air handling unit and ductwork distribution system was installed circa 1967, and is approximately 48 years old and past its expected service life.

Cafeteria – Ceiling Diffusers

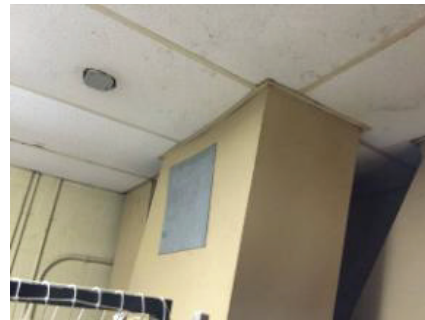
The Kitchen has a stainless steel exhaust hood that is exhausted by a centrifugal utility set exhaust fan located in the Penthouse Mechanical room. The kitchen exhaust ductwork riser does not appear to meet all current NFPA 96 code requirements as the riser is not located in a 2-hr fire rated enclosure. The Kitchen is heated by supplemental hot water unit heaters and supply air registers that are connected to a make-up heating and ventilation air-handling unit (AHU-7). There is a wall mounted propeller fan that is utilized to provide airflow movement within the space. The dishwasher is exhausted by stainless steel ductwork that is connected to an exhaust air fan. The Kitchen service corridor is heated by a unit heater.

Kitchen Exhaust Duct Riser in Storage Closet

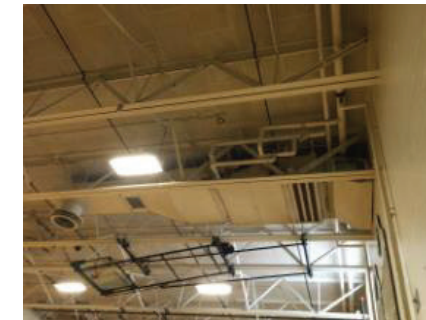
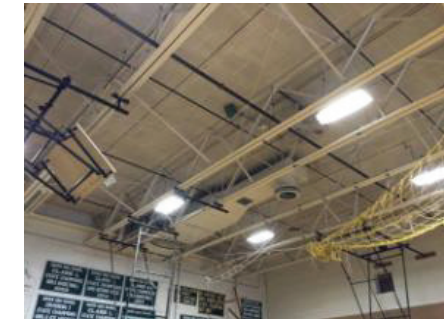
The Gymnasium is heated and ventilated by four (4) indoor, ceiling suspended, hot water heating and ventilation units (AHU-1, 2, 3 & 4). The units appear to have been installed circa 1967 and are in poor physical condition and have exceeded their expected service life. Exhaust air is removed from the gymnasium via ceiling exhaust grilles that are connected to roof exhaust fans. There are (4) four roof exhaust fans.

Gym Heating & Ventilation Units

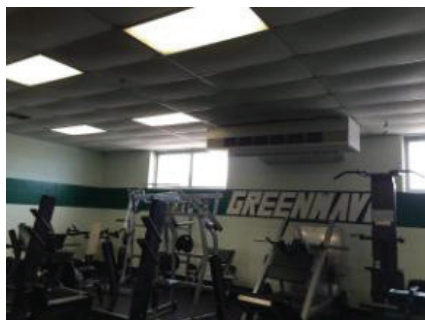
The Fitness Room is heated by a ceiling suspended hot water unit ventilator. It appears that the unit ventilator is originally installed equipment circa 1967. The heating and ventilation system appears to be in poor condition and past its expected service life.

Fitness Room Unit Ventilator

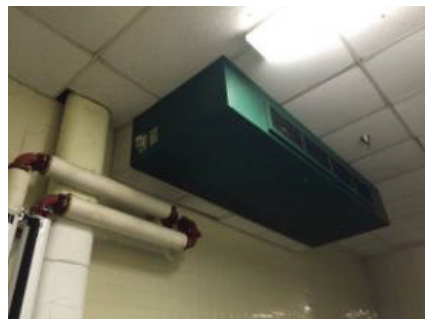
The Locker Rooms are heated by a combination of suspended hot water unit ventilators and hot water fin tube radiation heating equipment. The Girls locker room has a ducted exhaust air system that is served by two (2) inline exhaust air fans. The Boy's Locker room is exhaust by rooftop exhaust air fans. It appears that the heating and ventilation system appears to be originally installed equipment, in poor physical condition and past its expected service life. Sections of the fin tube radiation and several of the air distribution devices appear to be rusted and soiled.

Locker Room Unit Ventilator

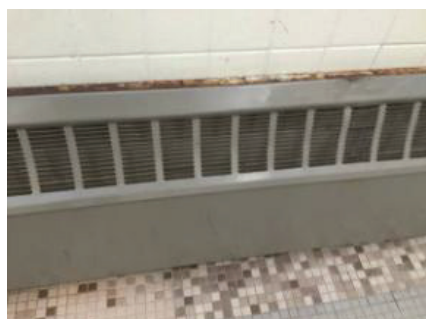
Locker Room Fin tube Radiation

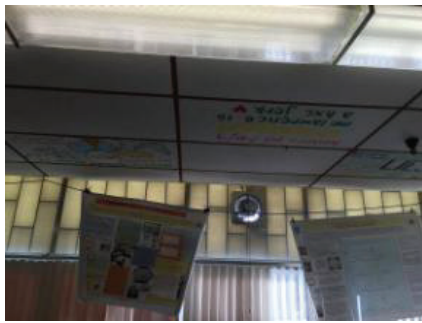
Science Classroom Sidewall Exhaust Fan

Some of the Science Classrooms have fume hoods and associated exhaust air fan systems. Some of the Science classrooms also have a sidewall exhaust air fan. It has been reported that the fume hood operation interferes with the heating and ventilations system's ability to properly heat the space, as warm air is exhausted through the fume hood and sidewall exhaust air fan while they are in operation. Tempered mechanical make-up air ventilation should be provided in these Classrooms.

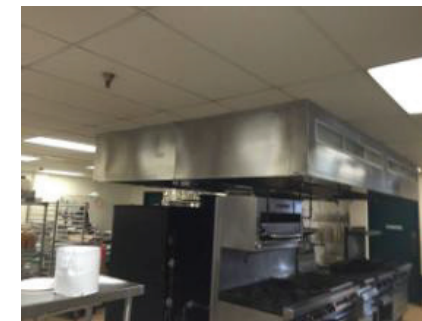
The 1989 Addition Kitchen has a main stainless steel kitchen exhaust hood and associated roof mounted exhaust air fan. There is also a stainless steel canopy dishwasher hood. There are hot water ceiling suspended unit heaters that provide heating to the kitchen. Make up air ventilation is provided by a roof top make-up air unit. The exhaust, make-up air and heating systems appears to have been installed circa 1989 and appear to be in fair to poor condition.

Kitchen Exhaust Hood

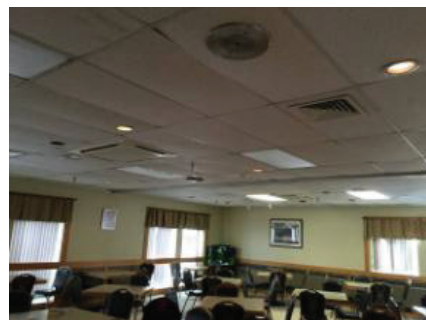
1989 Addition Dining Room - Cassette Type AC Unit (left)

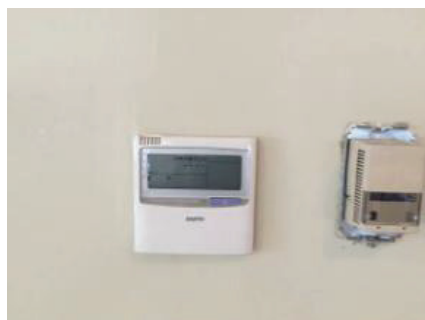
1989 Addition Dining - Thermostats

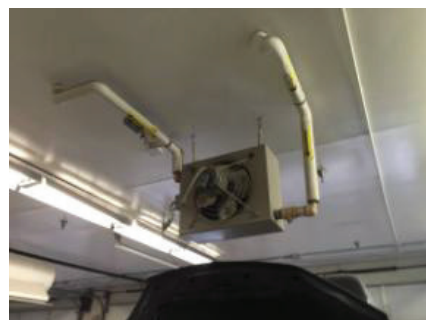
The Auto Shop is primarily heated and ventilated by a central indoor air handling unit and duct mounted hot water heating coils. Supplemental heating is provided by hot water unit heaters. There are general exhaust air, welding booth and under-slab exhaust air systems installed. The air handling unit, unit heaters, general exhaust and under slab exhaust were installed circa 1989 and are generally in poor physical condition. The welding booth exhaust and ventilation ductwork appear to be in fair condition.

Auto Shop Unit Heater

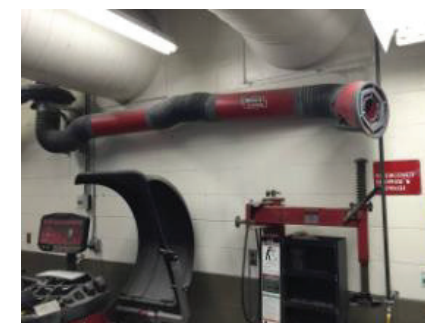
Auto Shop Welding Exhaust System

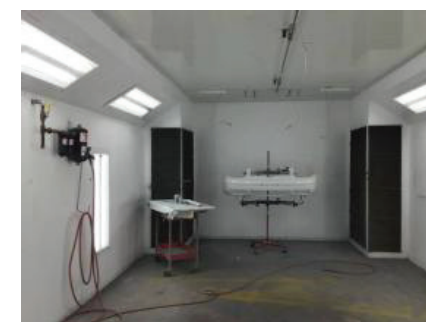
The Auto Body Shop is primarily heated and ventilated by a central indoor air handling unit and duct mounted hot water heating coils. Supplemental heating is provided by hot water unit heaters. There are general exhaust air, and paint booth exhaust welding booth systems installed. The air handling unit, unit heaters and general exhaust systems were installed circa 1989 and are generally in poor physical condition. The paint booth make-up ventilation air is provided from a rooftop unit and exhaust air is provided by an associated exhaust fan. The paint booth appears to be in fair condition.

Paint Booth

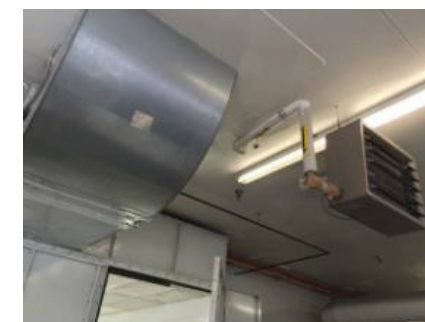
Paint Booth Ductwork and Unit Heater

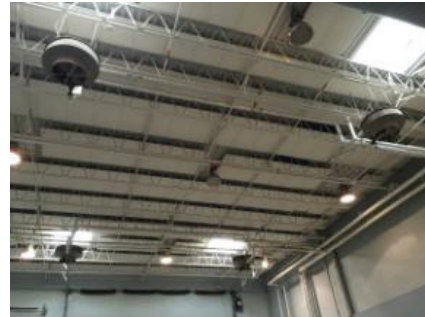
The Trades Shop is primarily heated and ventilated by a central indoor air-handling unit and duct mounted hot water heating coils, and supplemental heating is provided by ceiling suspended propeller type unit heaters. The unit heaters appear to be in good condition. There is a re-circulating filtered type dust collector installed. The dust collector appears to be in good condition.

Unit Heaters

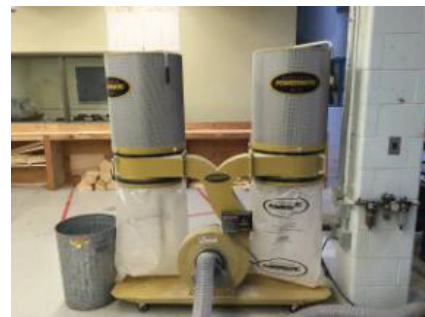
Dust Collector

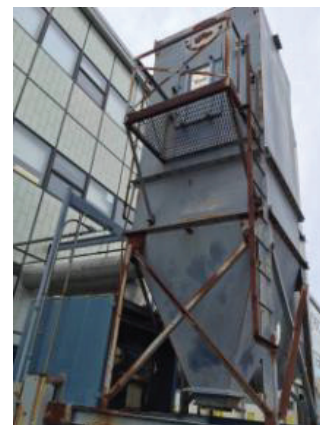
The Wood Shop is primarily heated and ventilated by a hot water unit ventilator, and supplemental ventilation air is provided by a central station air handling unit. There is an outdoor grade mounted dust collector installed that is ducted to wood-working saws and equipment via galvanized sheetmetal ductwork. The unit ventilator, dust collector and associated ductwork appears to be in poor condition.

Wood Shop - Dust Collector

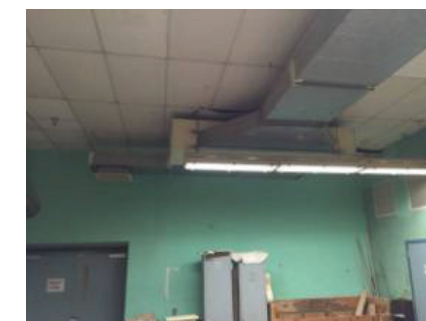
Wood Shop Unit Ventilator

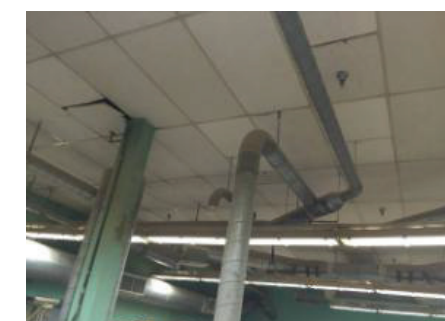
Wood Shop Dust Collector Exhaust Ductwork

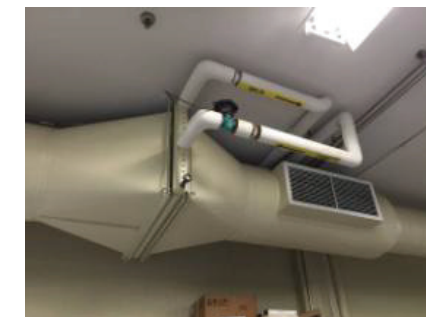
The CADD Classroom and Shop is primarily heated and ventilated by a central indoor air handling unit and duct mounted hot water heating coils. There are general exhaust air and hose-reel exhaust air systems installed. The air handling unit, general exhaust fan and hose-reel exhaust systems were installed circa 1989 and are generally in poor physical condition. The exhaust and ventilation ductwork appear to be in fair condition.

CADD Shop Heating Coil and Ventilation Ductwork

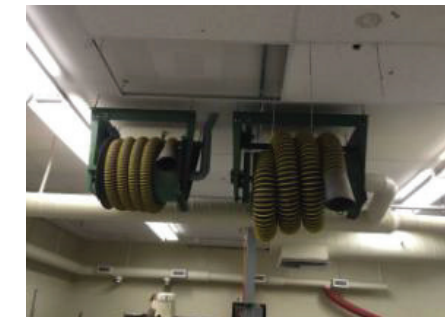
Hose-Reel Exhaust

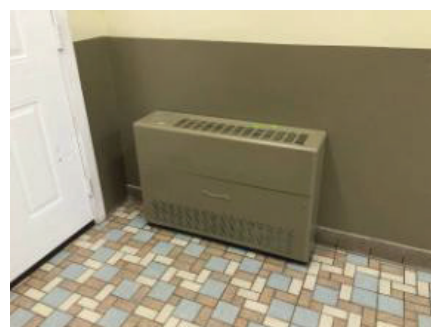
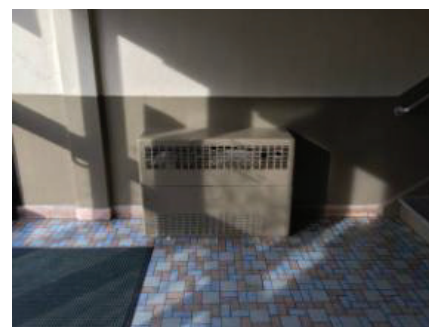
Entryways, stairwells, and corridors are typically heated by cabinet unit heaters. There are also locations where hot water fin tube radiation is installed. In general, the heating equipment is originally installed equipment, approximately 25 to 48 years old dependent upon its location and date of installation.

Existing Cabinet Unit Heater

- Corridor and Entryway Heating and Ventilation – The majority of corridor areas should be provided with improved mechanical ventilation, as many appear under ventilated*. Existing ductwork and diffusers should be replaced and existing hot water radiator/convectors/unit heaters should be replaced.

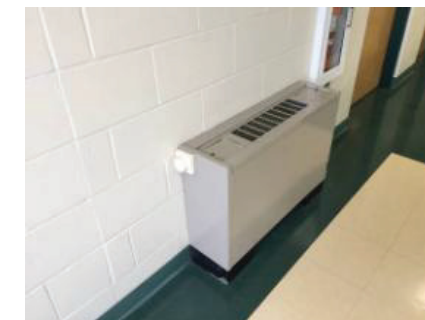
Existing Cabinet Unit Heater – World Arts Wing

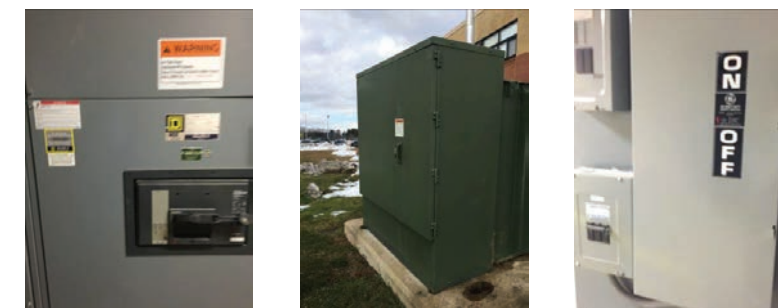
The service voltage is 120/208V rated at 2000 amps. The switch is in fair condition and within its 40 year useful life. The main switchboard does not have space for future expansion. The main switchboard is manufactured by Square D.

The power for the facility is in poor/fair condition, a new power distribution system should be provided at 277/480 volt distribution.

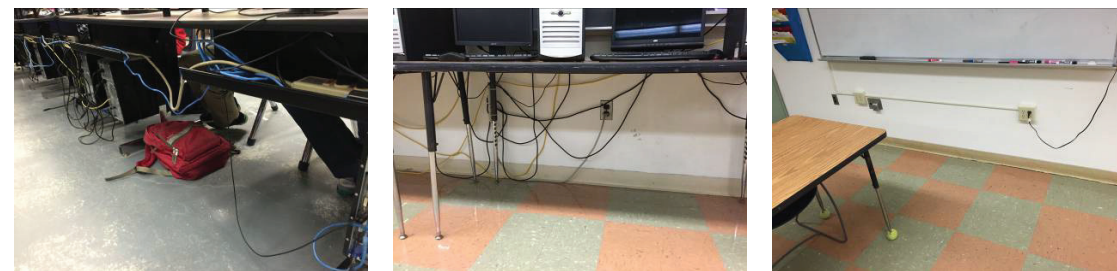
Kitchen and Science Lab receptacles are not on GFCI circuits to meet present code. Science labs do not have EPO's installed.

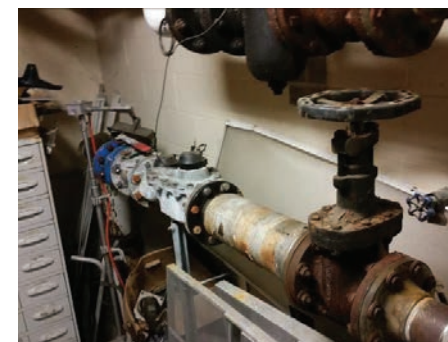
In the 1967 School there is a dedicated 4" domestic water service which enters the mechanical room. There is a 4" domestic water meter and two 2" reduced pressure backflow preventers with pressure reducing valves located in parallel. There is also two 1-1/2" pressure reducing valves piped in parallel configuration. The distribution main is 4" in size.

1967 school water service & meter

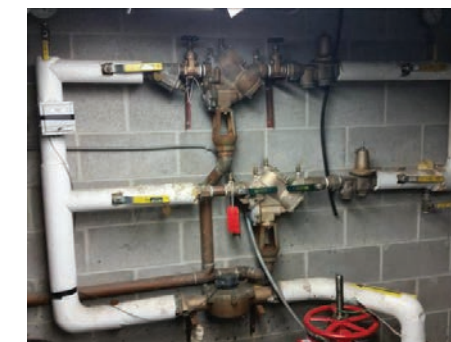
In the 1989 Addition there is a combined 8" water service which enters the lower level mechanical room. Off of this service there is a 2-1/2" domestic water supply with 2" water meter and two 1-1/2" reduced pressure backflow preventers with 1-1/2" pressure reducing valves located in parallel. The outlet water pressure is 70 PSI.

1989 addition water meter

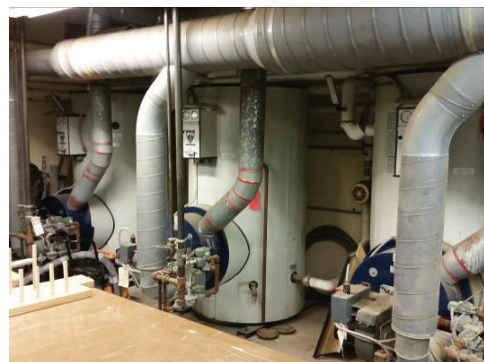
Domestic hot water in 1967 School is generated through three natural gas fired storage type water heaters. Water heaters are PVI model 750N-400A, with a natural gas input of 600,000 BTUH and 400 gallon storage capacity. The water heaters are in fair condition. The hot water systems are recirculated. There are two thermostatic mixing valves on the systems to prevent scalding, Lawler model 805 and Lawler model 802.

1967 School water heaters

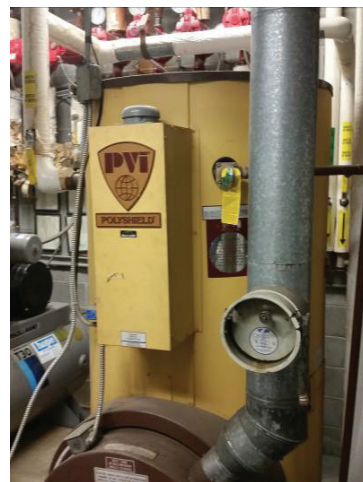
Domestic hot water in 1989 Addition is generated through a gas fired storage type water heater. Water heater are PVI model 375P-225, with a natural gas input of 300,000 BTUH and 225 gallon storage capacity. The water heater is in fair condition. The hot water system is recirculated. There are two thermostatic mixing valves on the systems to prevent scalding, both are Symmons model 5-900.

1989 Addition water heater

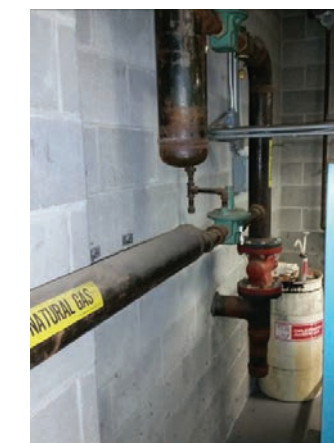
1989 building gas piping

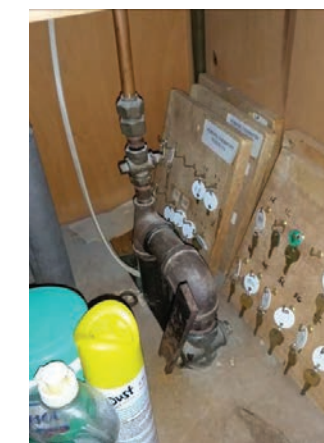
Science room gas valve

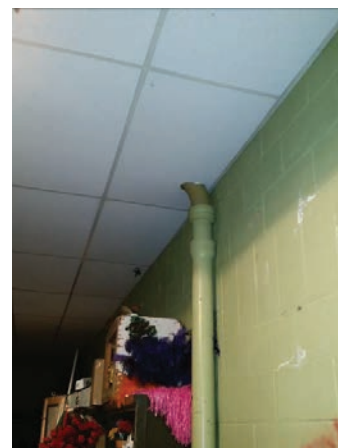
Cast iron is used for sanitary and storm drainage. Where visible, the cast iron pipe appears to be in fair condition. Smaller pipe sizes appear to be copper or PVC.

Cast iron drainage piping

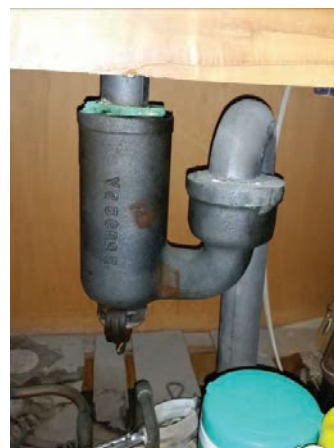
Acid waste and vent piping is hub and spigot dur-iron. The systems is not piped to an acid neutralization system

Science waste piping

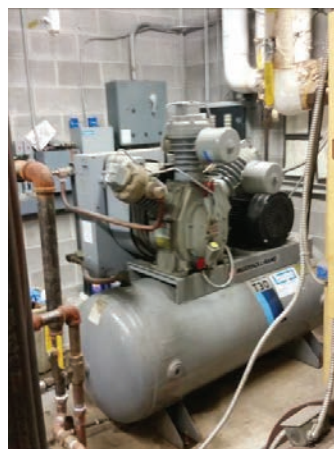
The compressed air is provided by a single 15 h.p. motor located on a horizontal receiver. Compressor is located in the 1989 Addition mechanical room. The air compressor is in good condition.

Air compressor

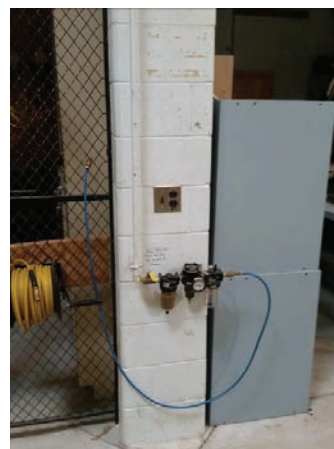
The technical shops are provided with compressed air. There are various pipe drops in each shop supplied from the piping distribution system. Typical outlets include a filter and pressure regulator.

Typical air outlet station

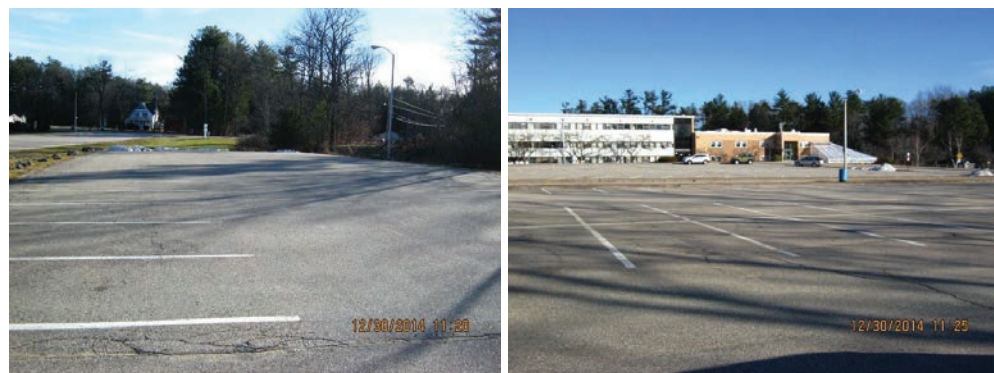
Senior Lot

- Upon visual inspection the condition of the existing pavement is generally in satisfactory to less than satisfactory condition. Longitudinal and traverse cracking is low to medium in severity while alligator cracking is minimal. None of the cracks observed in the pavement have been sealed using asphalt crack sealant.
- Raveling and aging (pavement surface deterioration/loss of aggregate) of the pavement is not evident.

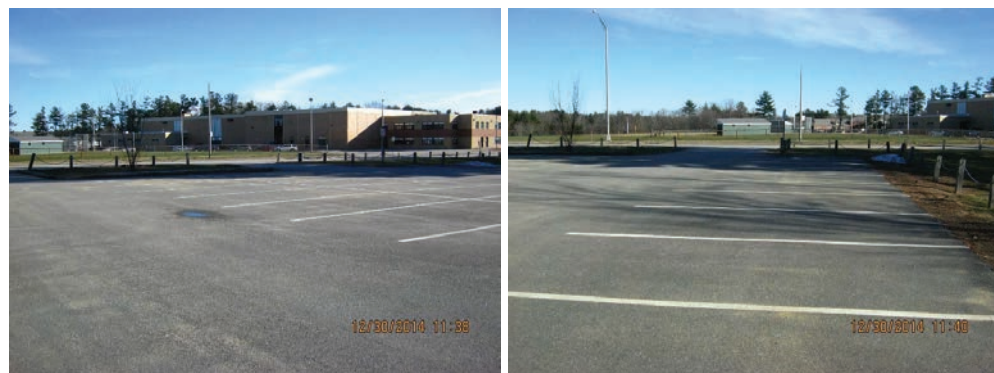
Dover Alternative Program Parking Lot (50 Alumni Drive)

- Upon visual inspection the condition of the existing pavement is generally in good condition.
- No cracking, raveling and aging (pavement surface deterioration/loss of aggregate) of the pavement is evident.
- A couple of minor puddles were observed in the parking lot.

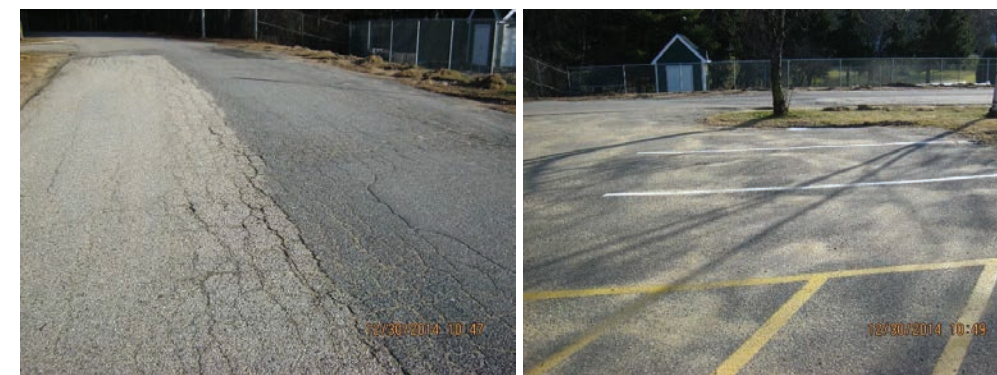
Pavement East of 1989 Addition (Including the access road from Alumni Drive)

- Upon visual inspection the condition of the existing pavement is generally satisfactory to less than satisfactory. Numerous cracks (longitudinal, traverse, alligator) were observed in the pavement. None of the cracks observed in the pavement have been sealed using asphalt crack sealant.
- There is minor raveling and aging (pavement surface deterioration/loss of aggregate) of the pavement evident throughout the area.
- The pavement overlay at the entrance and exit from Alumni Drive is in good condition.

- Full depth pavement reconstruction, including new pavement and gravels. Installation of heavy duty pavement section for truck travel paths in Lot C. Addition of geogrid may be necessary pending results of a geotechnical investigation.
- Bituminous concrete curb
- Bituminous asphalt sidewalks including along Alumni Drive (pavement replacement only)

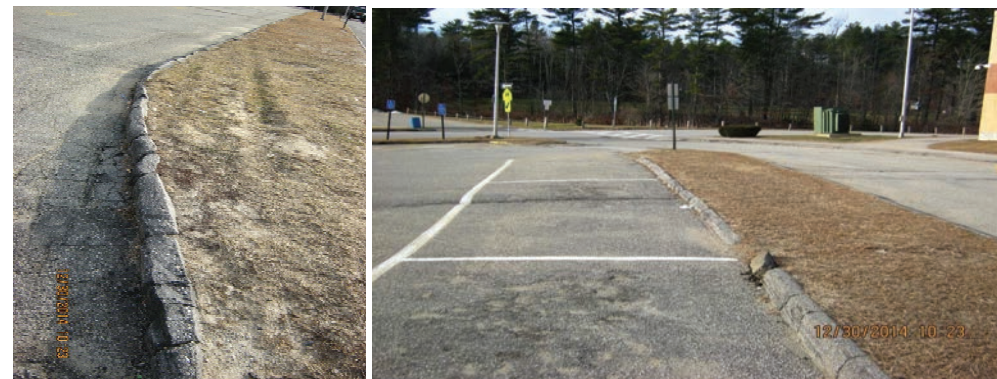
A Lot & Bus Drop-off

- The A Lot and Bus Drop-off driveway are surrounded by bituminous concrete curb (BCC) except along the face of the concrete sidewalk entering the main entrance to the building.
- Based on visual inspection most of the BCC is nearing the end of its life cycle however it still appears to be functioning as designed. The BCC is cracked into several small 1 to 2 foot sections and is deformed in areas. BCC is a cost-effective curb, however, the harsh New England winters and snow plows shorten its useful life.
- The height of BCC is generally desired to be about 4-5 inches above finished grade. Nobis observed sections of BCC less than 3 inches (likely due to pavement overlays over the years).
- Recommend replacing BCC with vertical granite curb (VGC) along sidewalk for pedestrian safety.
