DOVER HIGH SCHOOL AND CAREER TECHNICAL CENTER Site & Building Assessment Report

Dover, New Hampshire

August 2015

Volume 2 of 3

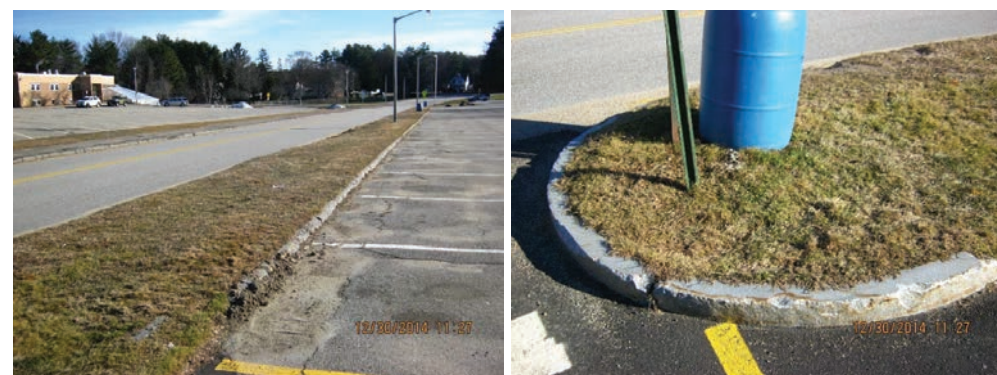
Senior Lot

- No curb except around the landscape island abutting Alumni Drive. The landscape island has BCC along both sides of the island and VGC around the radial ends.
- The condition of the VGC is satisfactory while the condition of the BCC is nearing the end of its useful life. The BCC is cracked into several small 1 to 2 foot sections but has not begun to lose its alignment.

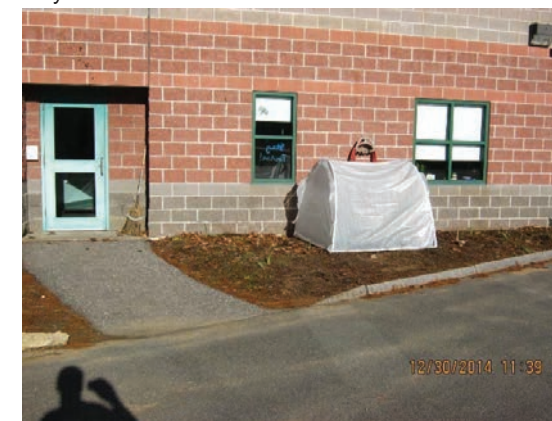
Dover Alternative Program Parking Lot (50 Alumni Drive)

- No curb except around the southeast corner of the building. The curb around the edge of the parking lot surrounding the southeast corner of the building is sloped granite curb (SGC). The SGC is in satisfactory condition.

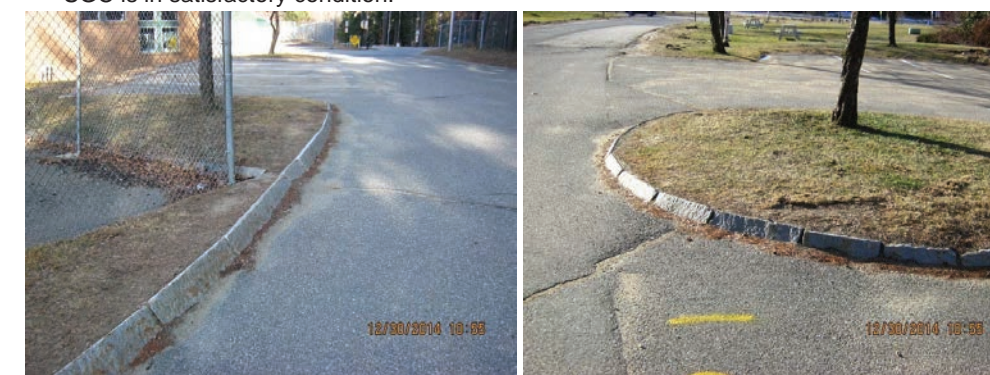
Pavement East of 1989 Addition (East Side of DHS)

- SGC around portions of the asphalt perimeter along the east side of the 1989 addition. The SGC is in satisfactory condition.

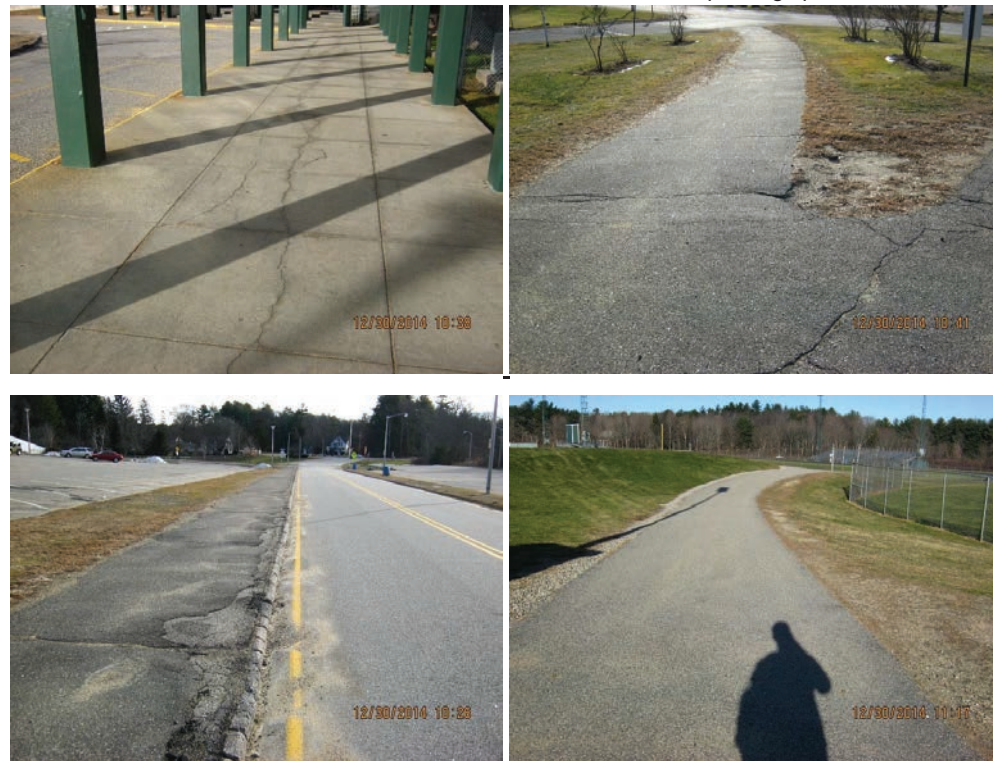
- The concrete sidewalk along the main entrance at the front of the school is in satisfactory condition. There is some cracking along the sidewalk and minimal chipping. The concrete steps to the main entrance have some chipped concrete at the edges.
- The asphalt sidewalk that loops from Alumni Drive along the front of the school is in less than satisfactory condition. Numerous cracks (longitudinal, traverse) were observed along the sidewalk. Some of the cracks have been treated with asphalt crack sealant but the majority

of the cracks have been left untreated. Appeared that the sidewalk has been overlain in the past.

- The sidewalk along the edge of Alumni Drive is in poor condition. Numerous cracks (longitudinal, traverse, alligator) were observed in the asphalt. Raveling and aging (pavement surface deterioration/loss of aggregate) of the asphalt was also observed, most notably at the sidewalk edges. Appeared that the sidewalk has been overlain in the past.
- The walkways to the building at 50 Alumni Drive are in good condition.
- The walkway from the B Lot to the ball fields was in good condition.
- The walkway from the B Lot to the doors at the front of the 2002 addition (Door #3 & Door #4) are in good condition.
- The concrete sidewalk leading to Door 28 at the east side of the 1989 addition is in poor condition. The concrete has deteriorated next to the accessible parking space.

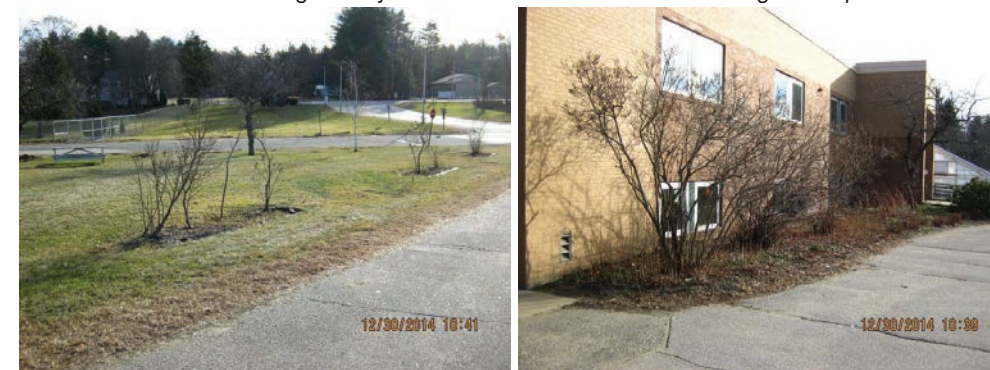
- Landscape inspection included the inspection of the trees and shrubs around the perimeter of the buildings and parking lots. The inspection did not include the landscaping and vegetation of the ball fields.
- The trees and shrubs planted around the buildings and parking lots appeared to be well established and healthy.
- The majority of the planted tree and shrubs are along the front face of the buildings and along the western edge of the driveway from Alumni Drive heading towards the C lot and middle school.
- Visible inspection of the grass appeared to be well established throughout the campus.
- The existence of an irrigation system could not be determined during the inspection.

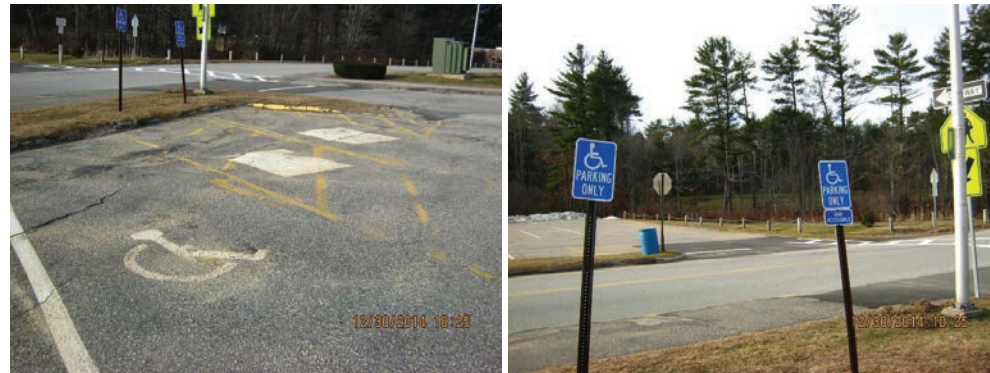
A Lot & Bus Drop-off

- Upon visual inspection there are two accessible parking spaces in the A lot and one accessible ramp into the main entrance of the building. There are approximately 87 parking spaces in the A Lot. According to state and federal ADA design standards there should be a minimum of 4 accessible parking spaces. In addition to having less than the minimum number of accessible spaces required, the access aisle striping and parking space signage are out of compliance. Also the head of the accessible aisles does not lead to an accessible path of travel as required by ADA.

- Insufficient number of accessible parking spaces (Section 208.2)
- No van accessible space designated (Section 502)
- Improper signage for accessible spaces (Section 502 & 703)
- Access aisle does not lead to accessible path (Section 403 & 502)
- Access aisle does not meet running and cross slope requirements (Section 403)

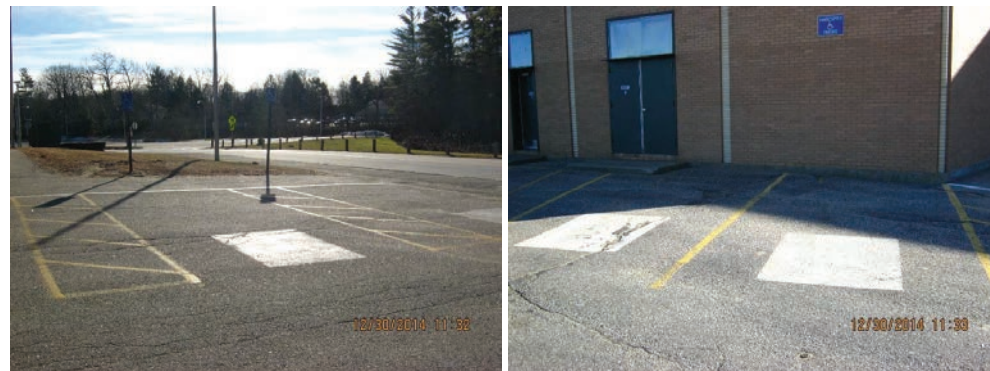
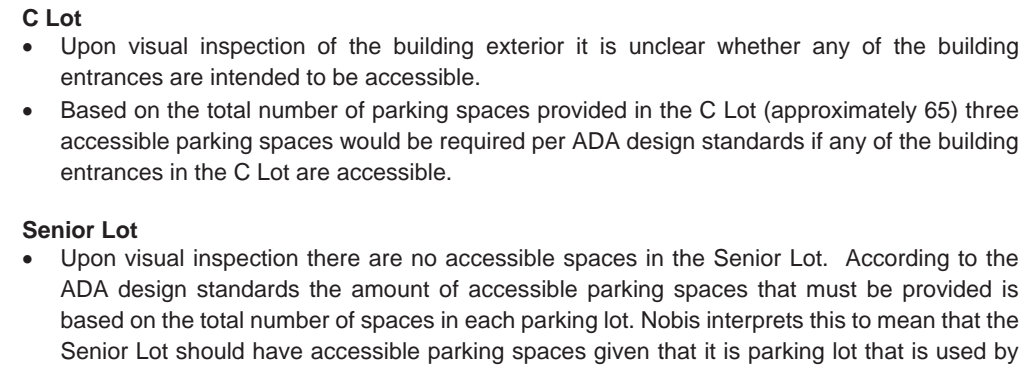
B Lot

- Upon visual inspection of the building exterior it appears that Door 3, 4, 5, and 12 are accessible building entrances. There are approximately 90 parking spaces in the B Lot. According to ADA design standards there should be a minimum of 4 accessible parking spaces for which 4 accessible parking spaces are provided in the B Lot.

- There are two accessible parking spaces designated in the shortest accessible route to Door 5. Although the number of spaces is adequate one of the spaces should be designated as van accessible and the accessible spaces are not properly striped with an access aisle.

- There is a long concrete ramp leading to the Door 5 entrance. This ramp should have a handrail and a level landing per the ADA standards.
- No accessible parking spaces are provided to access Door 12. If this is an accessible building entrance a minimum of one van designated accessible space should be provided.

- Accessible parking spaces are not located in the shortest accessible route to a building entrance (Section 208.3)
- No van accessible space designated (Section 502)
- Improper signage for accessible spaces (Section 502 & 703)
- Access aisle does not lead to accessible path (Section 403 & 502)
- Access aisle may not meet running and cross slope requirements (Section 403)
- Ramp does not have handrails or a level landing (Section 405.7 & 405.8)

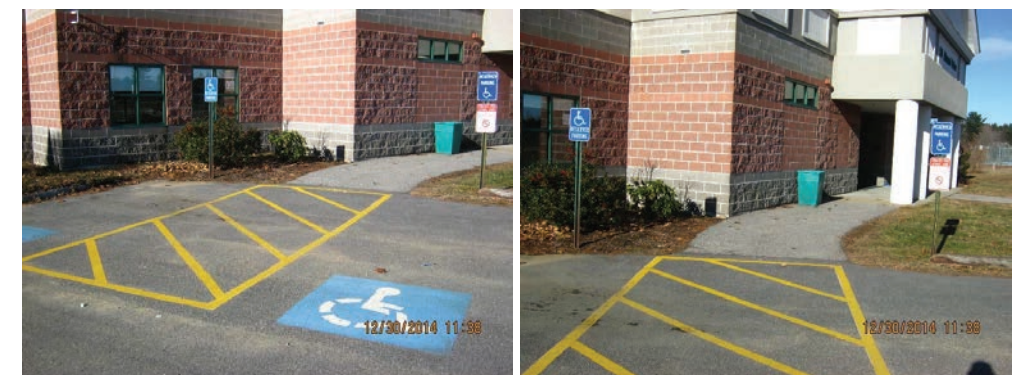
Dover Alternative Program Parking Lot (50 Alumni Drive)

- Upon visual inspection there are three accessible parking spaces in the parking lot and there appears to be one accessible entrance at the front of the building. There are approximately 76 parking spaces in the parking lot.
- Two accessible parking spaces are properly located closest to the accessible entrance although one of the spaces should be designated as van accessible. The other accessible space is located closest to the walkway to one of the ball fields. To be in accordance with ADA design standards this accessible space should be designated as van accessible and have an 8 foot wide access aisle to the right of the space.
- Based on the 76 parking spaces in the parking lot per ADA design standards 4 accessible parking spaces are required and only 3 accessible parking spaces are provided.

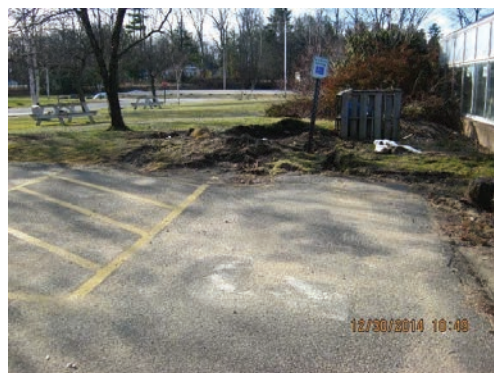
1989 Addition Parking Spaces

- Upon visual inspection there is one accessible entrance (Door 28) to the 1989 addition. There is a small 4 parking space lot accessible to this entrance. One of the four parking spaces is accessible which meets ADA design standards. However, this accessible parking space should be designated as van accessible and have an 8 foot wide access aisle to the right of the space.
