CITY OF DOVER FACILITIES, GROUNDS & CEMETERIES MASTER PLAN

CITY OF DOVER, NEW HAMPSHIRE

FEBRUARY 2018

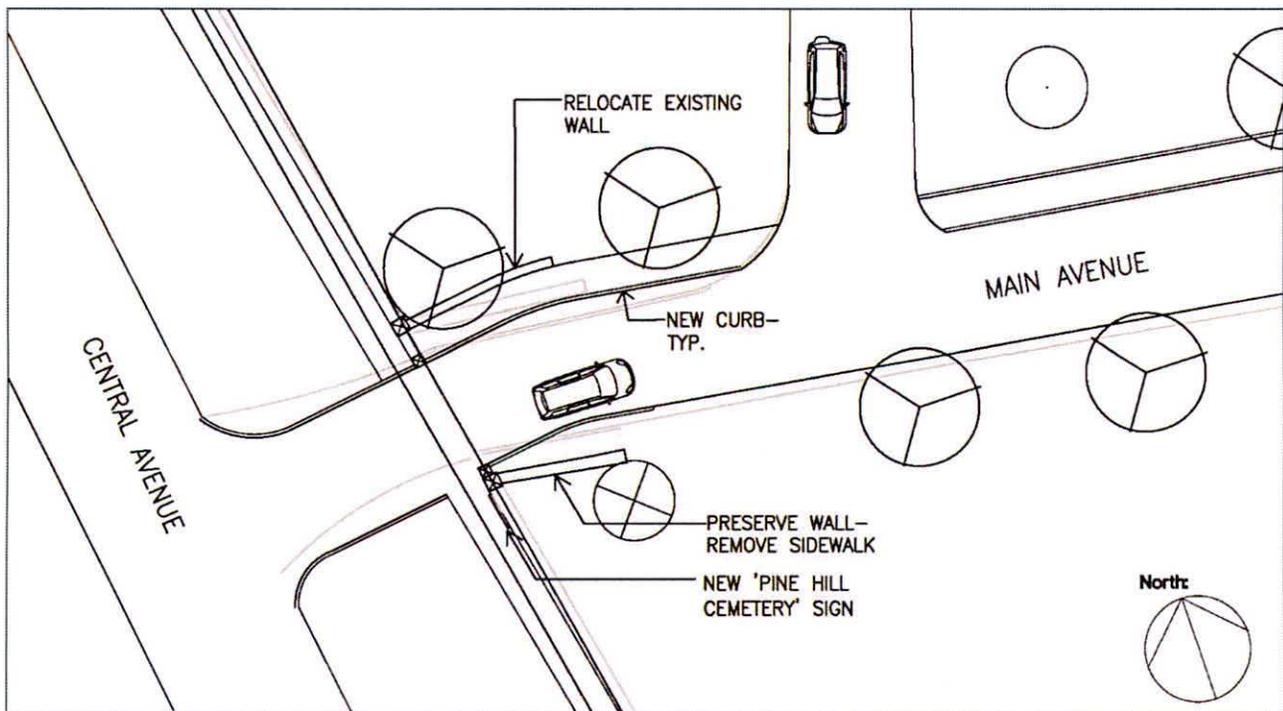
The main entrance into the cemetery from Central Avenue is difficult to navigate due to lack of signage, poor sidewalks, steep road grade and narrow road width. The proposed design removes the walkway on the south side of Main Avenue, widens the roadway and expands the sidewalk along the north side of the drive. Additional unified signage is recommended to allow clear identification/direction from Central Avenue.

The existing road to the chapel is in poor condition with cracked pavement and failing sections along the north side of road. Main Avenue should be repaired in this location.

- Install drip strip around chapel and underdrain for foundation.
- Review feasibility of improving access into the main entrance off of Central Avenue.
See Exhibit A and description of existing conditions.
- Widen the sidewalk to five feet from Central Avenue to the Chapel with new curbing along Main Avenue to the Chapel entrance drive.
- Repair failing sections of pavement on Main Avenue near chapel entrance.
- Investigate options to improve drainage on Main Avenue where the main entrance meets Central Avenue.
- Close public vehicular access into the cemetery from East Watson Street at Avenue M and Avenue R intersection to improve vehicular safety along the road curve and manage controlled points of access to the cemetery.
- Remove utility poles that no longer provide service.

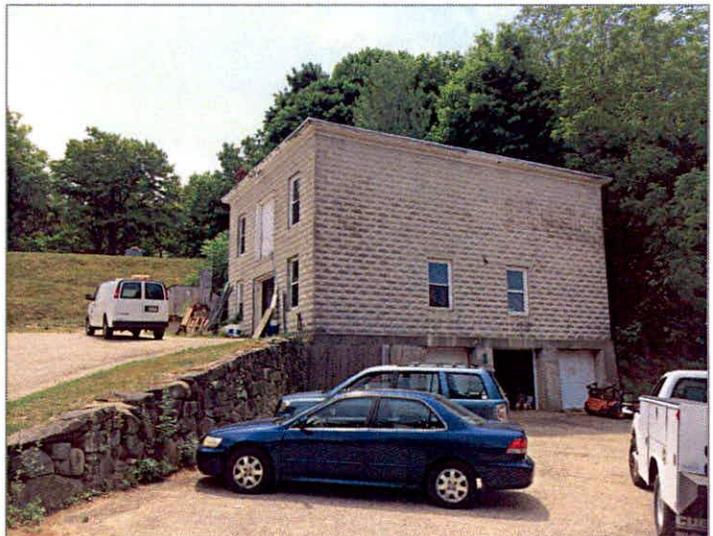
The cemetery barn has many structural issues highlighted in the report by Building Envelope Specialists. Functionally, the space is highly inefficient to serve the diverse needs of the grounds crew.

The following deficiencies were highlighted:

- **Work space.** Lack of heated workshop space for equipment repair & lack of a repair bay hoist
- **Equipment Storage Space.** Lack of heated garage bay for bucket truck and temperature sensitive machinery
- **Code Compliant Storage Space.** Flammable materials storage space
- **Storage Space.** Lockable tool storage
- **Functional Space.** Adequate breakroom/kitchenette space
- **Functional Space.** Adequate restroom facilities
- **Fuel Storage.** Code compliant fuel storage
- **Exterior Storage.** Exterior materials storage

- Building Envelope Solutions completed an assessment of the maintenance barn and provided the following; the barn is in need of repair. Open mortar joints are visible all around the building masonry features and on each elevation. Exterior load bearing walls are in poor conditions with spalling and fractured masonry units. The split-face blocks have been coated with a cementitious coating that is now peeling, resulting in spalling units. Embedded steel lintels over the large door openings are in poor condition due to the oxidation of the steel. Wooden soffit trim has larger areas of rot and peeling paint due to moisture infiltration. Wooden trim around door and windows are peeling with some areas of rot. The ballasted roof was not observed closely, however damage to the wooden soffits suggest moisture infiltration at the roofs edges. Due to the condition of the building and lack of efficient programming, BES recommends this building be demolished.

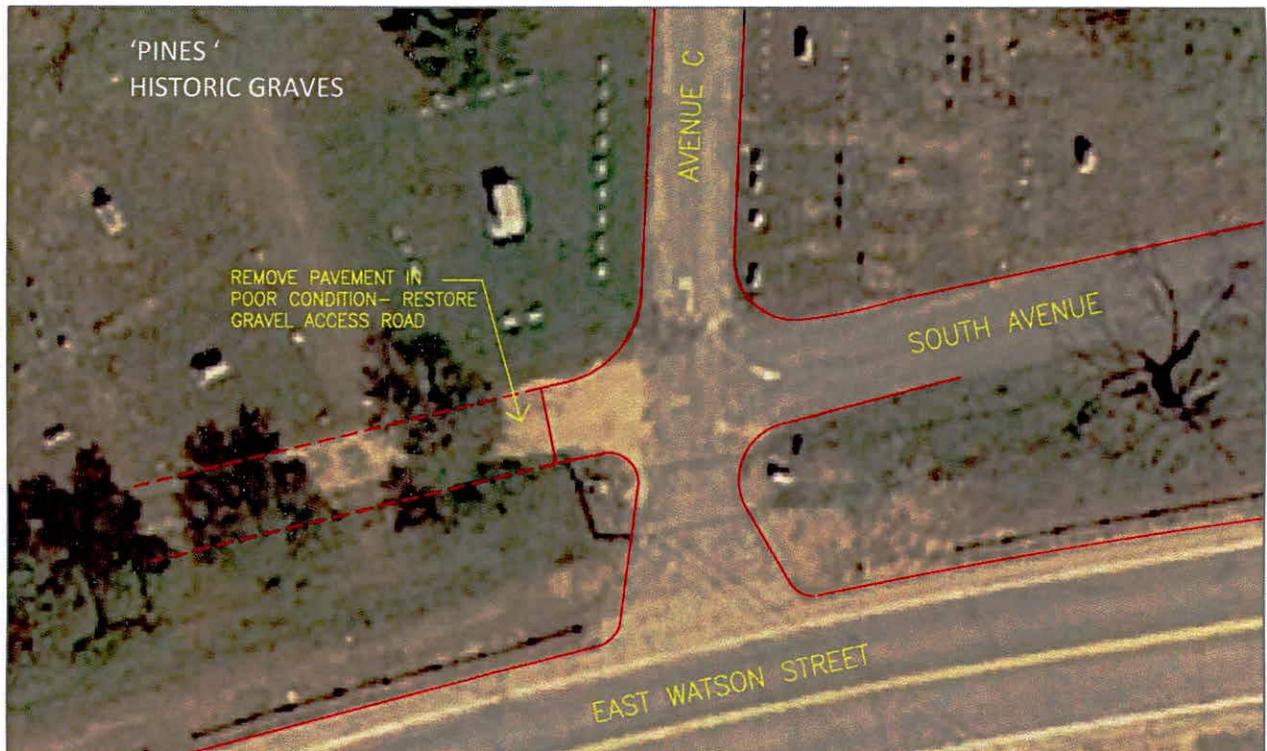
Some of the less used paved roadways are in poor condition. Removal of pavement within these locations and restoring them to gravel would maintain access, improve aesthetics and decrease long term paving costs. The above Exhibit F highlights 170 linear feet of asphalt in poor condition within the historic section of the cemetery.

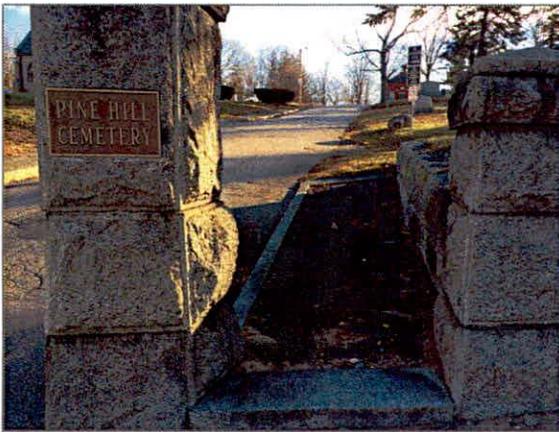
Identification Sign

The main entrance to Pine Hill Cemetery is highlighted by a beautiful stone wall that extends the length of the Central Avenue frontage. Stone pillars mark pedestrian and vehicle access. A small bronze placard with the words 'Pine Hill Cemetery' is located on a pillar at the entrance; this is the only identification signage for the entire cemetery. On an adjacent pillar, a sign with the address is strapped to the pillar with metal straps.

Despite the prominence of the walls and pillars, the combination of having a narrow entrance and the relative height that the cemetery sits above Central Avenue, make identification of Pine Hill Cemetery difficult. The signage at the main entrance is inadequate for easy recognition from Central Avenue. From East Watson Street and Court Street, there is no signage that identifies the cemetery at any of the entrances.

- Develop a consistent signage design for use within City of Dover cemeteries
- Develop an attractive entrance sign that clearly welcomes, directs, informs and regulates visitors. The signs shall be located at each entrance to the cemetery with larger entrance signs at main entrances.

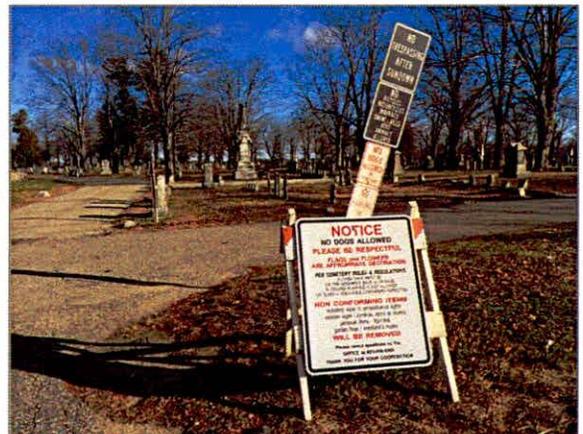
Regulatory signage dominates the cemetery entrances from East Watson Street. Signs consist of standard, utilitarian, street-type signs on posts, nailed to a utility pole or located on a moveable sign board. The clustering of multiple signs stating what the visitor is allowed/not allowed to do presents an uninviting image. This focus misses an opportunity to welcome and share the rich history of the site with visitors. Rules can be incorporated within the context of one sign that conveys respect.

There is a need to establish a coordinated signage plan and design for use throughout the cemetery for informational, directional and regulatory signage. In addition, the use of interpretive signage is an

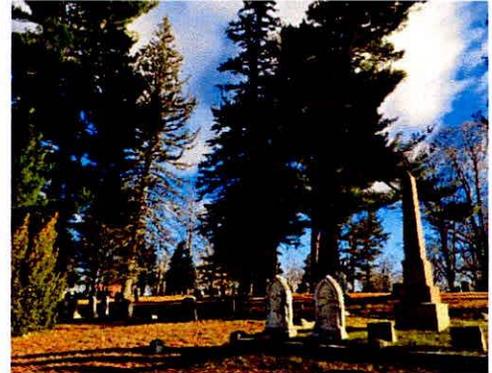
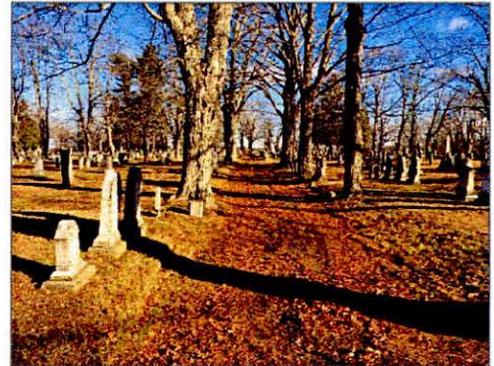
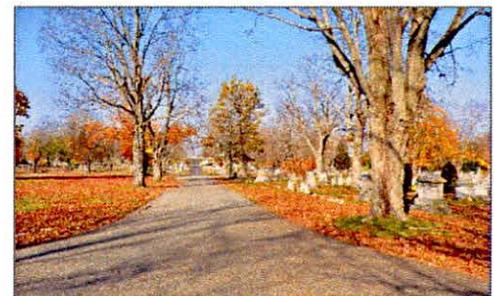
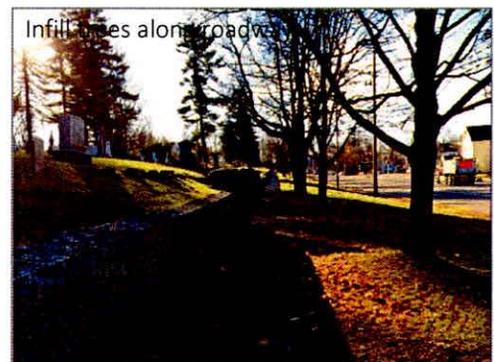
Lawn is the predominant ground cover and grubs have been a problem in the past. Grub control was applied in 2015 and 2016. Treatments should be applied on an annual or biennial basis. In general the lawn areas were in good condition. Regular parking along the edges of internal roads has

caused compaction in some areas. If this is a consistent problem, signage could be introduced to direct vehicles to park in grassed travel ways. Fertilization and aeration could improve the health and vitality of lawn areas. Low maintenance, low growing ground covers should be considered within raised graves sites to minimize mowing requirements and provide diversity within the ground plane. Ground covers could also be used within steep sloping areas that are a challenge to mow.

- Install additional tree plantings along the perimeter of the cemetery at Central Avenue, East Watson Street and Court Street.
- Review options to install ground covers within areas that are difficult or time consuming to mow (steep slopes, raised grave sites).
- Grind stumps and plant new trees where possible.
- Develop a planting plan for newly developed cemetery areas that can be implemented in the capital improvement plan. Refer to appendix 5.5 Recommended Plant List.
- Develop a maintenance program of lawn fertilization, aeration and over-seeding. Prior to fertilization, perform soil testing to determine soil nutrient deficiencies.

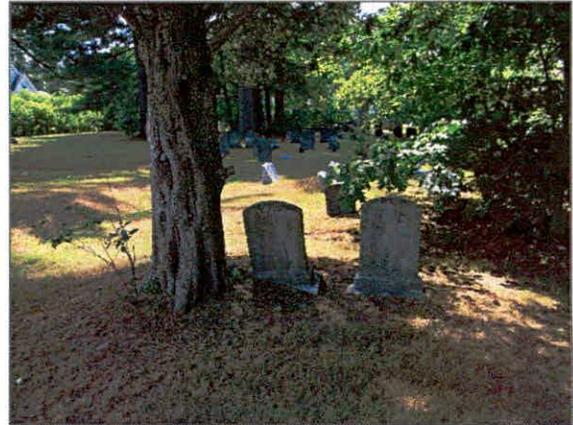
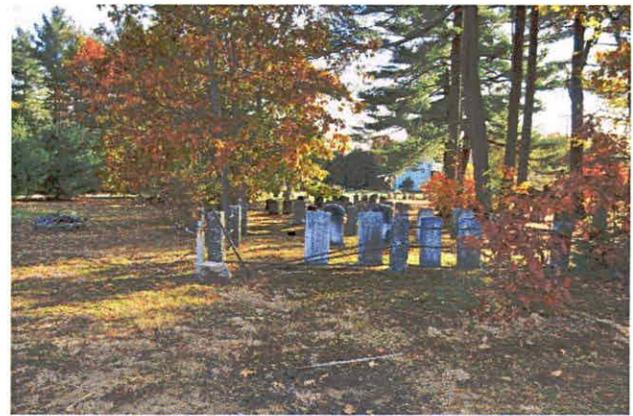
The small cemetery is located within a rural neighborhood, surrounded by single family residences. The lot has well established trees with many large white pines, oak and cedar. Shrubs and understory trees edge the northern property line while a thick growth of Japanese knotweed is overtaking the southerly property line. Based on the existing groundcover of weeds and mosses it is assumed the soils within this area are acidic. Soil pH appears to limit the establishment of healthy lawn. The monuments are in generally good condition although pipe railing around two groups of plots were either bent or broken. Signs of neighborhood activity within the cemetery were visible including children’s play items and garden tools. The limit of the cemetery is not clearly defined.

- **Invasive Plant Material.** It is recommended that the Japanese knotweed along the southerly border be addressed as the aggressive root system will continue to overtake the cemetery. Currently, numerous headstones are buried within the knotweed.

- Develop a schedule for eradication of Japanese knotweed.
- Prune existing trees and shrubs to maintain sightlines and safety.
- Repair broken pipe rail fencing.
- Provide appropriate fencing or granite posts to clarify property lines, define ownership and initiate signs of care.
- Record condition of headstones and monitor for safety.
- Grind stumps if practical.
- Engage a monument specialist to evaluate condition of toppled monuments and options for restoration/repair.

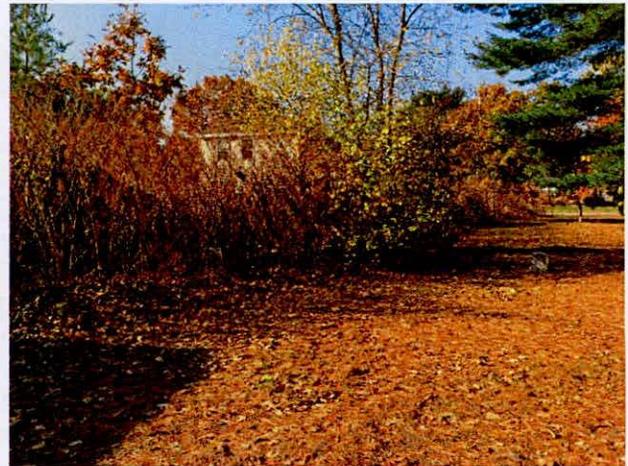
- **Vandalism.** Typically, neglected landscapes promote more vandalism than sites that are well cared for. While the site had no visible signs of vandalism, the combination of invasive plant material encroaching on the site, pipe railing that was broken or damaged and a lack of clear boundaries contributed to a feeling of neglect within the space. Continuing to maintain the property, repair minor features that do not require extensive restoration and maintain clear and open sightlines, will be important to project signs of care to help in limiting vandalism.

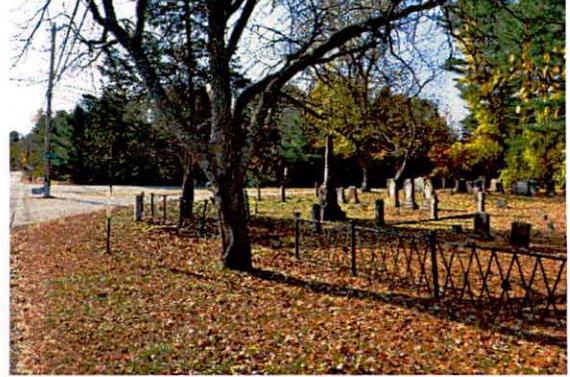
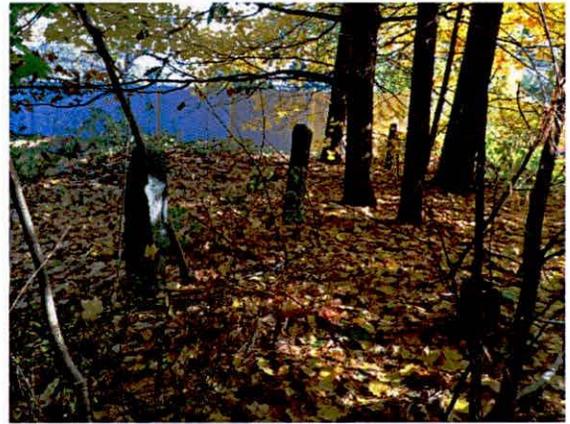
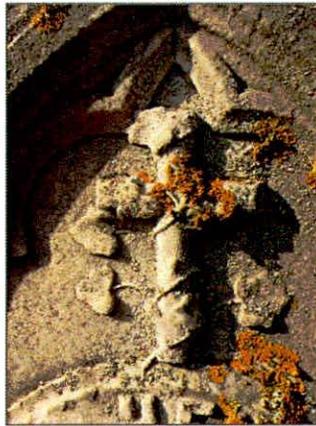
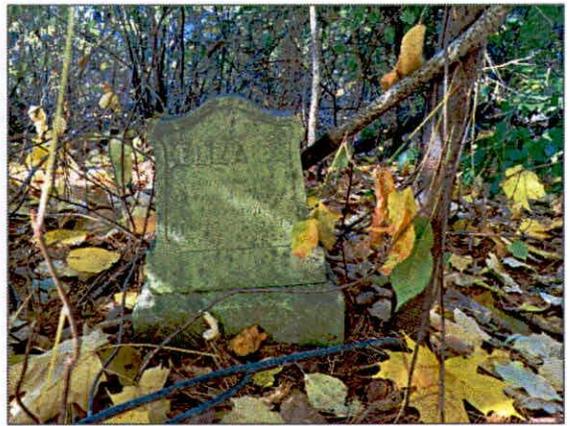
Within the mowed area, the monuments are in good condition with expected signs of deterioration. There are few trees within the maintained part of the cemetery and they appear to have been planted to define the perimeter of the cemetery. Throughout the years some of the trees have been removed and stumps remain while some trees have grown around adjacent granite monuments.

- **Monuments.** The grave markers were in good condition. Expected signs of deterioration were visible including discoloration, cracked and toppled headstones and surface deterioration which could be attributed to moisture, freeze/ thaw cycles, pollution and algae and lichen colonization. The headstones that are located within the overgrown woodland will deteriorate at a much faster rate. Vegetation should be removed around all existing headstones.

- Remove invasive vegetation from within the wooded area and remove plant material around gravestones. Maintain a vegetated buffer between adjacent properties.
- Prune existing trees and shrubs to maintain sightlines and safety.
- Remove broken granite posts.
- Provide appropriate fencing or granite posts to define property lines, clarify ownership and initiate signs of care.
- Record condition of headstones and monitor for safety.
- Grind stumps where practical.

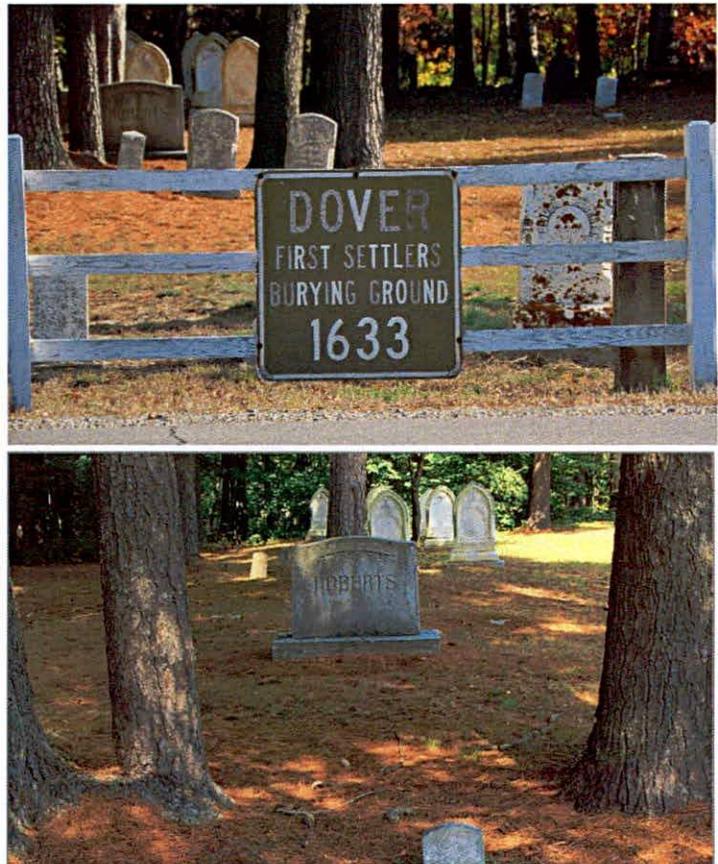
- **Monuments.** The grave markers were in good condition. Expected signs of decay were visible including discoloration, cracked and toppled headstones and surface deterioration which could be attributed to moisture, freeze/ thaw cycles, pollution and algae and lichen colonization.

- **Vegetation.** The cemetery is primarily open lawn which appears to be in poor condition. The lawn was patchy with prolific moss and weeds, both signs of soil deficiencies. If this was a priority, a combination of soil aeration, over-seeding, and fertilization would help bring a healthy lawn back. A woodland border extends around the rear and sides of the cemetery; canopy trees planted along Dover Point Road would add character and shade to this site.

- Record condition of headstones and monitor for safety.
- Grind stumps where practical.
- Plant three to four shade trees along the road frontage.
- Provide additional informational signage regarding the significance of this cemetery.
- Test existing soils to evaluate nutrient deficiencies and pH levels.
- Aerate soil, provide application of lime (based upon soil pH) and fertilize with an organic fertilizer before seeding. At a minimum, over-seeding with a drought tolerant grass is recommended for areas with exposed soil.

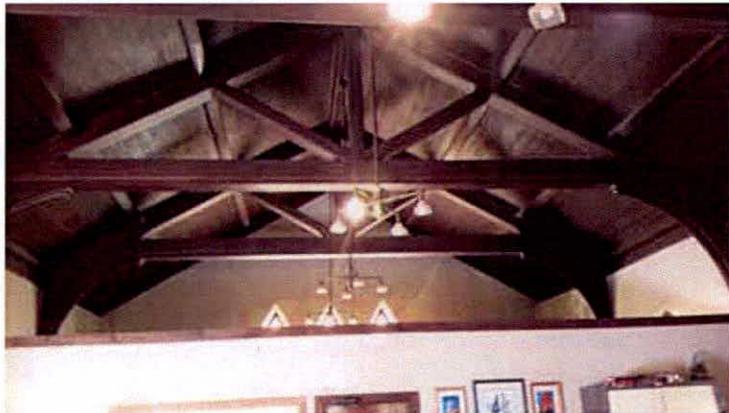
Chapel interior.
